SUBJECT: Submits relief request RR2-1 to allow continued plant operation w/two pin hole leaks in 3/4 inch ASME Code Class 2 chemical injection weldment.

KEWAUNEE

RELIEF REQUEST NO. RR2-1 TO ALLOW CONTINUED
PLANT OPERATION

Relief Request RR2-1

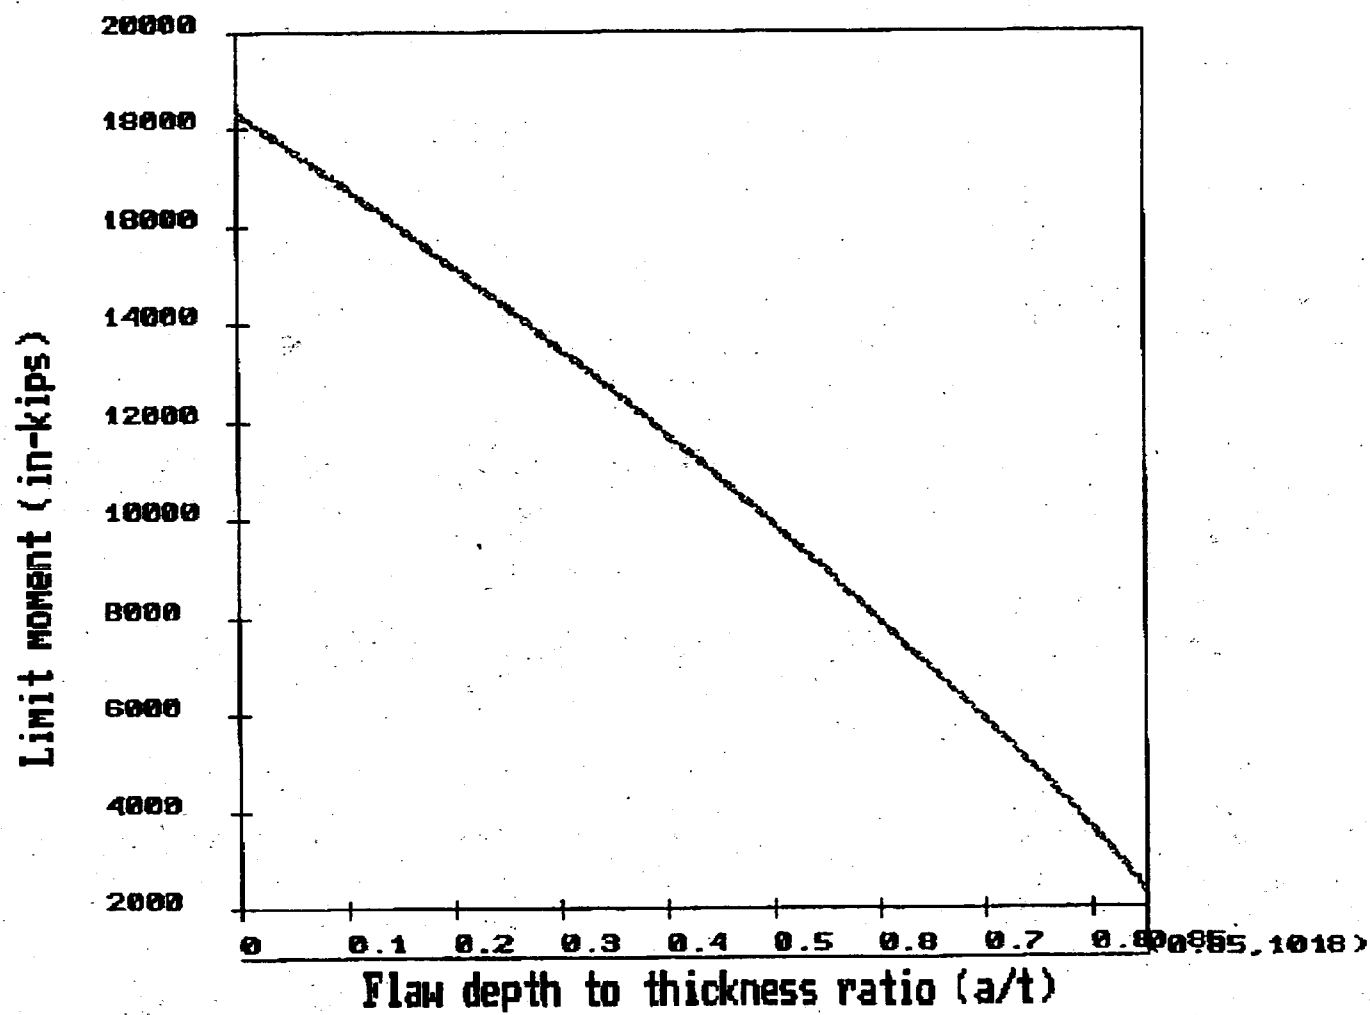
Figure 7

WEP FW line - dw + OBE

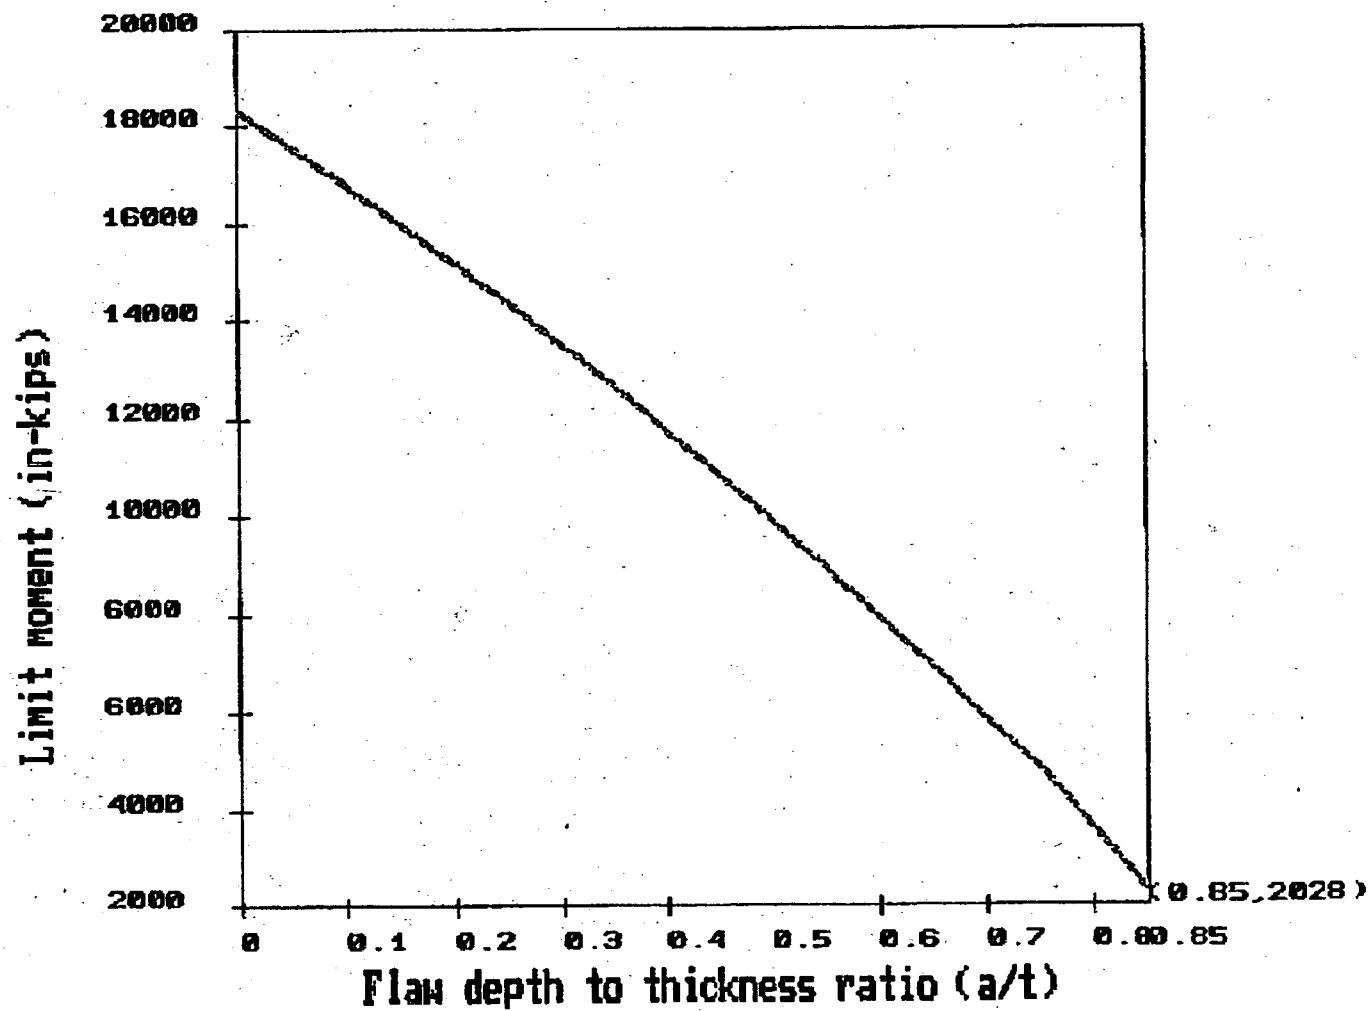
HEP FH line - DM + DBE
