SUBJECT: Proposed Amend 144b to License DPR-43, allowing laser-welded repair of Westinghouse hybrid expansion joint sleeved SG tubes. Non-proprietary & proprietary repts encl. Proprietary repts withheld.

Docket 50-305
Operating License DPR-43
Kewaunee Nuclear Power Plant
Proposed Amendment 144b to the Kewaunee Nuclear Power Plant Technical Specifications:
Laser Welded Repair of Degraded Westinghouse Hybrid Expansion Joint Sleeves

Proposed Amendment 144b

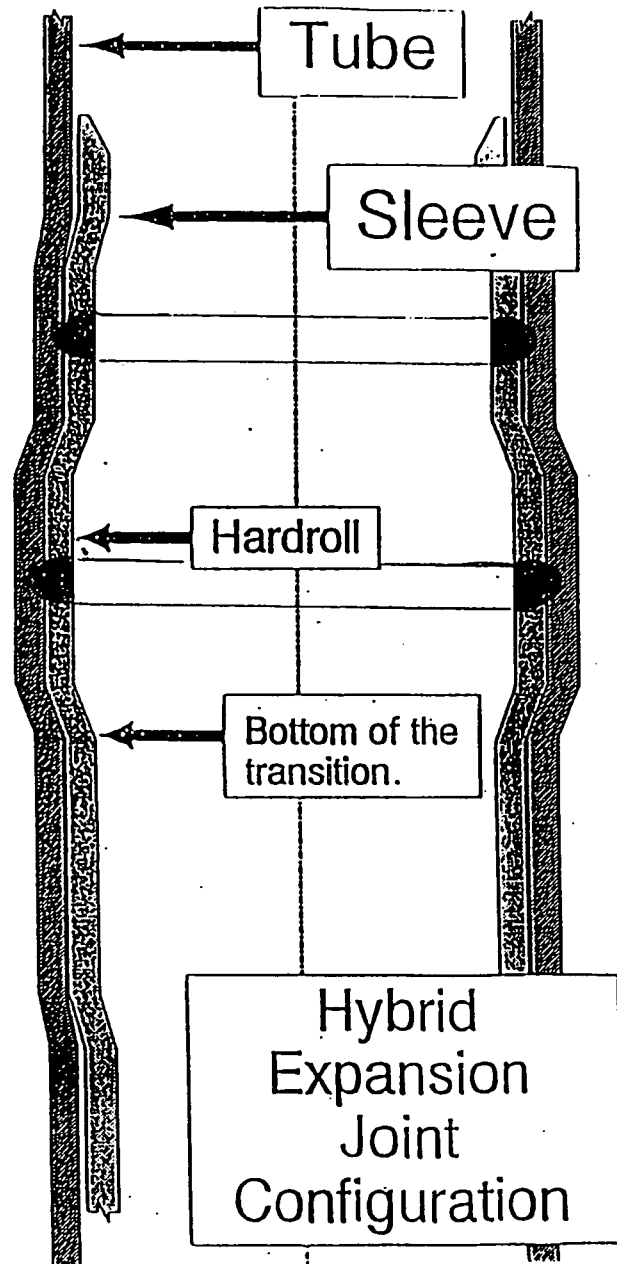
FIGURE 1

The proposed repair process, illustrated on Figure 1, is performed by fusing the parent tube and the sleeve using an autogenous laser welding technique. The repair weld is formed in either the approximate mid-point of the hardroll (HR), or in the upper hydraulic expansion (HE) of the upper HEJ. By fusing the sleeve to the tube, parent tube degradation below the weld location is isolated and a new pressure boundary is formed. The new pressure boundary (the weld) satisfies both the structural and leakage integrity requirements of the sleeved tube assembly with no change in the flow or heat transfer characteristics of the sleeved tube. Extensive testing and analytical work has been performed by WPSC and Westinghouse to demonstrate the acceptability of the LWR process. The results of this work are documented in the reports SGO-ATD-96-13, "Interim Report on Laser Weld Repair of Hybrid Expansion Joint Sleeves," dated April 4, 1996; WCAP-14685, Revision 2, "Laser Weld Repair of HEJ Sleeves for Kewaunee Nuclear Power Plant," dated April 1997; and Addendum 1 to WCAP-14685, "Evaluation of Weld Repaired HEJ Sleeved Tubes," dated April 1997.
