Docket 50-305
Operating License DPR-43
Kewaunee Nuclear Power Plant
Relief Request No. RR3-1 for Performing a Temporary
Non-Code Repair on the ASME Code Class 3 Service Water System

Relief Request
RR3-1

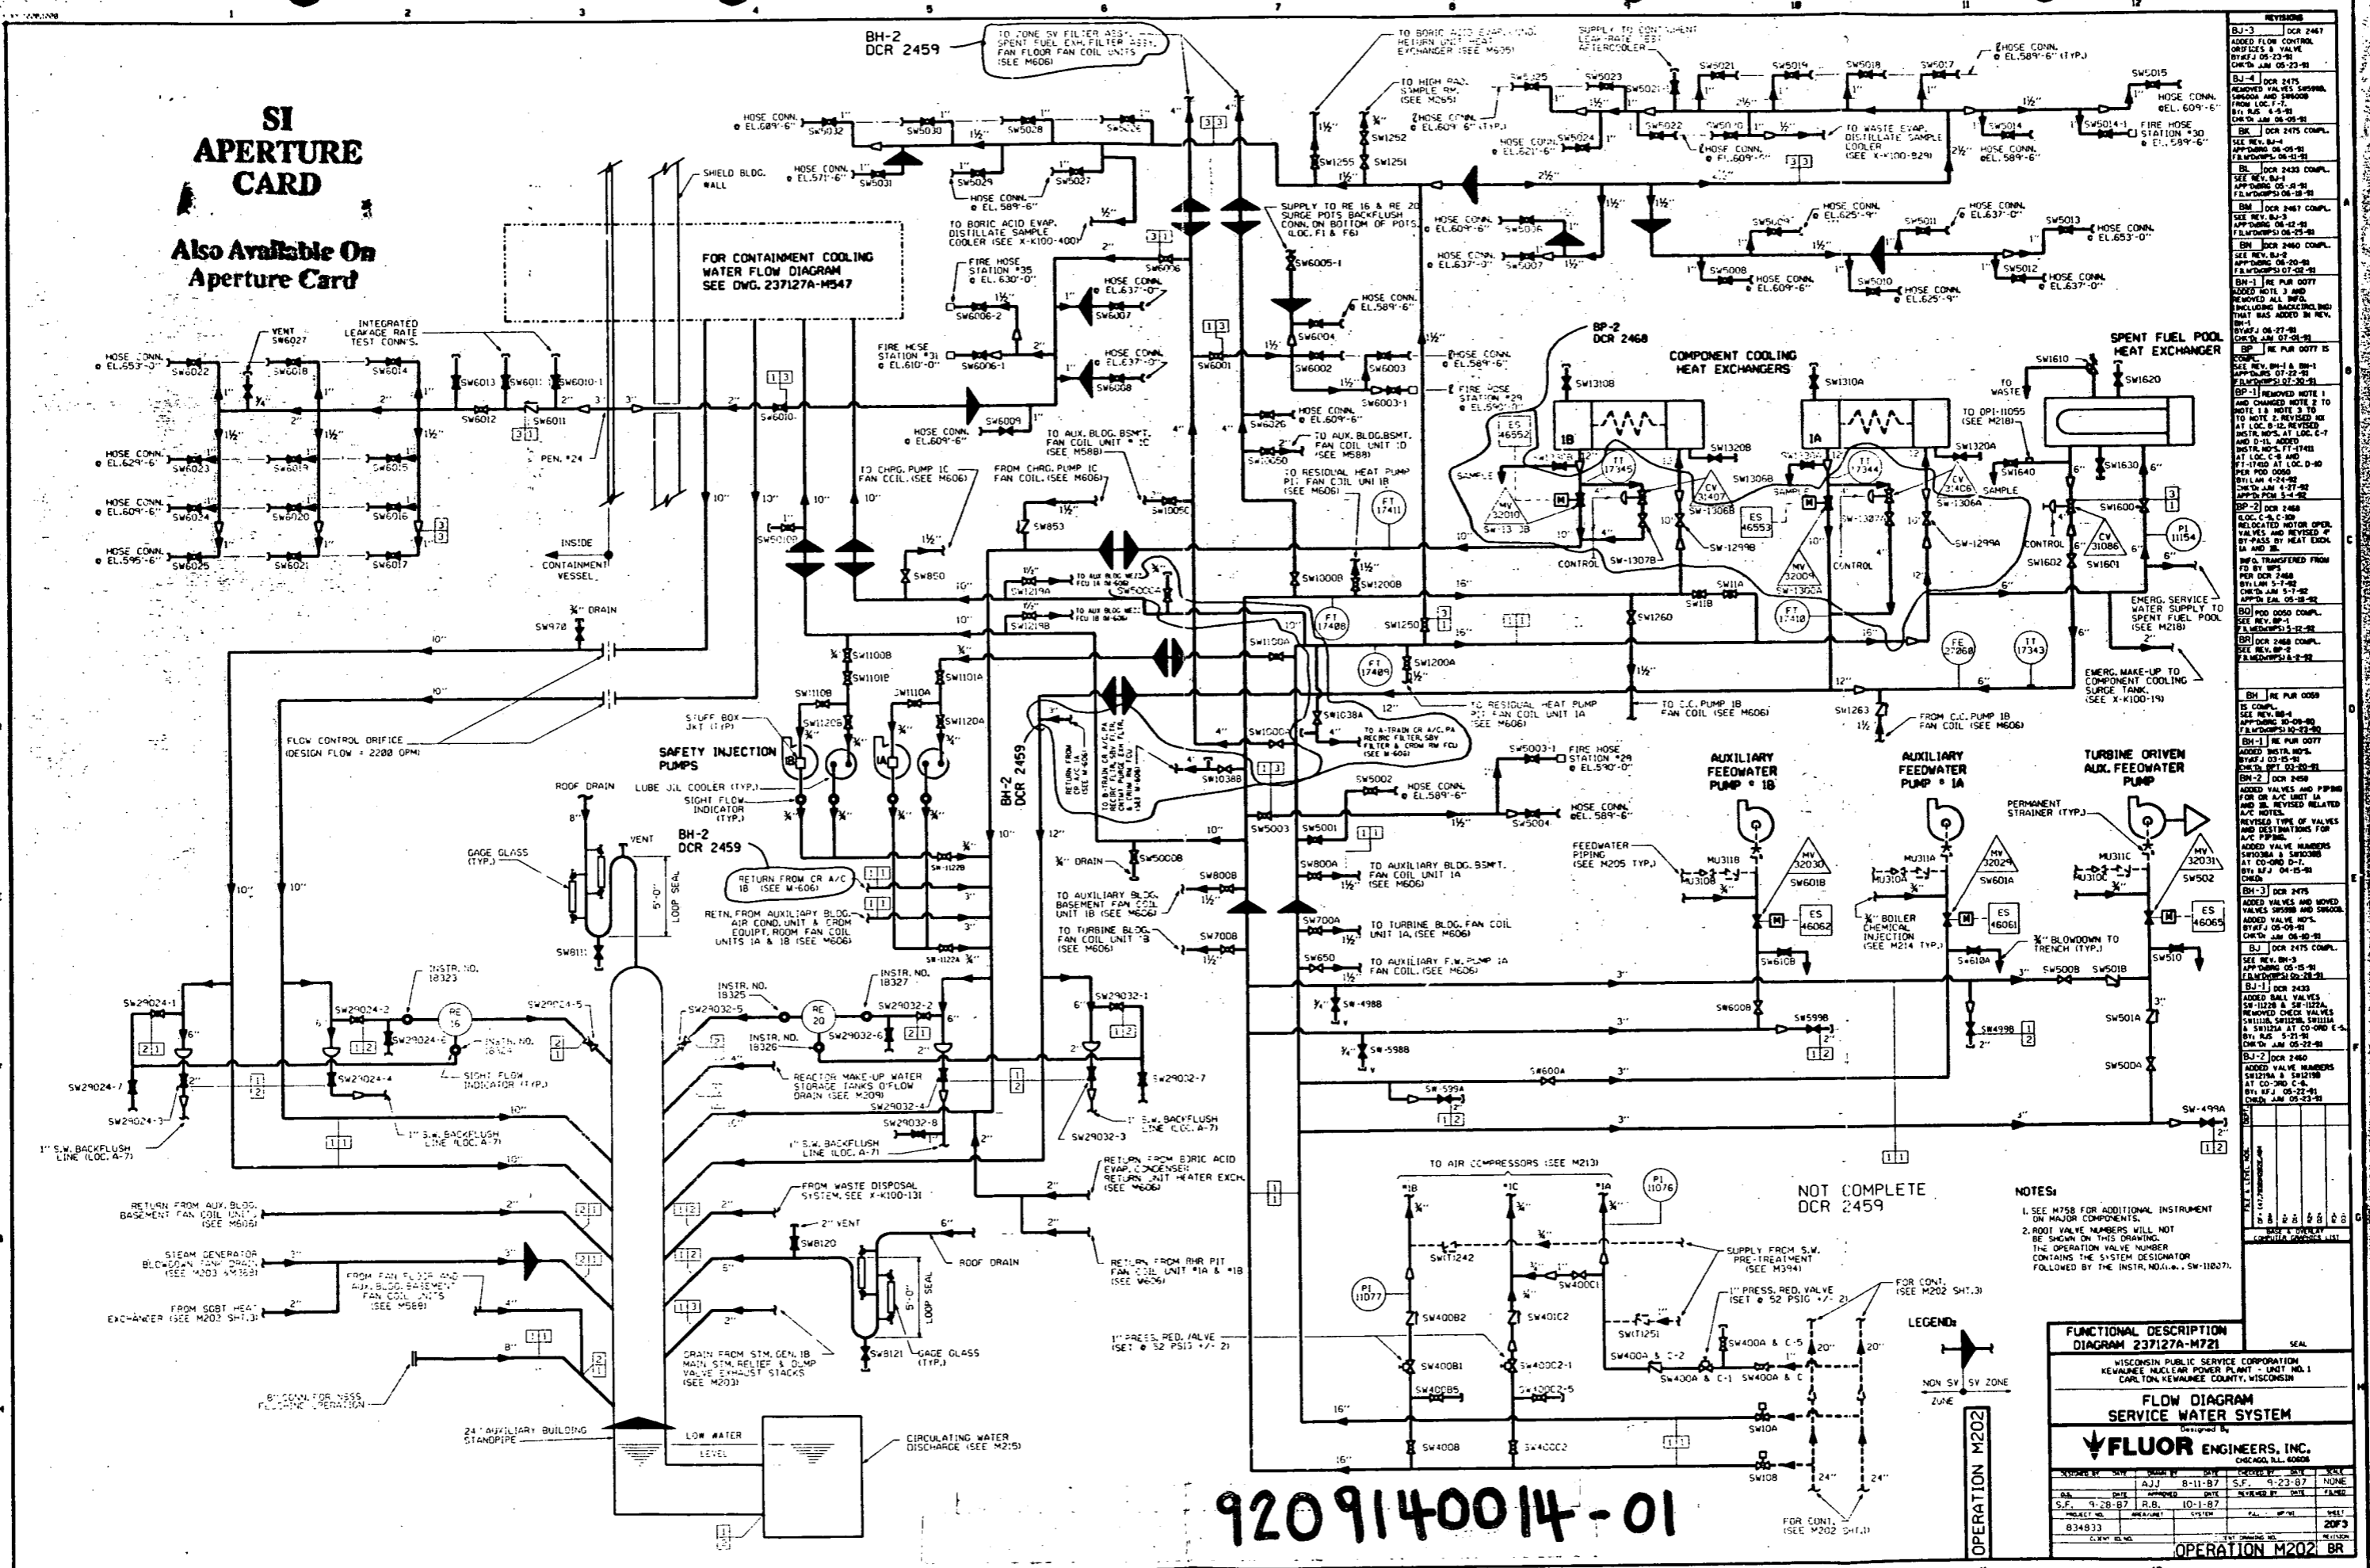
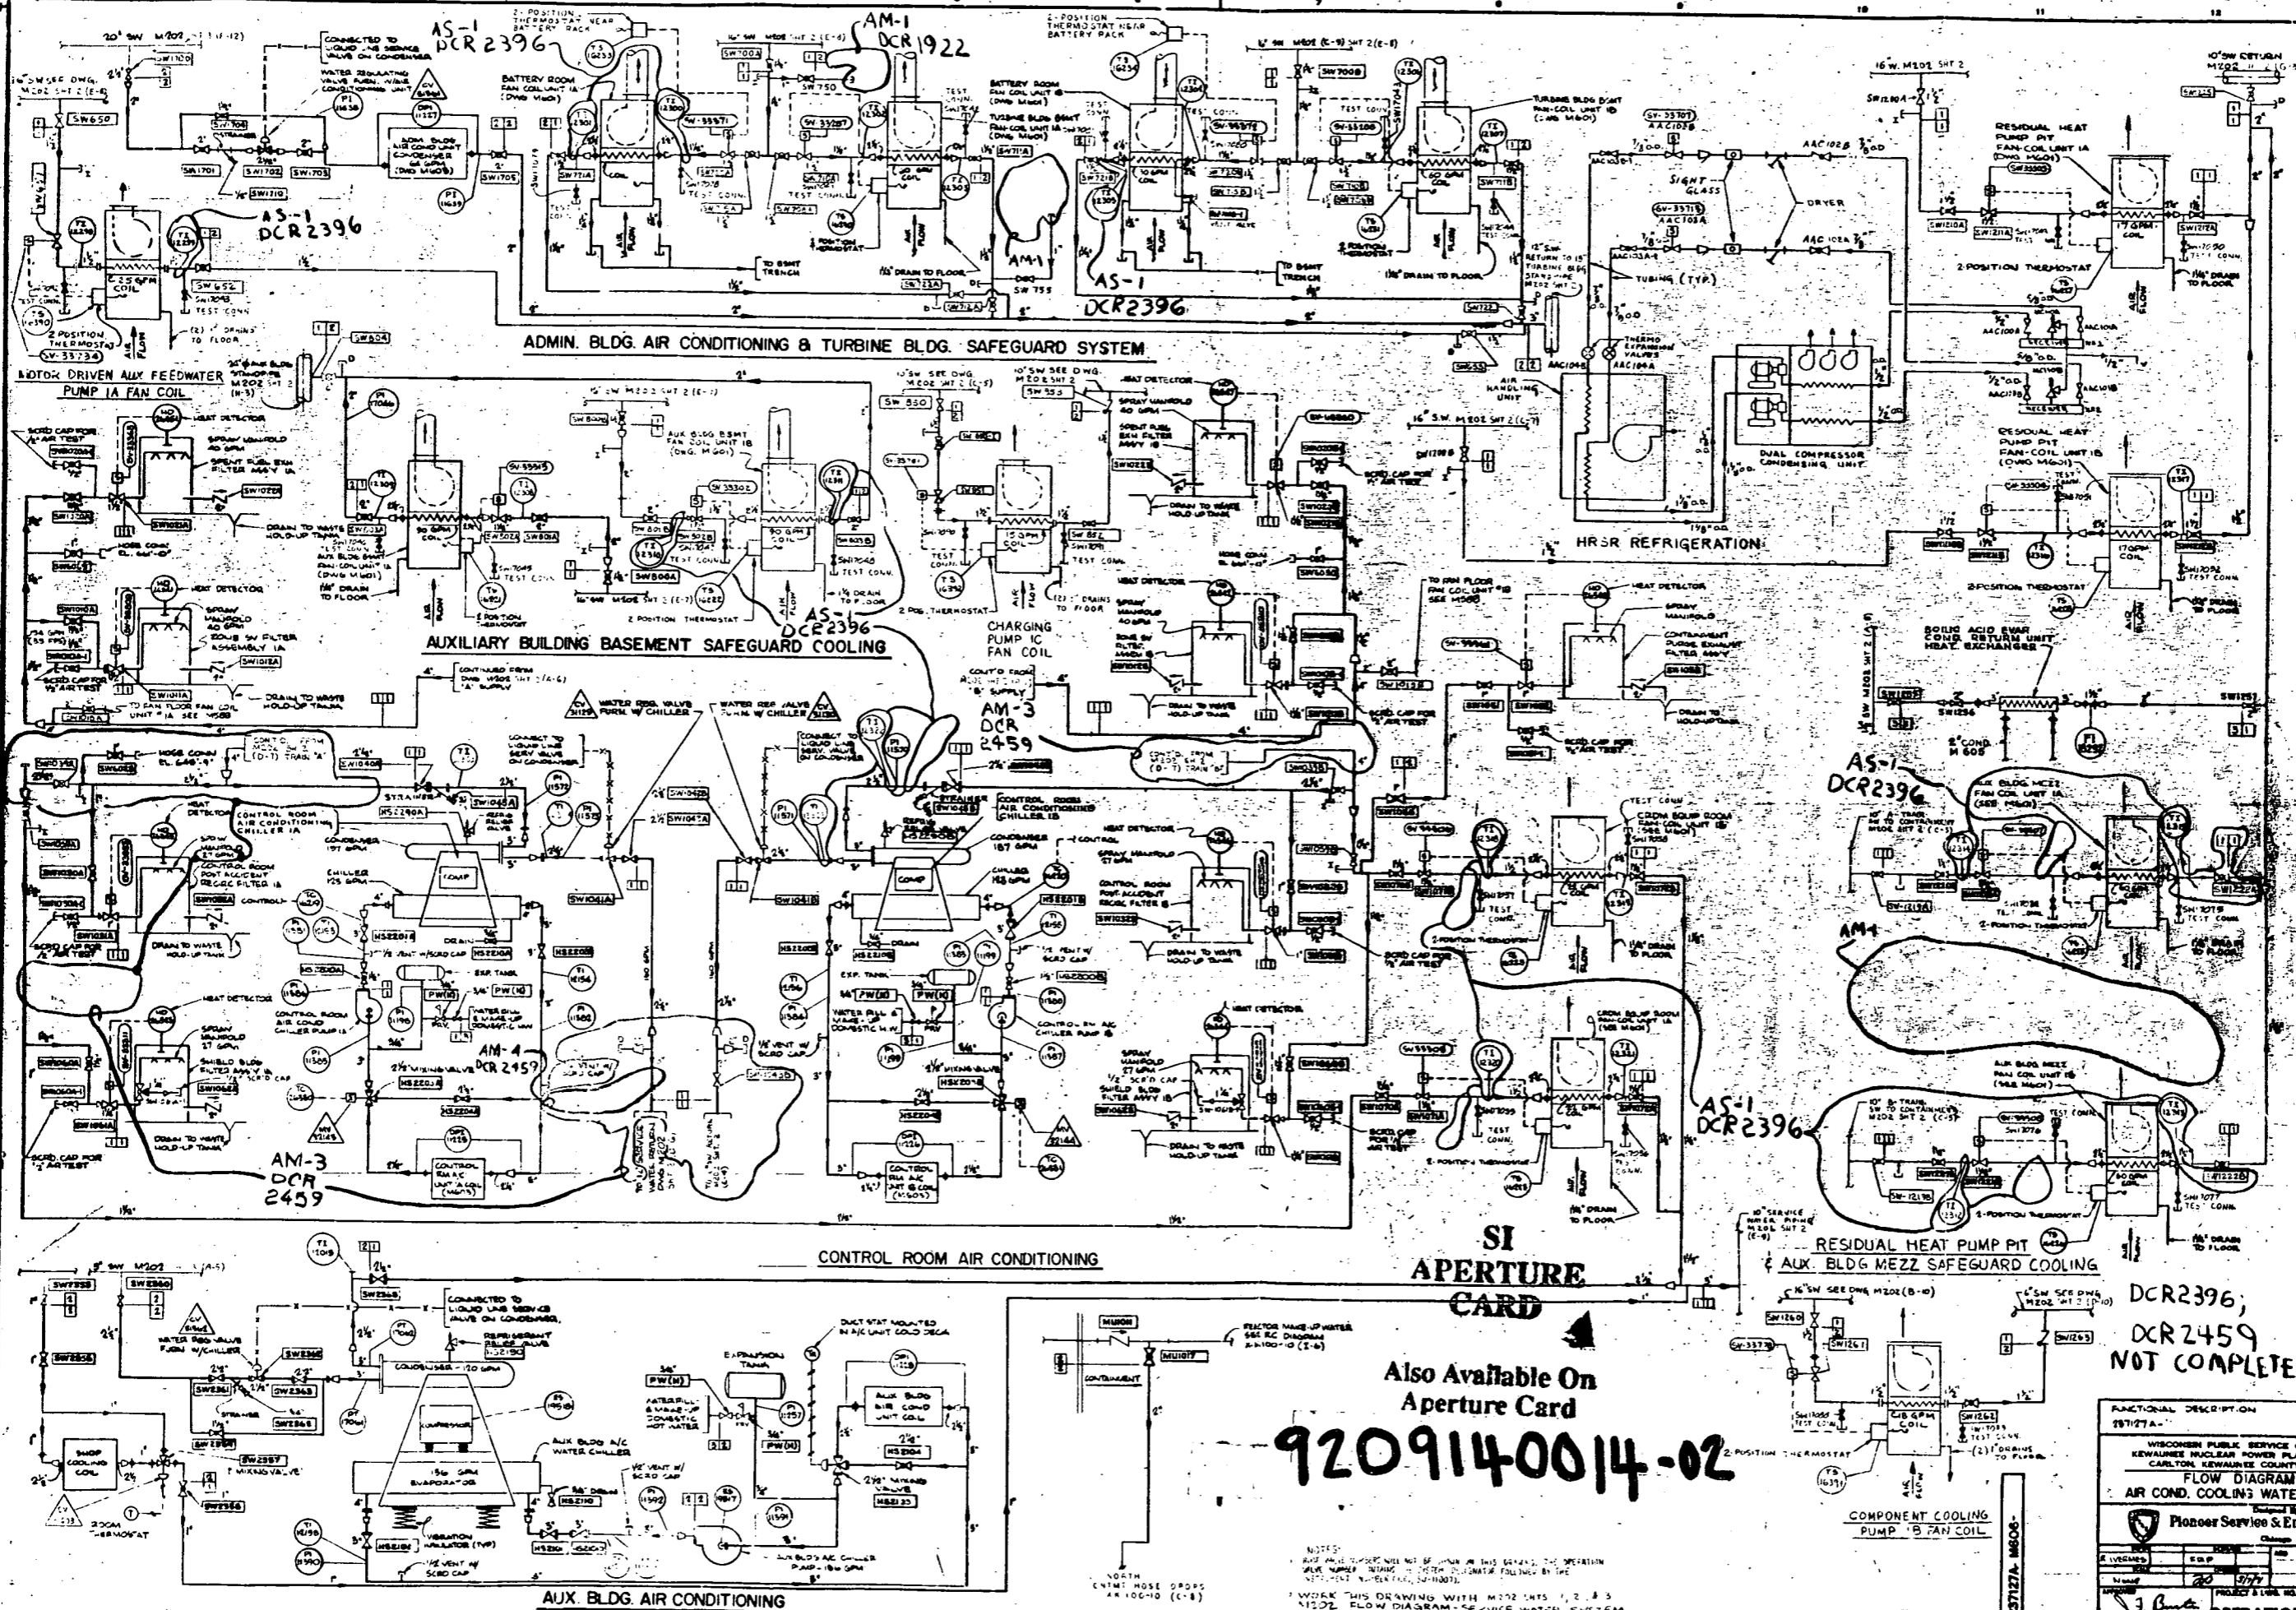
P&IDs M202, Sh 2
M606

During normal 100% power operation, leakage was detected on valve SW-800B. Valve SW-800B, as shown on the figure in Attachment 2, is the first isolation valve off the "B" SW 16" diameter header that supports "B" train engineered safety features (ESF) equipment. Several options to repair SW-800B were evaluated by the plant staff. A summary of the various repair options is provided in the attached relief request. The conclusion reached is that it was impractical to isolate the "B" train SW header to perform a code-qualified repair during plant operation. Management concluded that it was in the best interest of plant safety to perform a temporary non-code repair. The proposed temporary repair consisted of clamping a canister to each side of the valve, thus encasing the valve and ensuring structural integrity.

Valve SW-800B establishes the boundary between the Section XI portion of the system and the non-code class portion. The threaded connection to this valve has degraded allowing leakage. The plant is currently operating at 100% power. To implement a Section XI qualified repair, this portion of the Service Water System must be isolated and drained. As described in Section 3, "Basis for Requesting Relief," isolating the "B" service water train is impractical without a plant shutdown.

The initial root cause of the failure was classified as fatigue caused by the cycling of a downstream solenoid valve. As part of this temporary repair, the Section XI ASME Boiler and Pressure Vessel Code Class Boundary will be temporarily moved to the next valve (i.e., SW-801B). This piping valve extension are classified as QA-1 safety-related components. Furthermore, the solenoid valve of interest will be maintained in the open position to eliminate any additional fatigue.
