UNITED STATES
NUCLEAR REGULATORY COMMISSION

July 1, 2011

Subject: COOPER NUCLEAR STATION - NRC SPECIAL INSPECTION REPORT
05000298/2011008

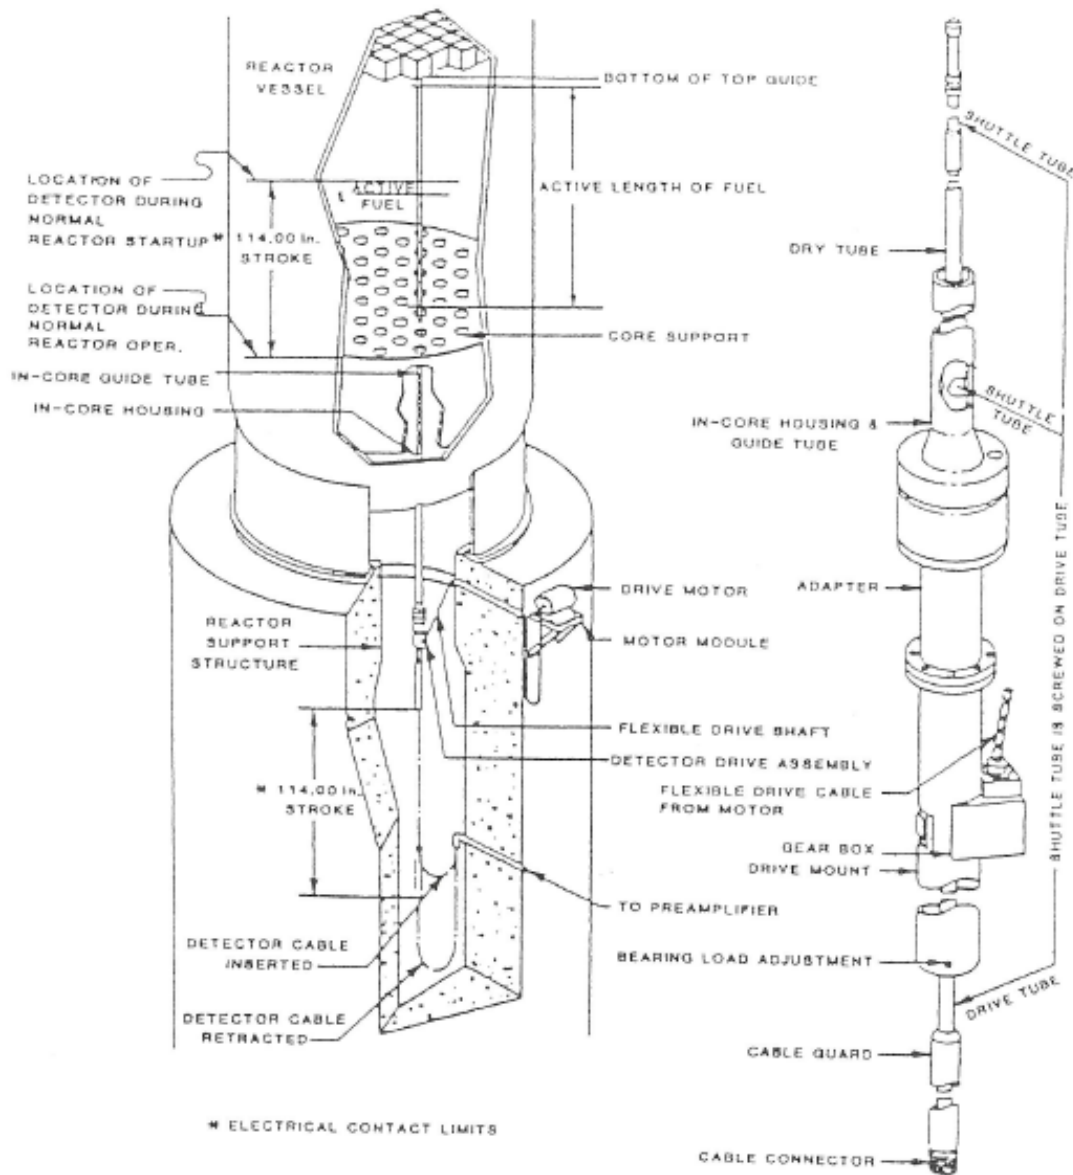
Figure 9, Rev. 0
IAC722-00-00

On April 2, 2011, instrumentation and control technicians prepared to remove the source range monitor B and the intermediate range monitor C shuttle and dry tube assemblies from the top of the reactor vessel in accordance with Work Orders 4741006 and 4741002. Each intermediate range monitor and source range monitor detector is contained inside a shuttle tube. This shuttle tube is fixed to a drive tube that a drive mechanism moves up and down inside a dry tube. The entire tube assembly, along with the detector was to be replaced. Arrangement of these components is depicted in Attachment 3.

SOURCE RANGE & INTERMEDIATE RANGE DETECTOR DRIVE

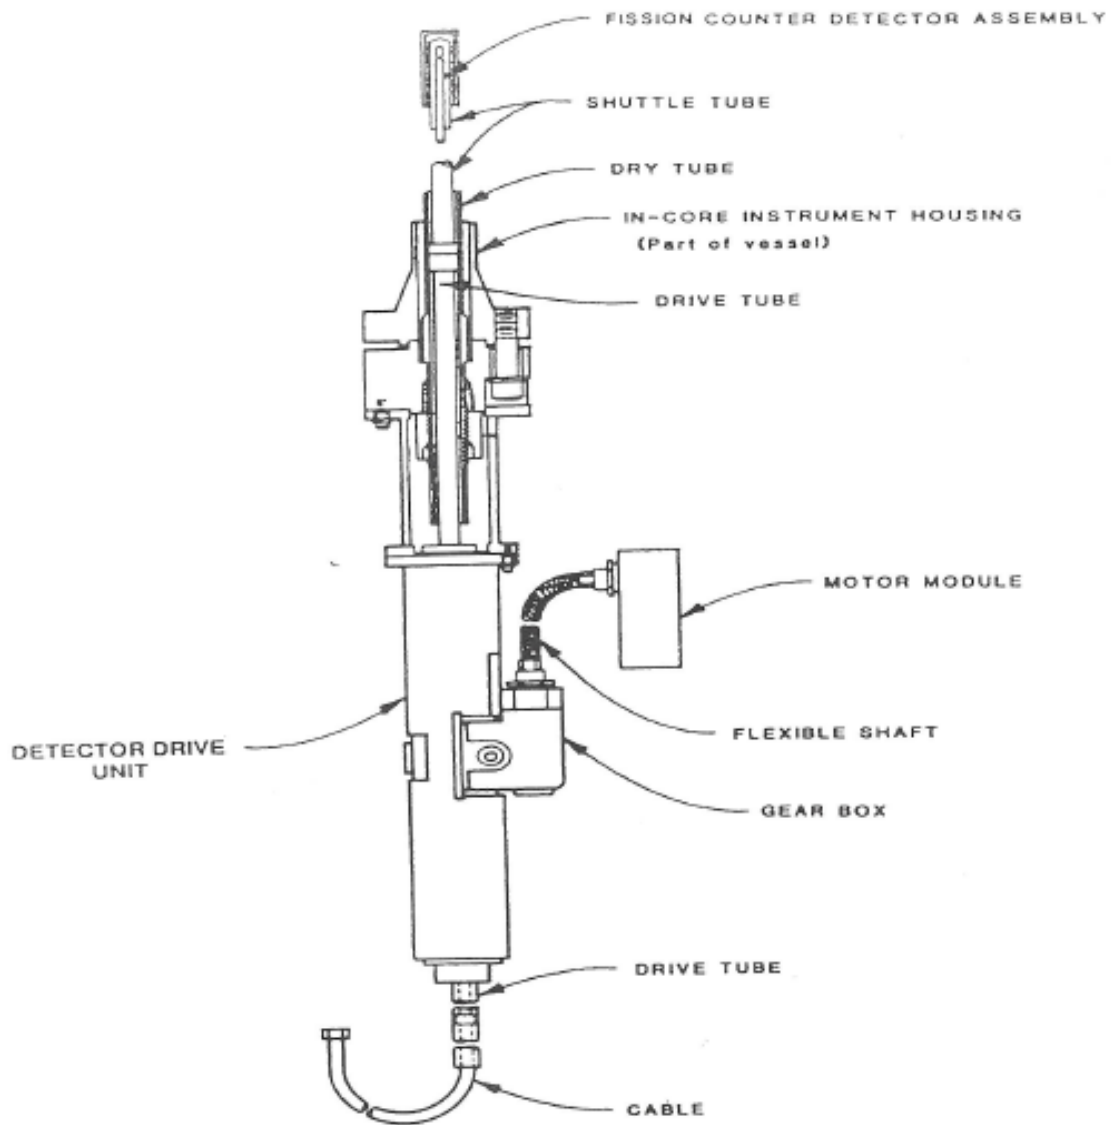
Figure 12, Rev. 0
IAC722-00-00

DETECTOR DRIVE UNIT
