SUBJECT: Forwards results of Zetec reanalysis for sample of SG tubes, as followup to util 930610 ltr providing summary info on util assessment of EddyNet program changes. Concludes that 1993 eddy current exam results remain unchanged.

Docket 50-305
Operating License DPR-43
Kewaunee Nuclear Power Plant
Additional Information on Eddy Current Data Reanalysis

ADDITIONAL INFORMATION REGARDING ZETEC STUDY
TO ASSESS DIFFERENCES IN REVISED MIX ALGORITHM

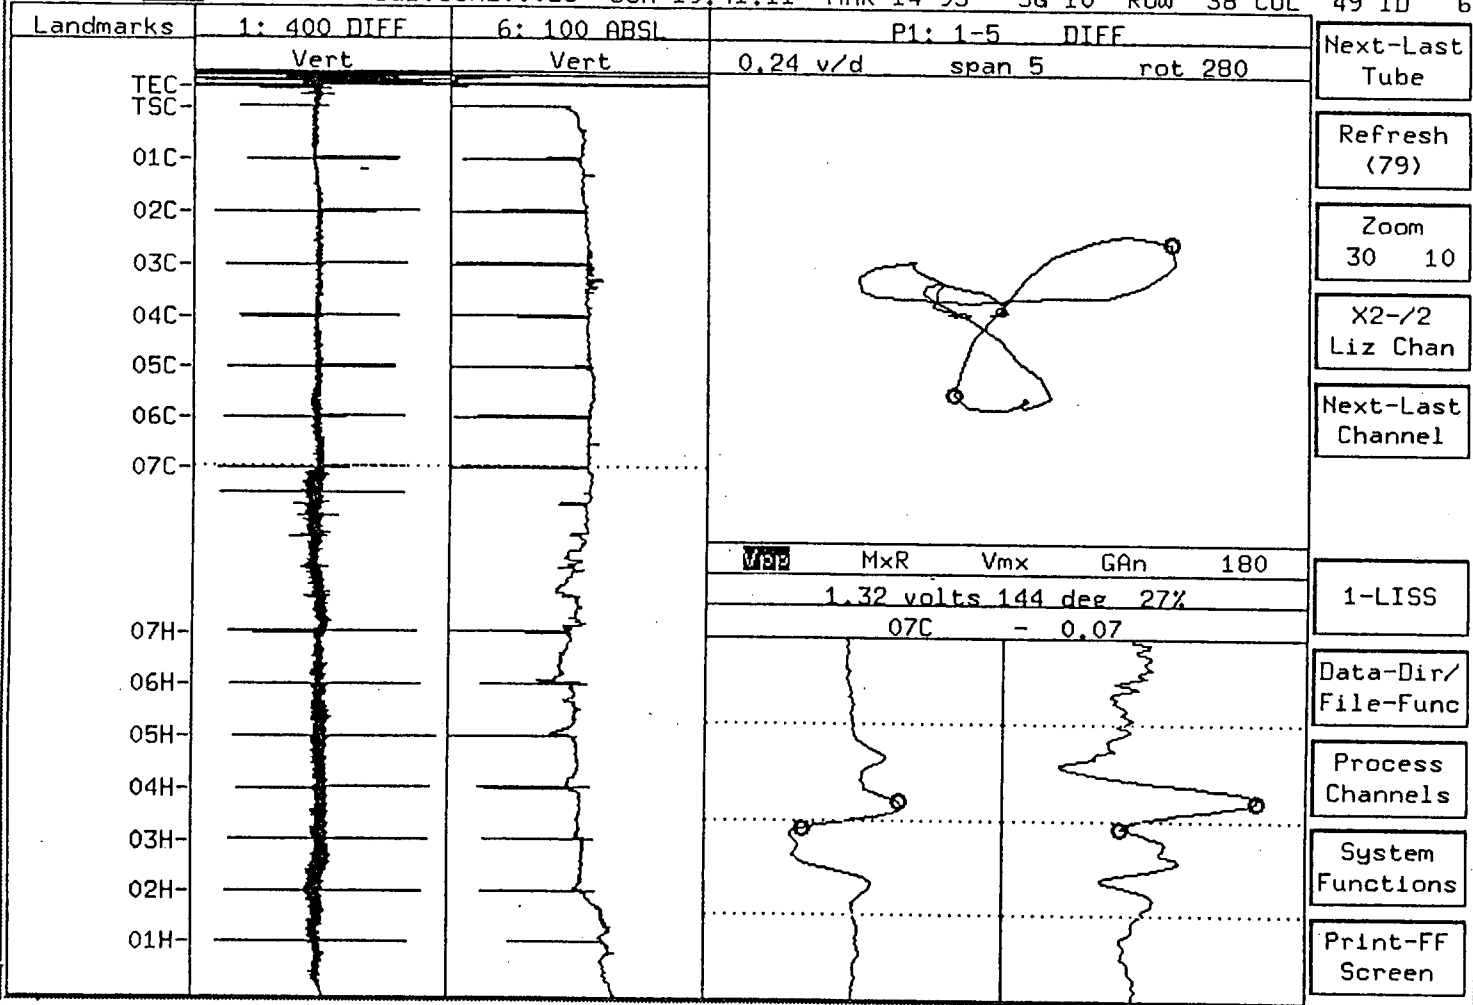
FIGURE 1

* Steam Generator A Row 38 Col 49 07C

The reported history during the field inspection was 21 % through wall. Reanalysis using a conventional peak to peak measurement with the old mix (Figure 1) indicates degradation at 27% through wall. Reanalysis with the new mix setup indicates degradation at 31 % through wall (Figure 2). Figure 2 illustrates a more clearly defined vector transition. In both cases, however, the indication is readily distinguishable from the lissajous pattern.

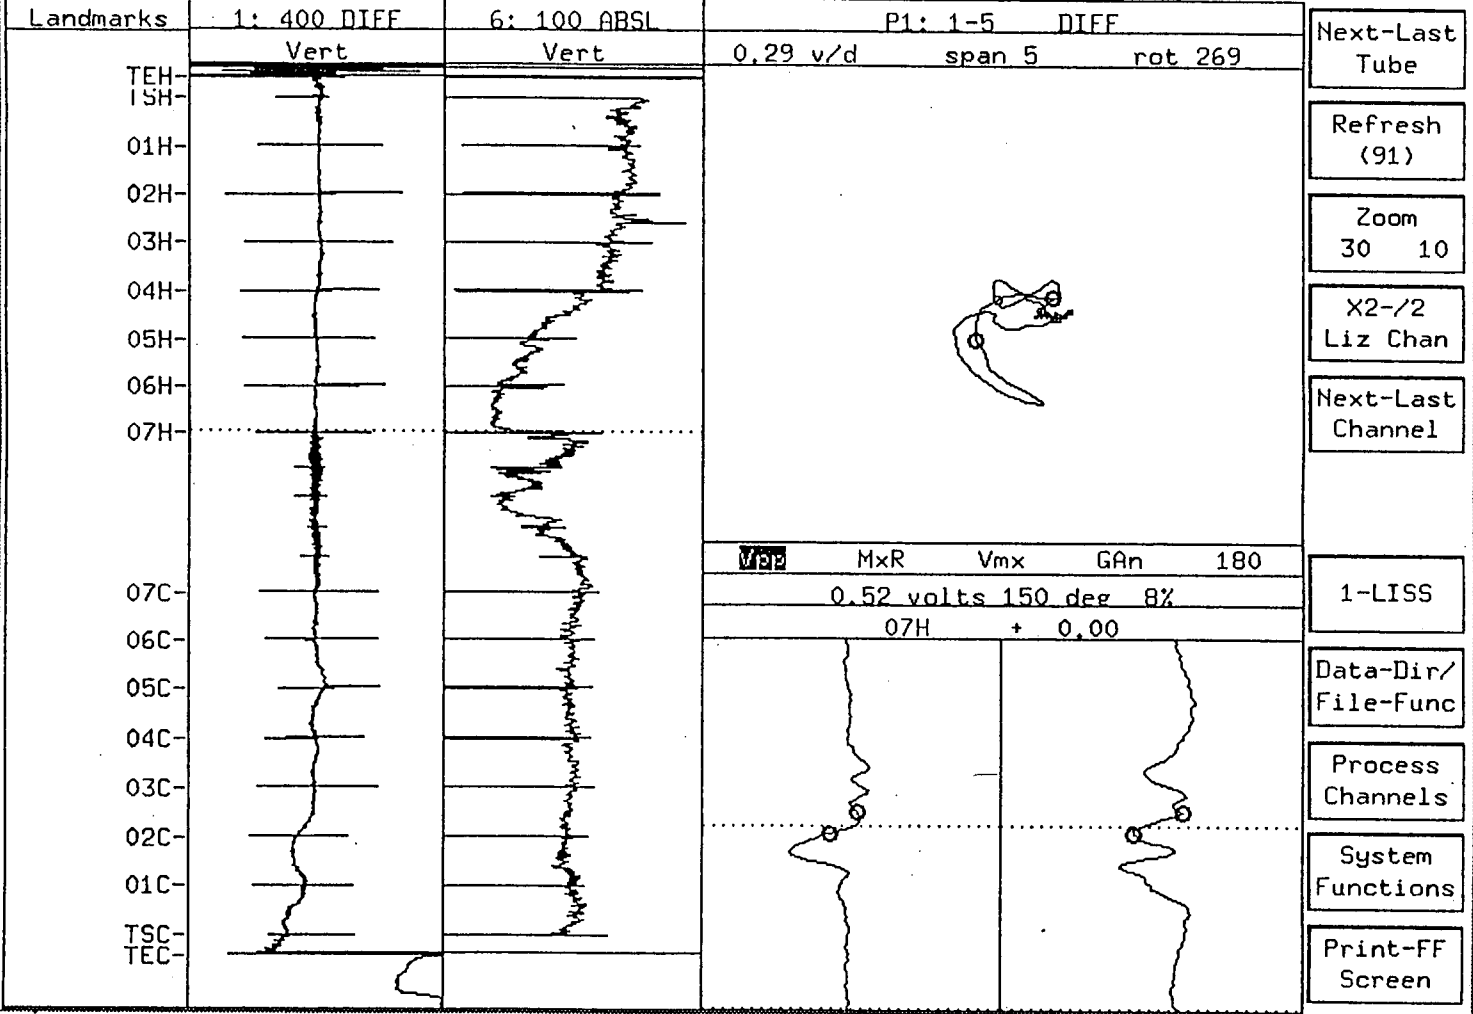
FIGURE 3

* Steam Generator A Row 40 Col 24 07H

Figures 3 and 4 show the eddy current traces of the reanalysis using the old and the new mix setups, respectively. Although the mix residual signal pattern has changed, the signal to noise of the indication remains approximately one to one. Therefore, with either the new or old mix the evaluation is affected by the noise in the mix residual. The new mix tends to have a straighter transition and in this case appears to be a bit deeper. This indication was subject to a MRPC exam during the 1993 outage and was not confirmed.

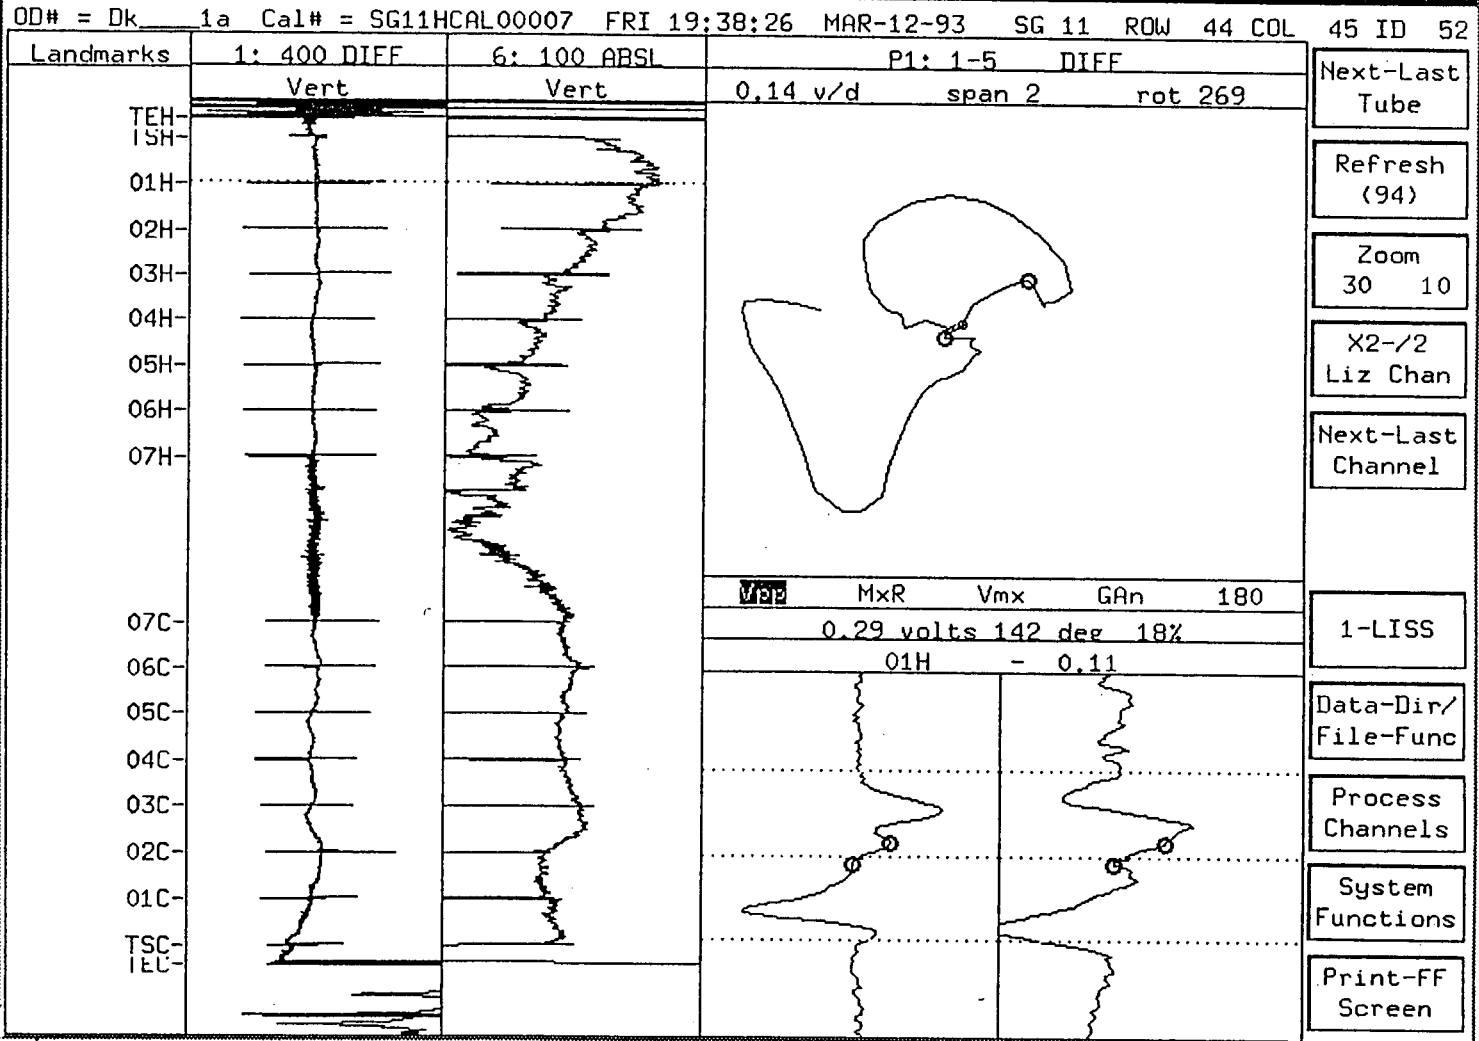
FIGURE 5

* Steam Generator A Row 44 Col 45 01H

Figures 5 and 6 show the eddy current traces of the old and new mix setups, respectively. Although the mix residual signal pattern has changed, the signal to noise of the indication remains a factor. In both the new and old mix, the evaluation is affected by the noise level in the mix residual. The new mix tends to have a straighter transition and appears to be a bit deeper.

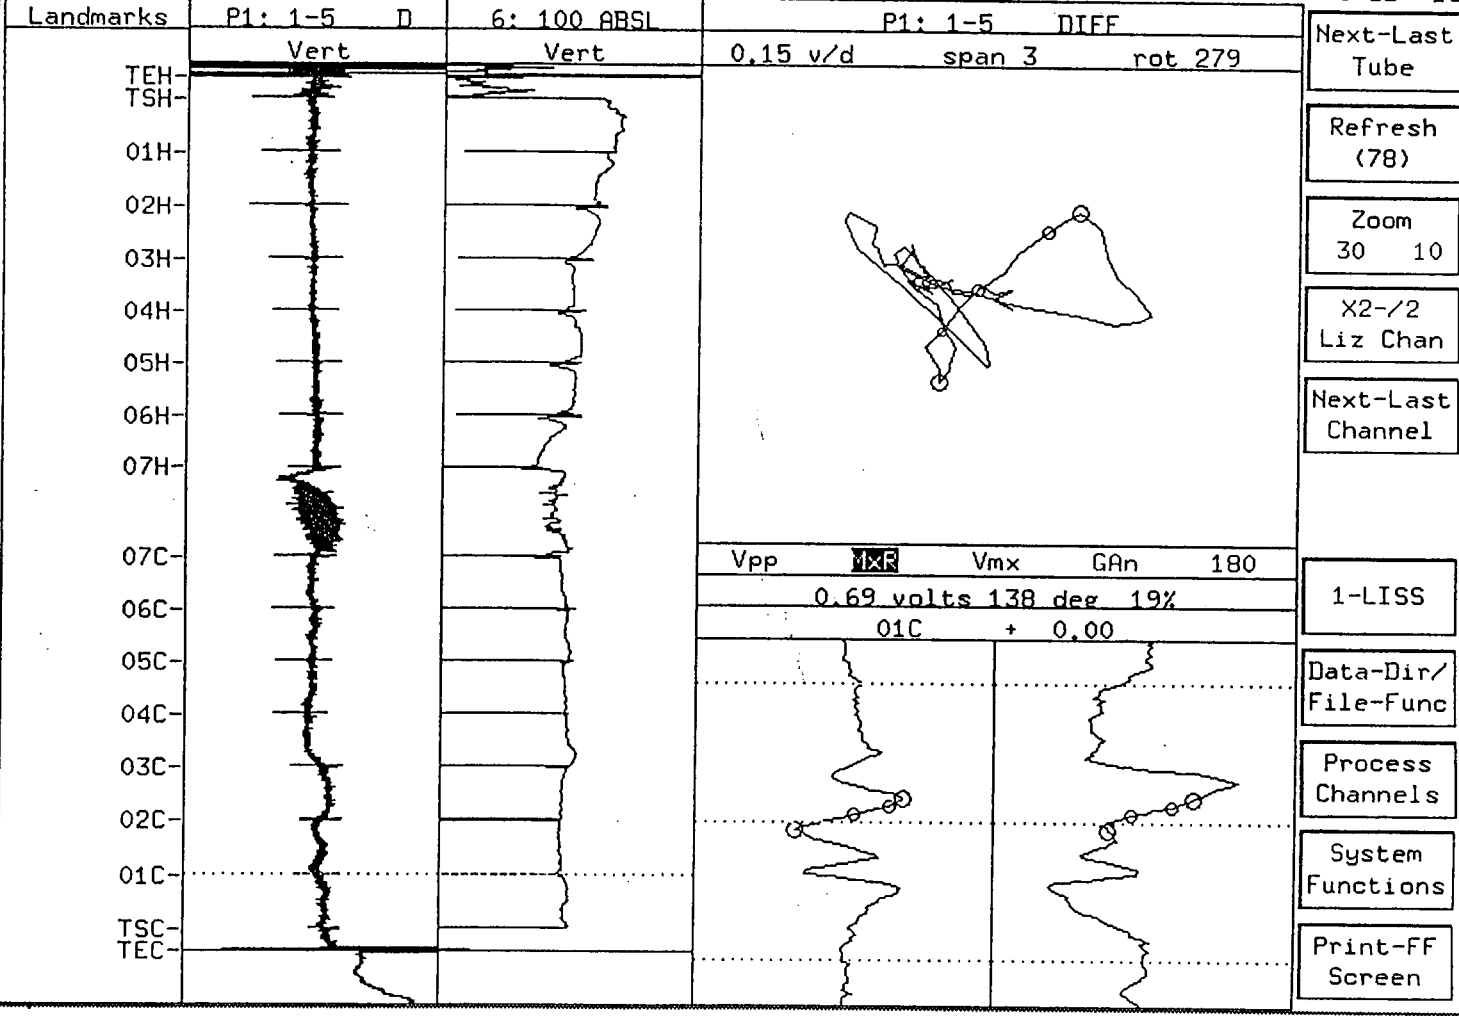
FIGURE 7

* Steam Generator B Row 19 Col 9 01C

Figures 7 and 8 show the eddy current traces of the old and the new mix setups, respectively. The mix residual signal pattern has changed. The signal to noise of the indication remains a factor. In both the new and old mix, the evaluation is affected by the noise level in the mix residual. The old mix in this case appears to be a bit deeper which would indicate when the signal to noise is less than optimum, the variation in the two mixes could show either an increase or decrease in depth.

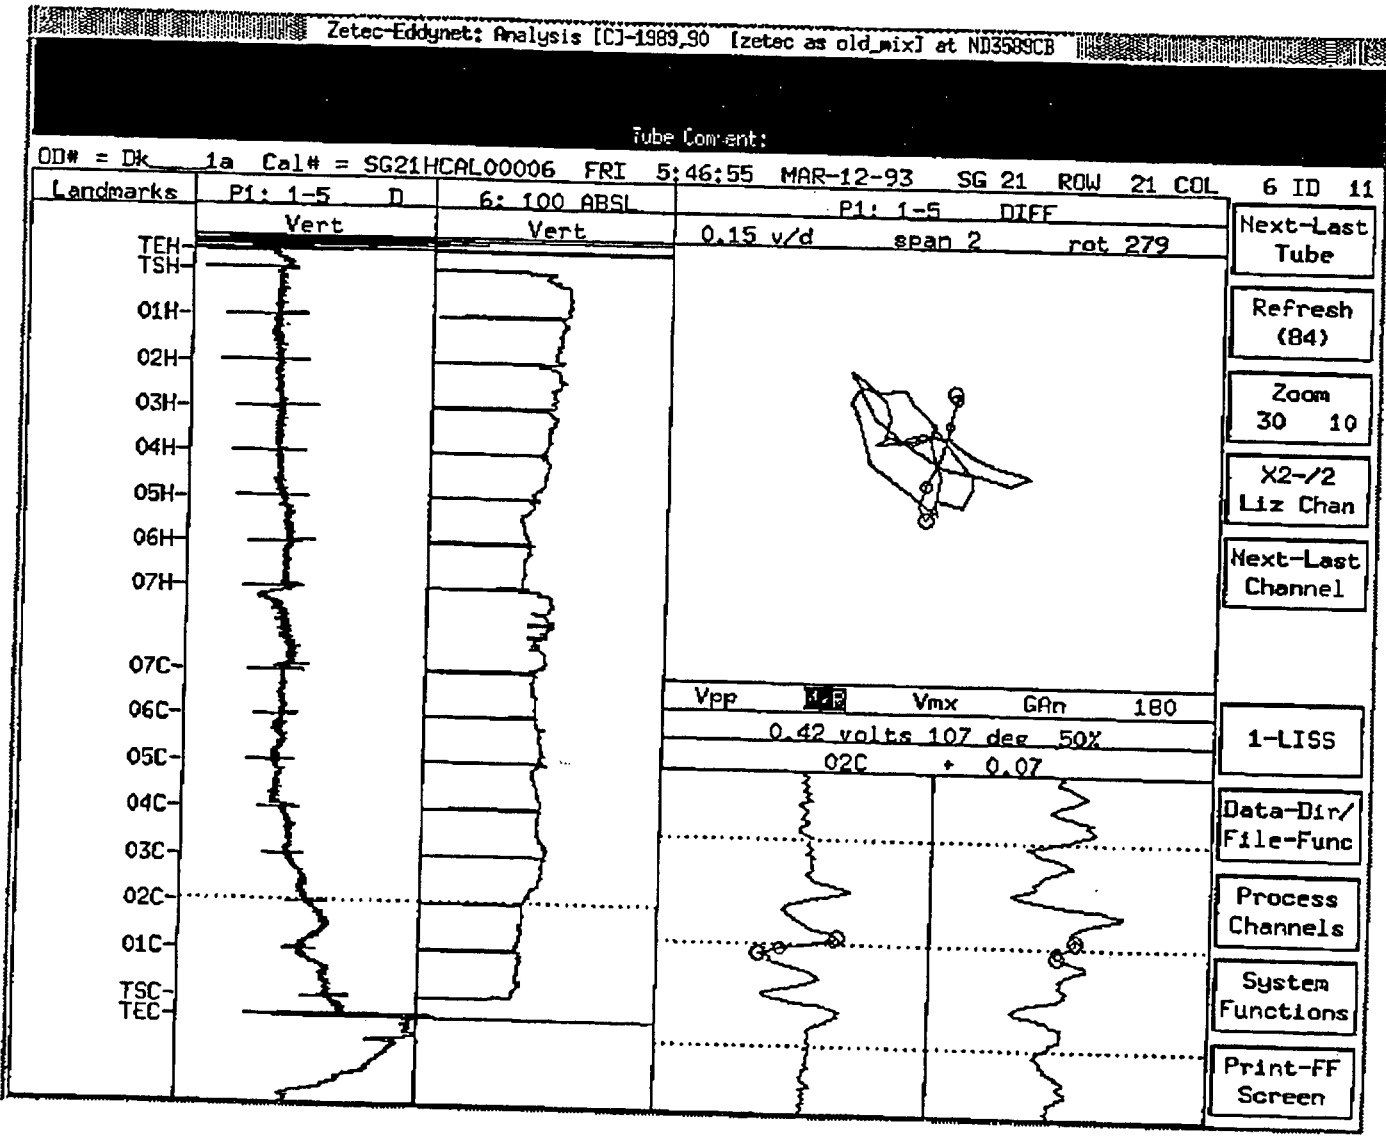
FIGURE 9

* Steam Generator B Row 21 Col 6 02C

Figure 9 and 10 show the eddy current traces from both the old and the new mix setups, respectively. Once again the old mix in this case appears to be a bit deeper which would indicate when the signal to noise is less than optimum, the variation in the two mixes

could show an increase or decrease in depth measurement using phase analysis. Reanalysis with the old mix setup reported degradation at 50% through wall. Original field analysis reported degradation at 46% through wall. Reanalysis with the new mix dispositioned this indication at 35% through wall.
