## CALVERT CLIFFS NUCLEAR POWER PLANT

**SUBJECT:** Calvert Cliffs Nuclear Power Plant  
Unit No. 2; Docket No. 50-318  
Spring 2011 – 180 Day Steam Generator Report

**CALVERT CLIFFS UNIT 2, SPRING 2011 –  
180 DAY STEAM GENERATOR REPORT**

**Calvert Cliffs Unit 2 -- U2R19 180-Day Report**

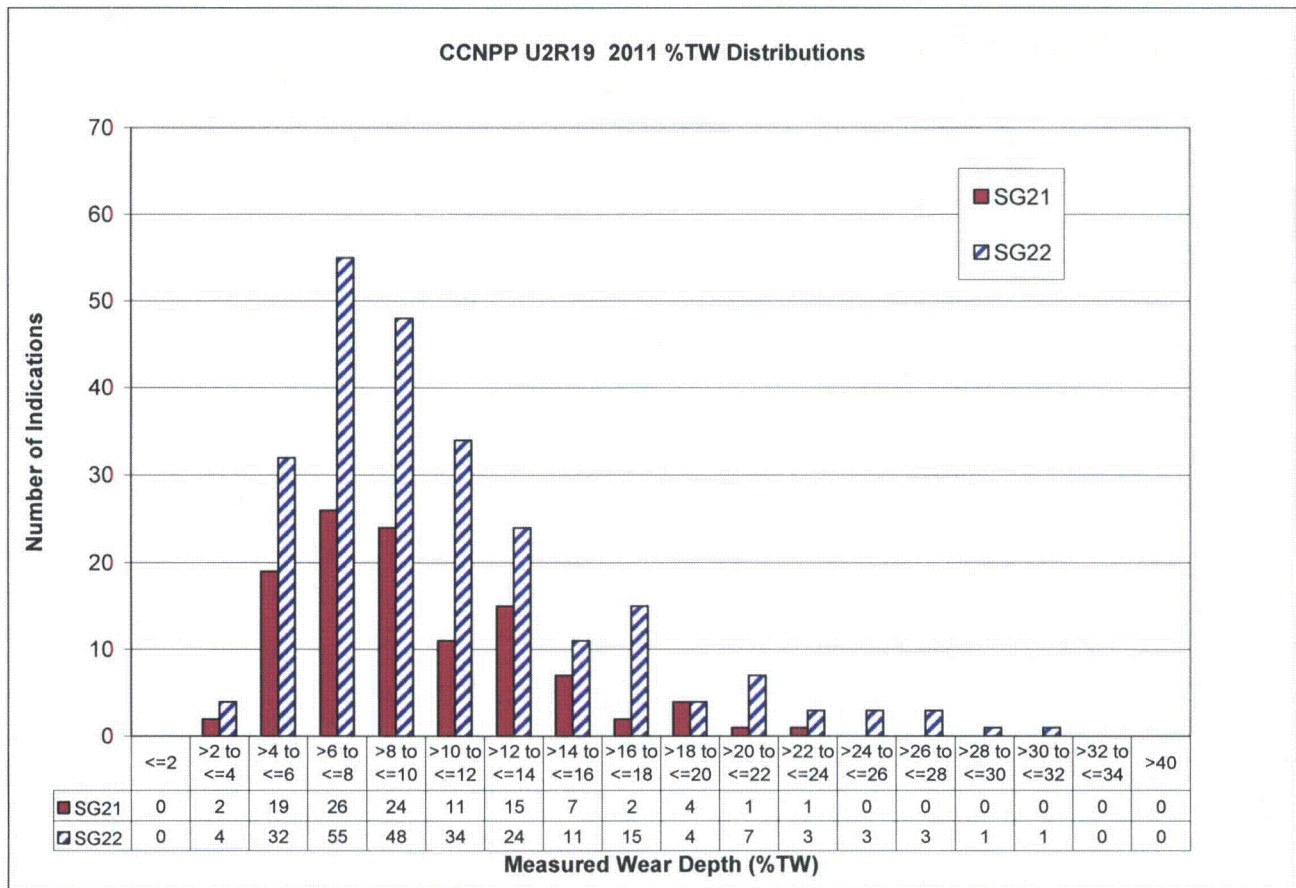
Figure 1 – Fan Bar Wear Throughwall Depth Distribution

Thirty-one of the 358 indications were newly reported during U2R19. This represents an increase of about 10% since the last inservice inspection in 2009 (U2R18). The maximum depth reported was a 32%TW indication in SG22. The largest newly-reported indication was an 18%TW indication in SG22. Figure 1 provides the distribution of fan bar wear depths for both steam generators as reported with the

bobbin coil probe. As shown in the figure, SG22 contained more indications and also contained the majority of indications that were greater than 20%TW.

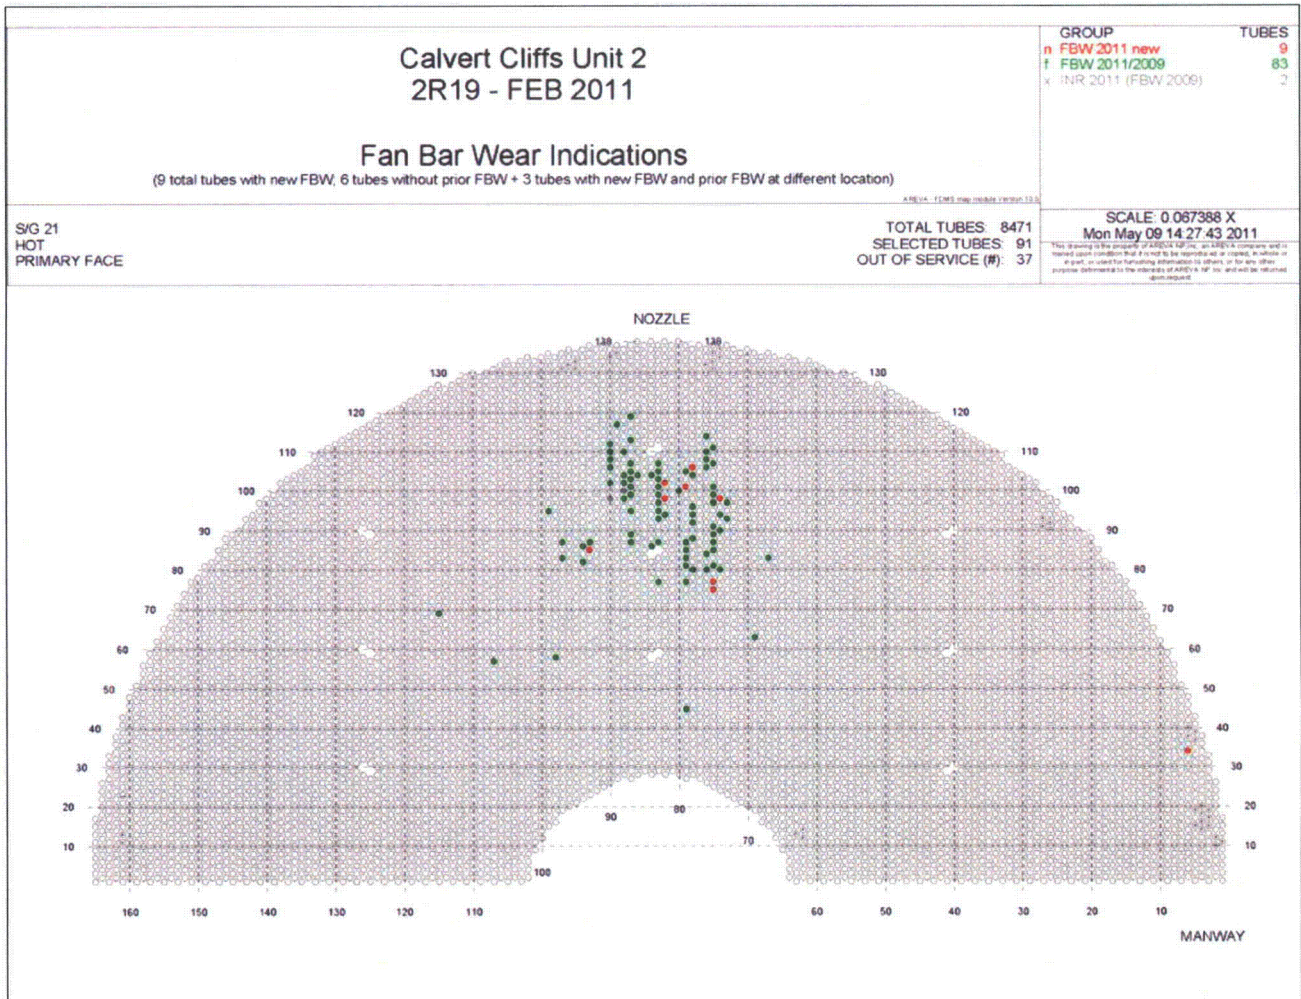
Figure 2 – SG21 Fan Bar Wear Locations

Figures 2 and 3 provide tube map locations of the reported FBW. Although the tube maps shown in Figures 2 and 3 provide a view of the tubesheet primary face from the hot leg side, both the hot leg and cold leg FBW indications are included on each map. Most of the wear continues to occur in longer tubes (i.e., larger unbend radius), clustered towards the center-most tube columns.

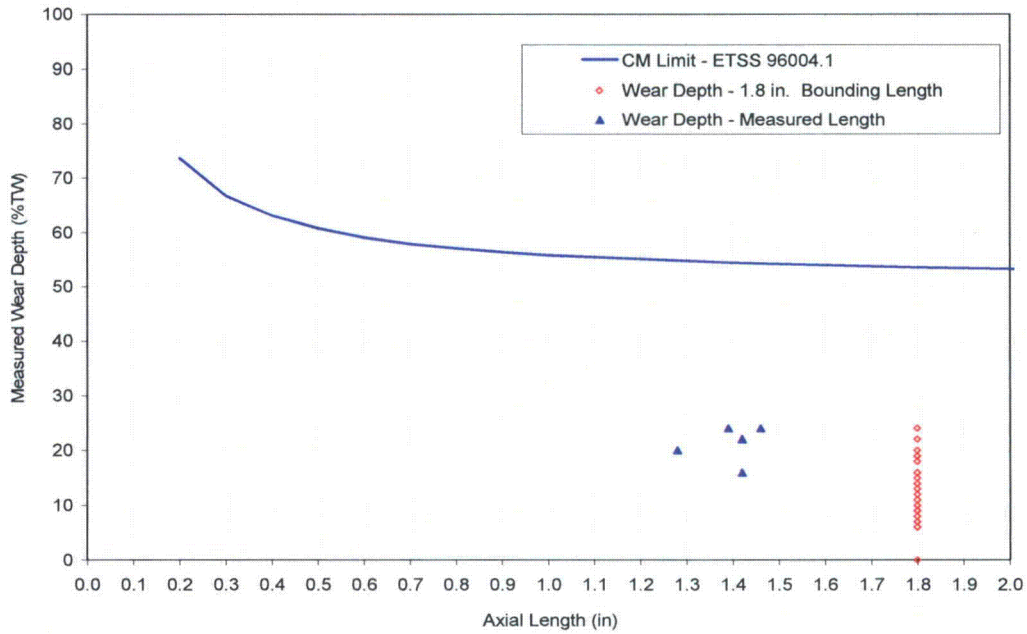
Figure 4 – SG21 Fan Bar Wear Condition Monitoring

The condition monitoring assessment is summarized in Figures 4 through 6. These figures provide the condition monitoring limit curves corresponding to the NDE technique employed for each degradation type. All reported degradation falls below the applicable condition monitoring curve and therefore satisfies the Technical Specification structural performance criteria.

Note that Figures 4 and 5 display the U2R19 FBW depths at a bounding 1.8 inch length for SGs 21 and 22 respectively. Also presented in each figure are the five deepest FBW indications sized using RPC. The five deepest were selected since larger axial lengths are typically associated with deeper FBW. The measured RPC length for these indications is plotted to demonstrate that the 1.8 inch length remains bounding. Because the RPC length measurements were not adjusted to compensate for rotating coil field spread effects, the indicated length values are considered to be overestimates of the actual lengths, thus adding to the conservatism for the 1.8 inch bounding length.

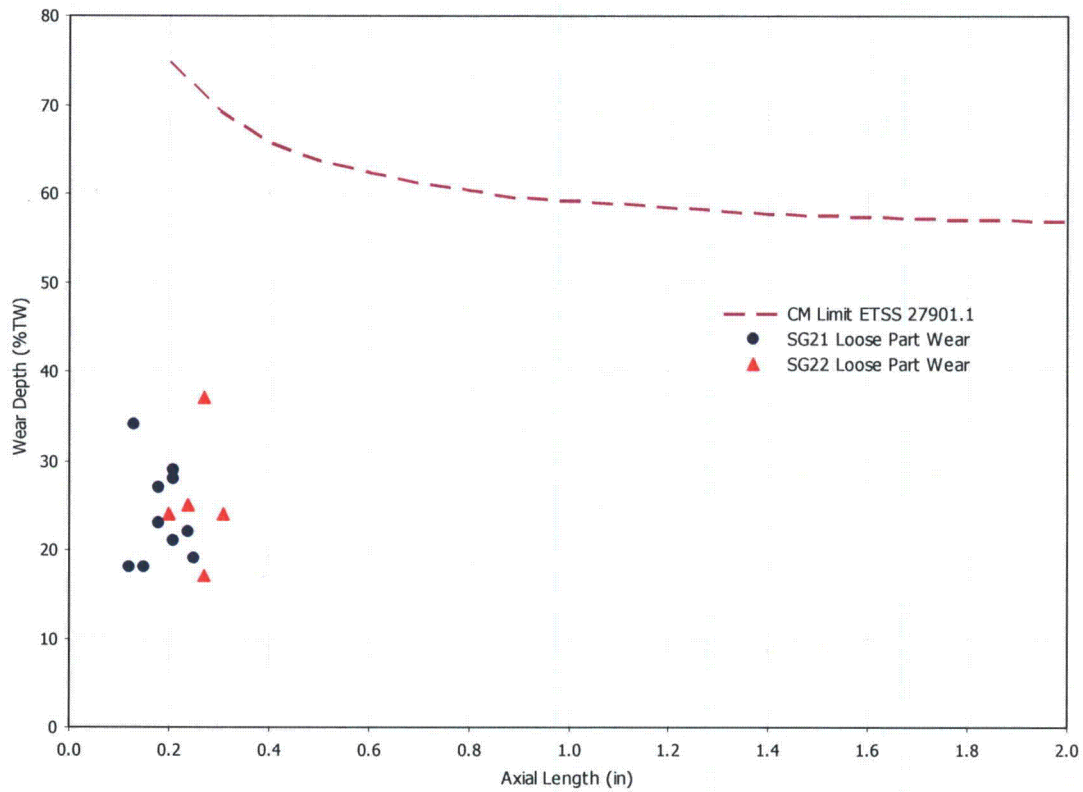
Figure 6 – SG21 and SG22 LP Wear Condition Monitoring

For volumetric indications, meeting the structural performance criteria also provides reasonable assurance that the accident leakage performance criteria would be satisfied at the steam line break pressure differential which is less challenging than the pressure differential required to demonstrate compliance with the structural performance criteria. Since this conclusion could be reached analytically using NDE inspection results with a full accounting of significant uncertainties, no in-situ pressure testing was required to demonstrate structural and leakage integrity, and no tubes were removed from the SGs for destructive examination. During the past operating cycle, no measurable primary-to-secondary leakage was observed, therefore the operational leakage performance criteria was satisfied. The results of the 2011 inspection and the condition monitoring assessment confirm that the 2009 operational assessment was appropriately bounding.
