Docket 50-305
Operating License DPR-43
Kewaunee Nuclear Power Plant
Response to Notice of Violation 93-012-01

Re: Inspection Report 93-012

NUCLEAR REGULATORY COMMISSION (NRC) NOTICE OF VIOLATION

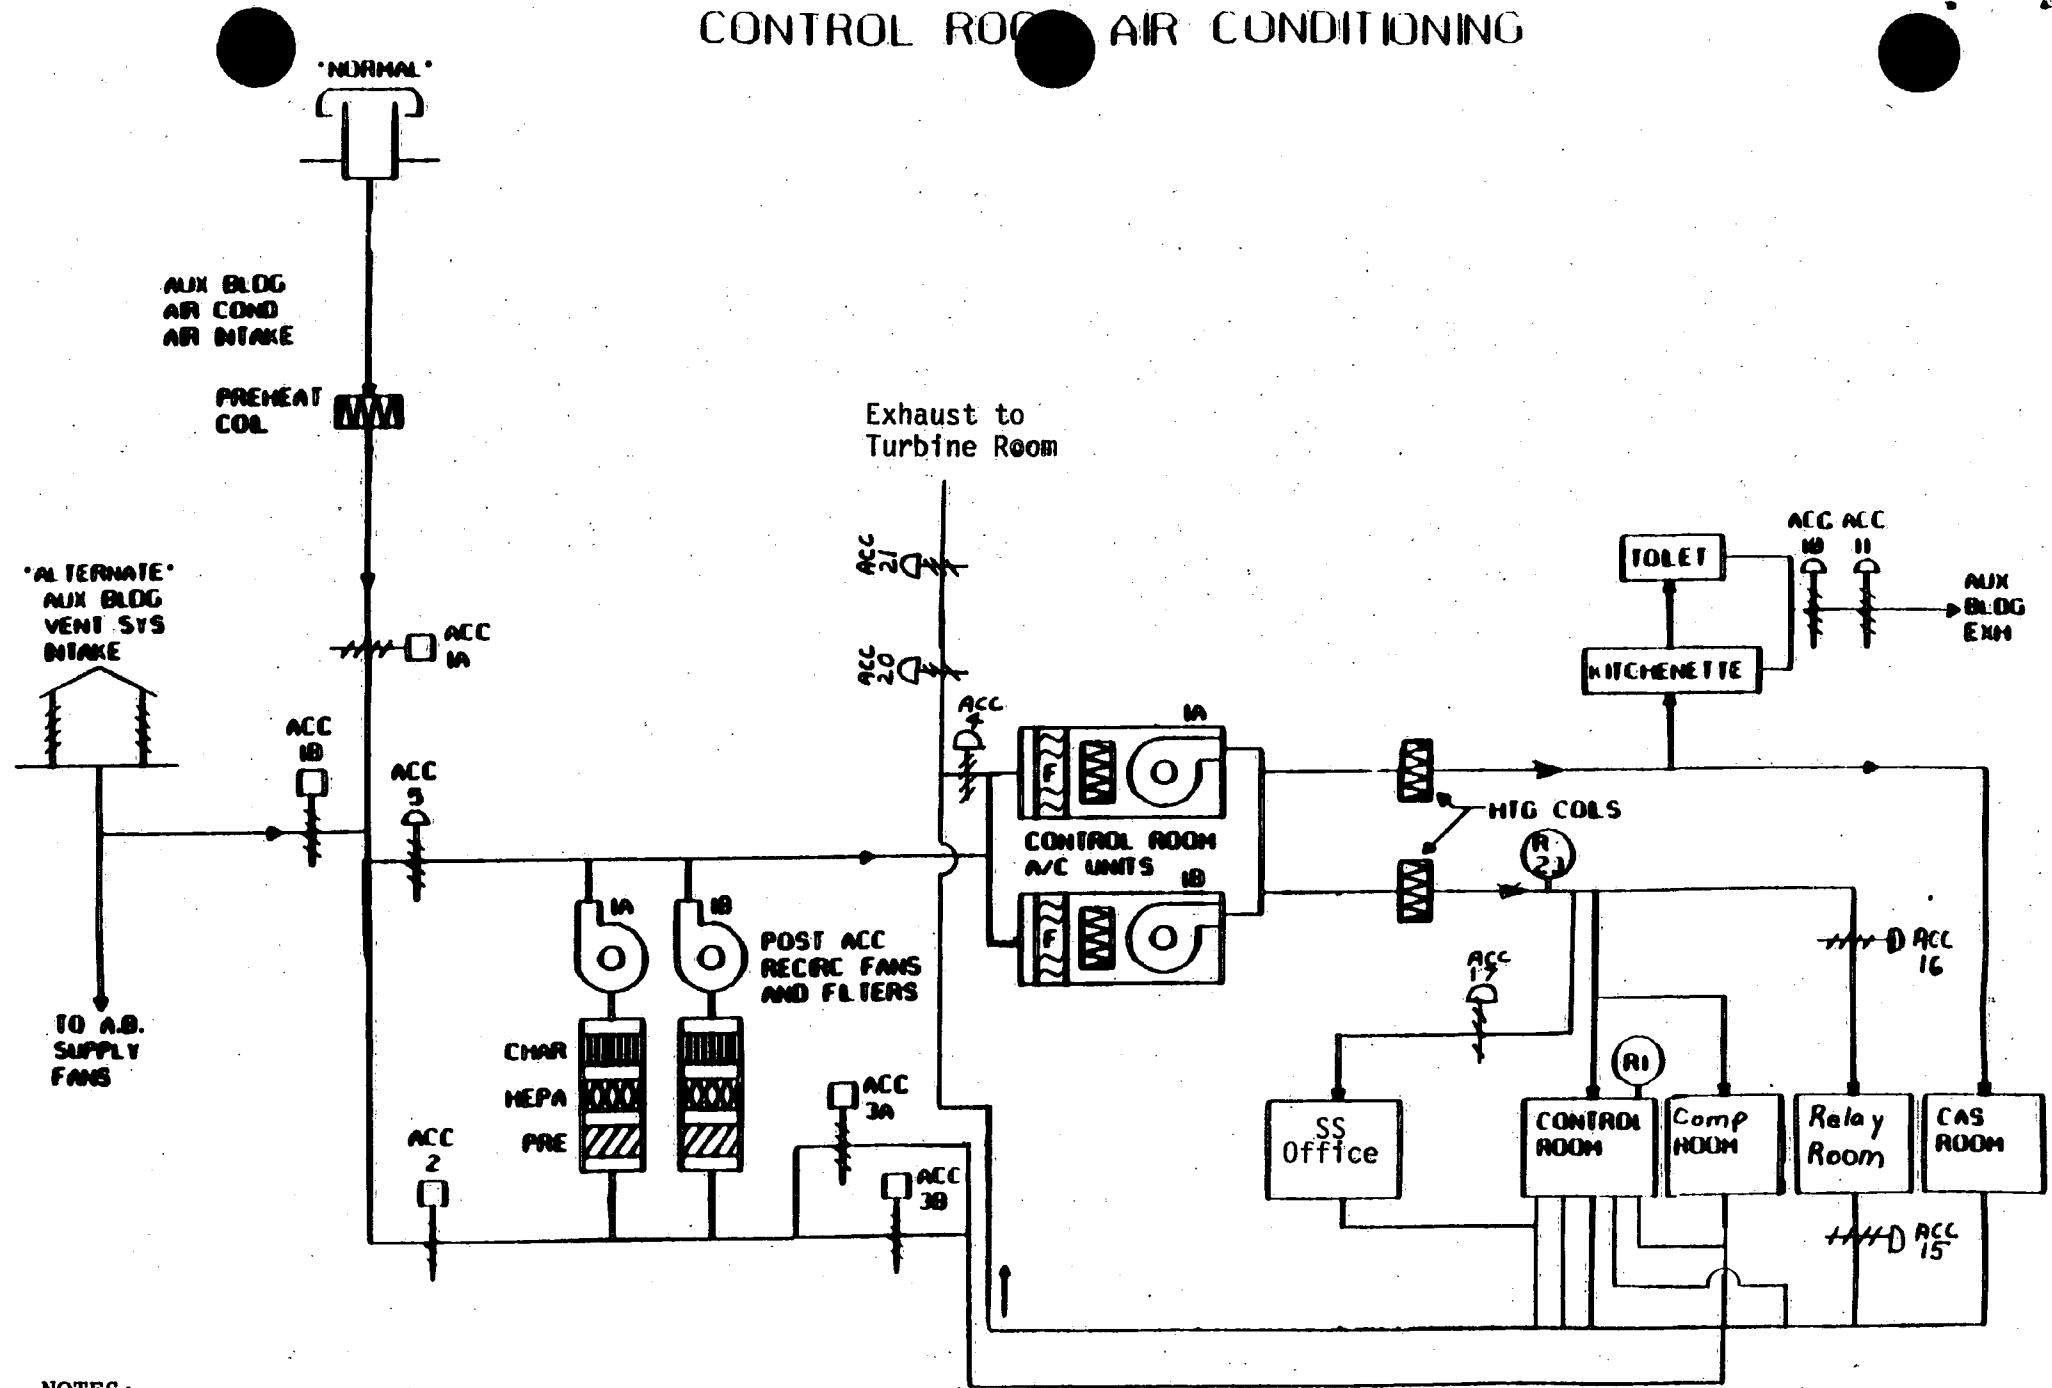
CONTROL ROOM AIR CONDITIONING

Design Change Request (DCR) 2373-2 was implemented in April 1991 to remove the interlock between the fresh air inlet damper (ACC-2) and the redundant recirculation dampers (ACC-3A and ACC-3B) in the control room post-accident recirculation (CRPR) system, refer to attachment 2. Removal of the interlock prevents a single failure of ACC-2 from isolating recirculation flow through ACC-3A or ACC-3B. As noted in the inspection report, the design package for the DCR failed to provide adequate justification that the removal of the interlock did not increase the probability of bypassing the charcoal filters. Bypassing the filters would allow unfiltered contaminated air to enter the control room.

In addition to the corrective actions already taken, the USAR will be revised to reflect how the system is described in operating procedure E-ACC-25. The annual update to the USAR is currently scheduled to be submitted to the NRC in November 1994. Furthermore, DCR 2373-2 will be used as a case study in the refresher training on the performance of safety evaluations. The training is tentatively scheduled to occur during the first quarter of 1994. The training will be provided to members of the engineering staff that are typically responsible for performing safety evaluations.
