Examination of Kewaunee Cold Leg Steam Generator Tube R15C28

P. Kuchirka*, A. Madeyski, and M. Blaszkiewicz

May 8, 1997

The first and second tube support plate crevice regions of cold leg Tube R15C28 from Steam Generator B of Kewaunee were examined by nondestructive and destructive examination techniques. Shallow, but extensively distributed, OD-origin intergranular corrosion was found contained in the tube support plate crevice regions of the mill annealed Alloy 600 tubing.

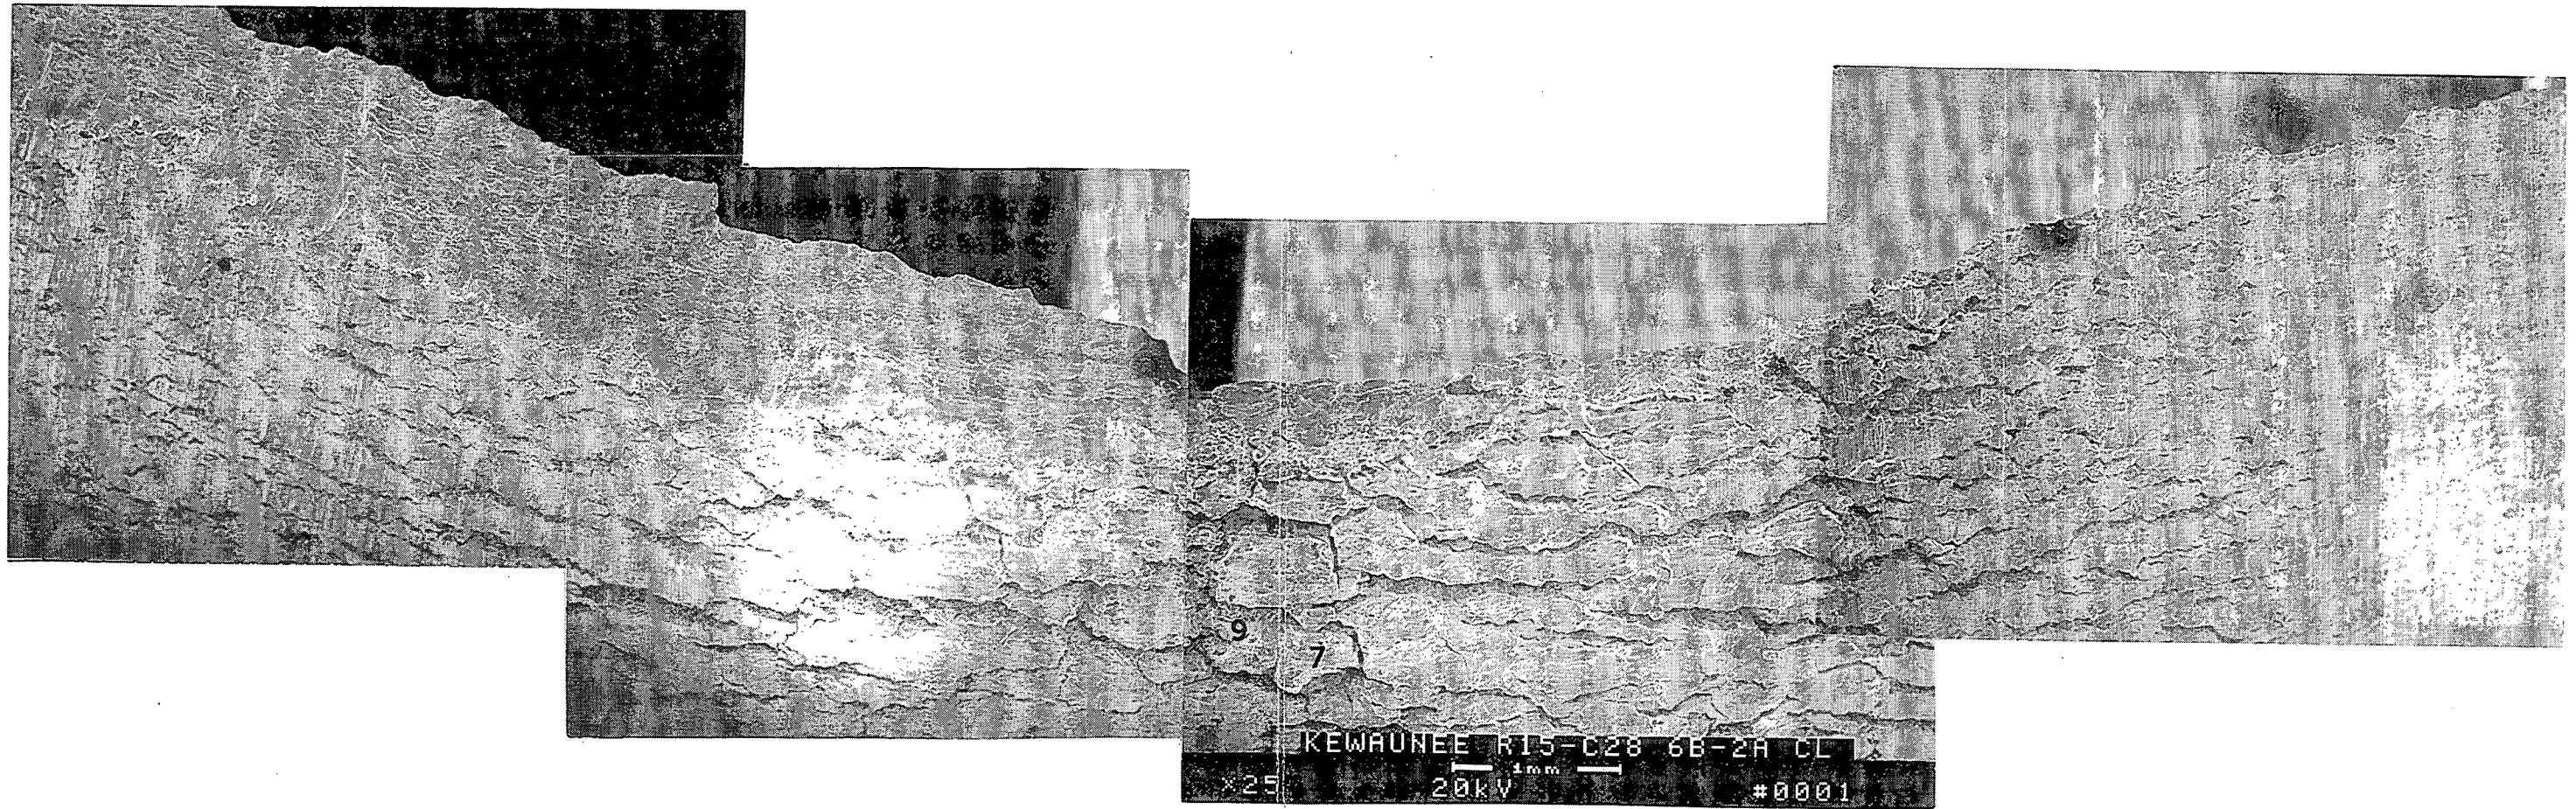
Figure 4-37 TSP2 crevice region Specimen 6B-2A of Tube R15C28. Side view of the opened burst fracture showing OD corrosion cracks opened wider by the burst test. Areas 7 and 9 on the OD surface are shown at progressively higher magnifications in Figures 4-38 through 4-40.

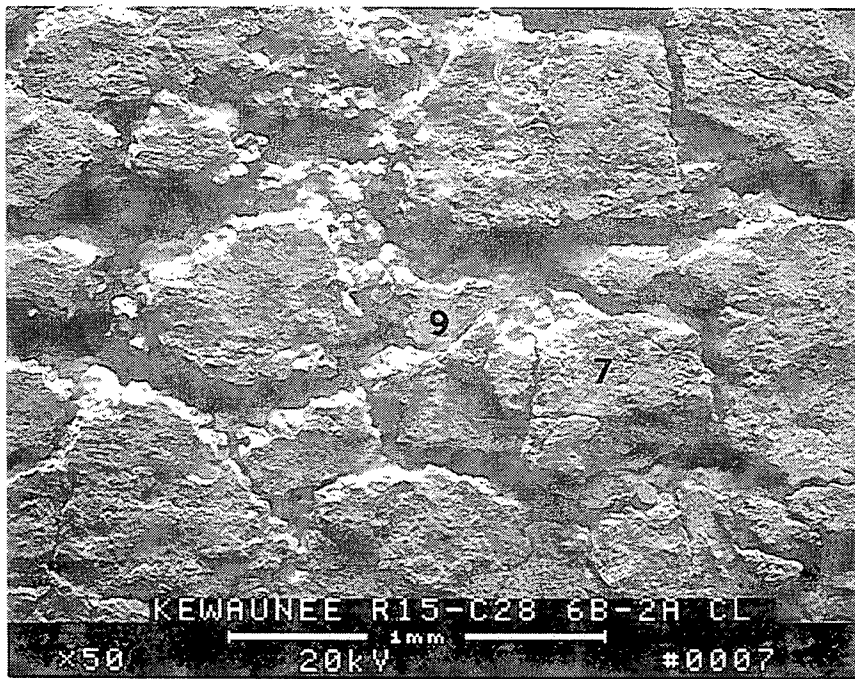
Figure 4-38 TSP2 crevice region Specimen 6B-2A of Tube R15C28. Side view of the opened burst fracture showing OD corrosion cracks opened wider by the burst test. Areas 7 and 9 on the OD surface from Figure 4-37, shown at a higher magnification.

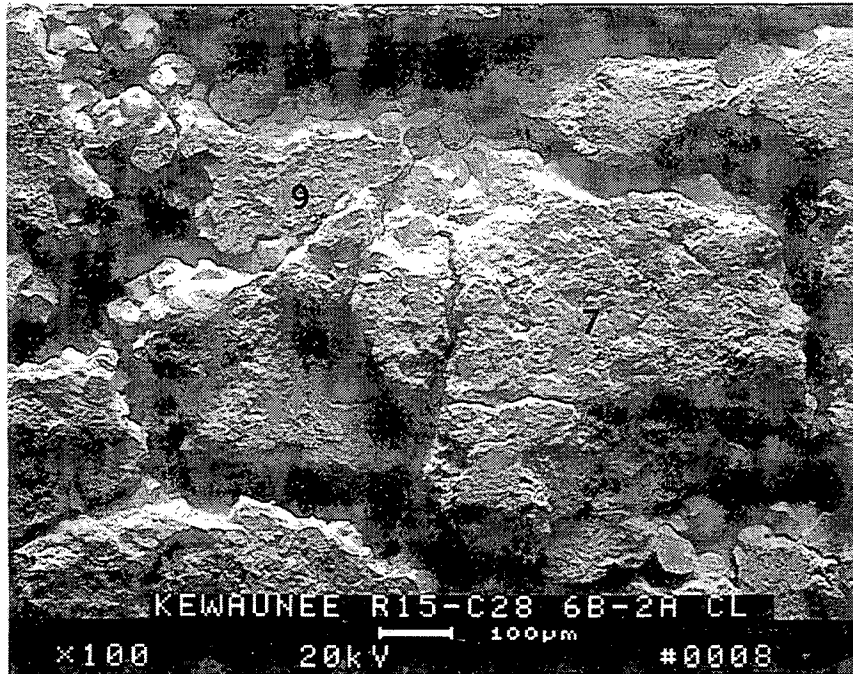
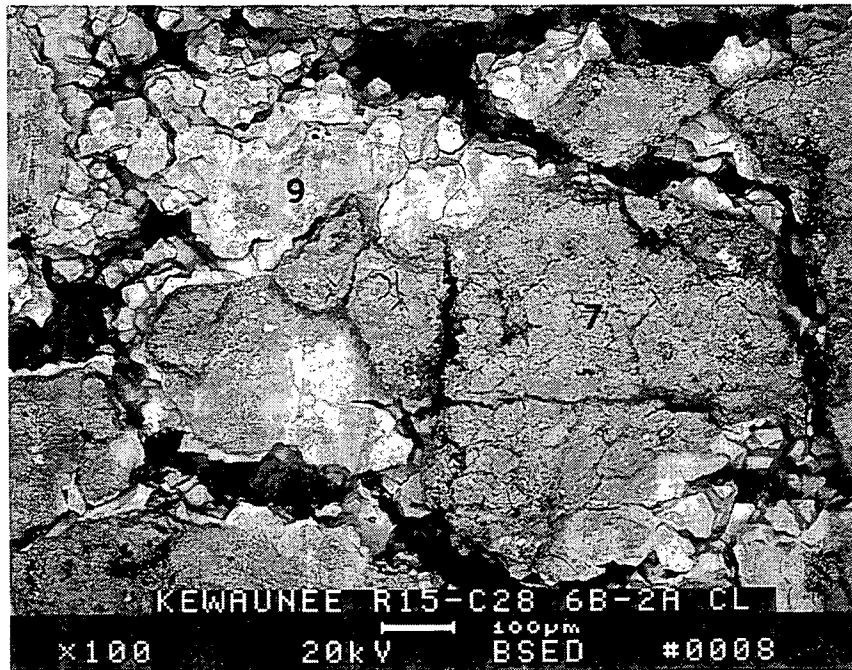
Figure 4-39 TSP2 crevice region Specimen 6B-2A of Tube R15C28. Side view of the opened burst fracture showing OD corrosion cracks opened wider by the burst test. Areas 7 and 9 on the OD surface from Figure 4-37 shown at a higher magnification. Upper photograph: reflected electron image. Lower photograph: backscattered electron image of the same area.

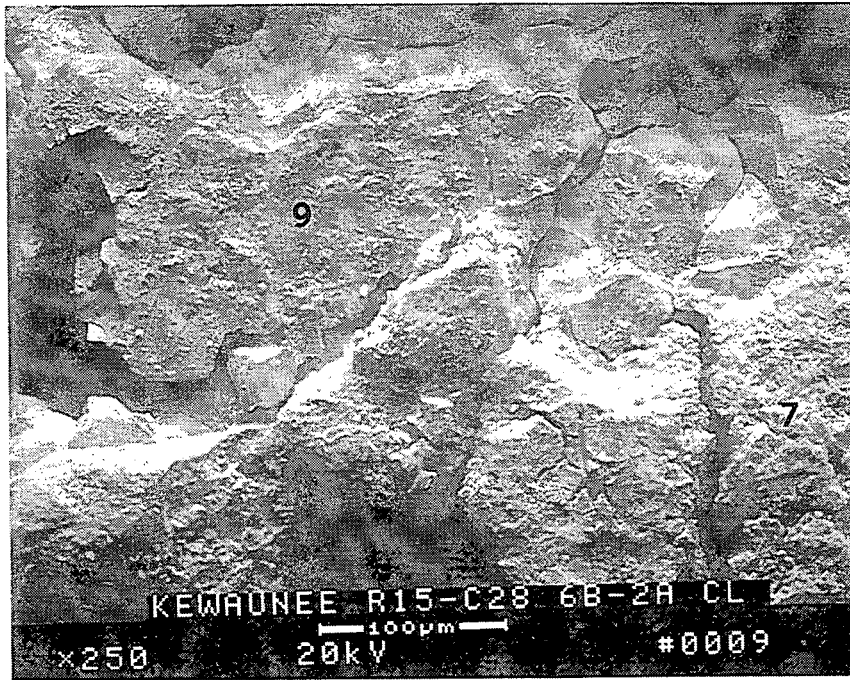
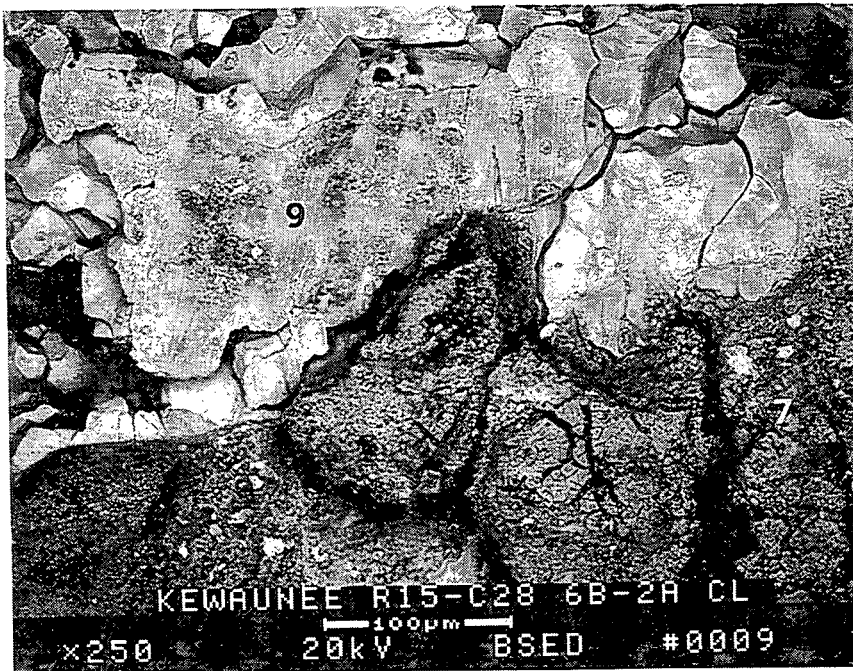
Figure 4-40 TSP2 crevice region Specimen 6B-2A of Tube R15C28. Side view of the opened burst fracture showing OD corrosion cracks opened wider by the burst test. Areas 7 and 9 on the OD surface from Figure 4-37, shown at a higher magnification. Upper photograph: reflected electron image. Lower photograph: backscattered electron image of the same area.

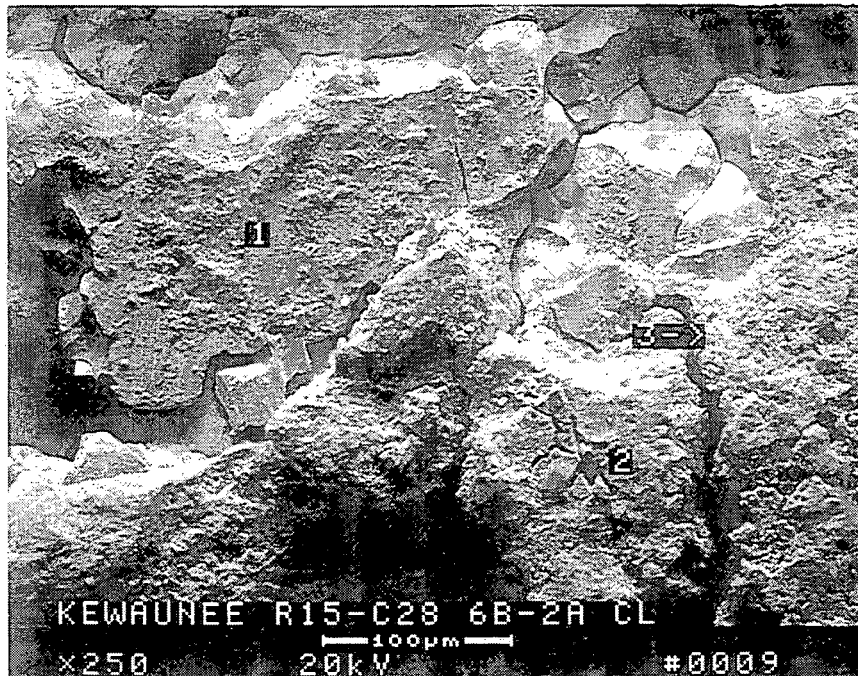
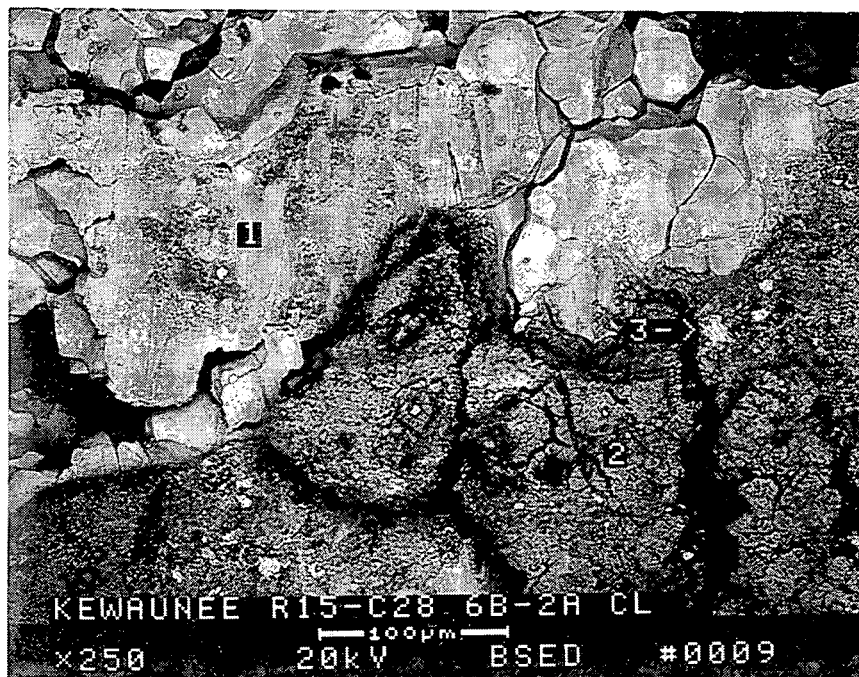
Figure 4-41 TSP2 crevice region Specimen 6B-2A of Tube R15C28. Side view of the opened burst fracture showing OD corrosion cracks opened wider by the burst test. Higher magnification photographs of Areas 7 and 9 on the OD surface from Figure 4-37, showing the locations of Spots 1, 2, and 3 which were analyzed using the energy dispersive X-ray spectroscopy (EDS) technique. The results of the analyses are shown in Figures 4-42, 4-43, and 4-44.

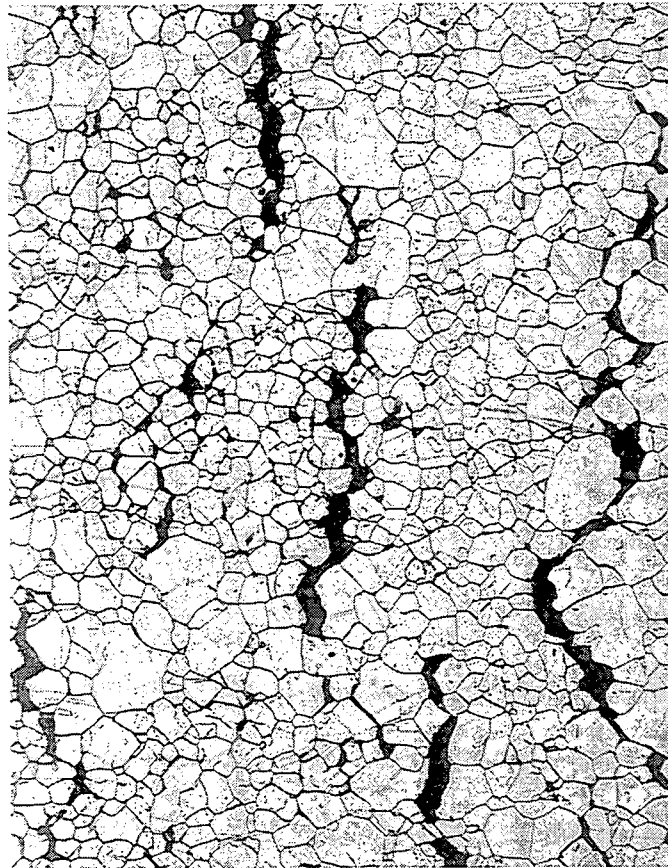
Figure 4-49 TSP2 crevice region Specimen 6B-2D of Tube R15C28. Radial metallographic sample after flattening and polishing to a depth of 0.001 inch below the OD surface. Examples of the corrosion crack pattern at this level of grinding and polishing. Mount M2163. Mag. 100X.

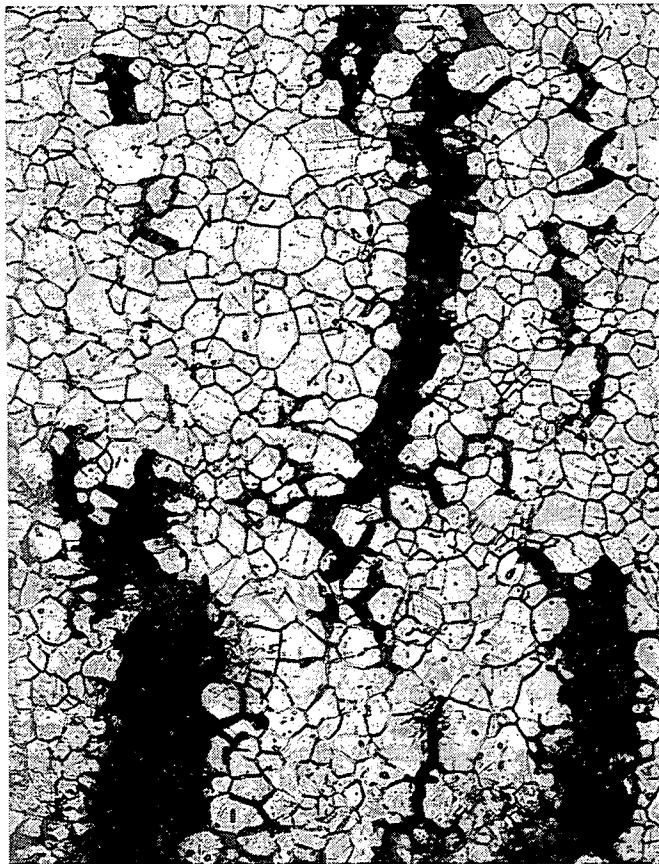
Figure 4-53 TSP2 crevice region Specimen 6B-2D of Tube R15C28. Radial metallographic sample after flattening and polishing to a depth of 0.005 inch below the OD surface. Example of the corrosion crack pattern at this level of grinding and polishing. Mount M2163. Mag. 100X.

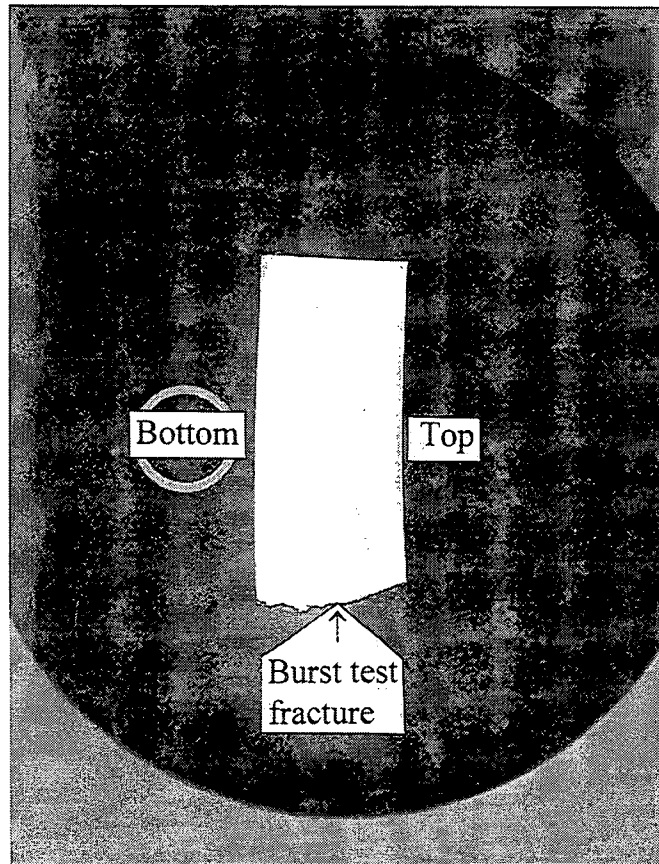
Figure 4-54 TSP2 crevice region Specimen 6B-2D of Tube R15C28. Radial metallographic sample after flattening and polishing to a depth of 0.010 inch below the OD surface. Note the absence of cracks. Mount M2163. Mag. 3.25X.

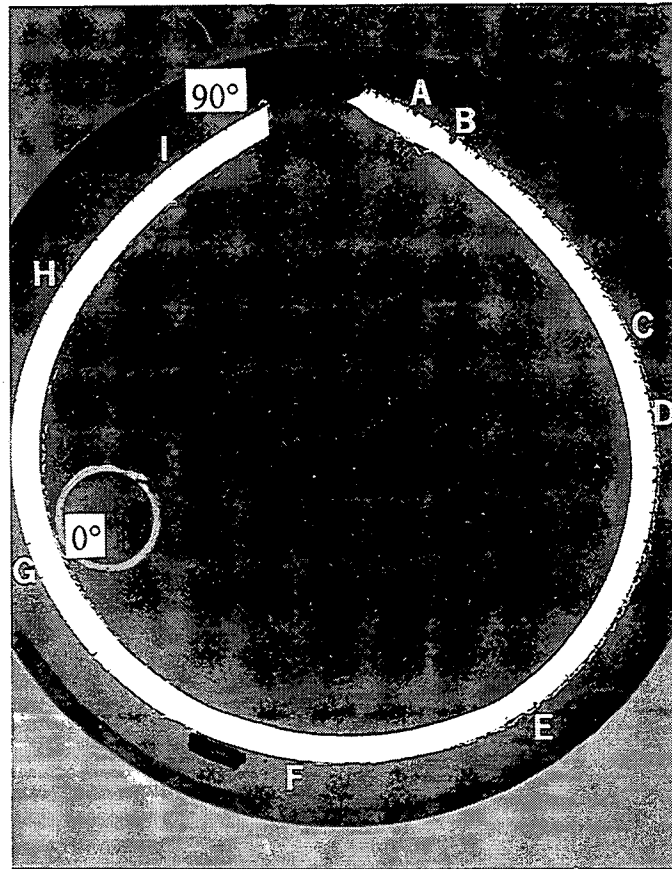
Figure 4-55 TSP2 crevice region Specimen 6B-2C of Tube R15C28. Transverse metallographic sample. Areas A through I are shown at a higher magnification in Figures 4-56 through 4-60. Mount M2162. Mag. 3.25X.

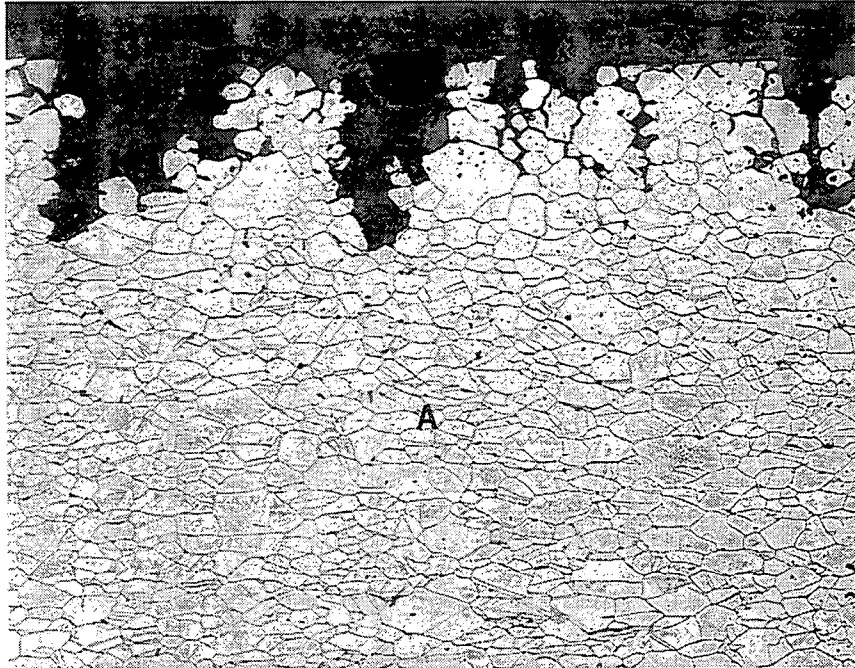
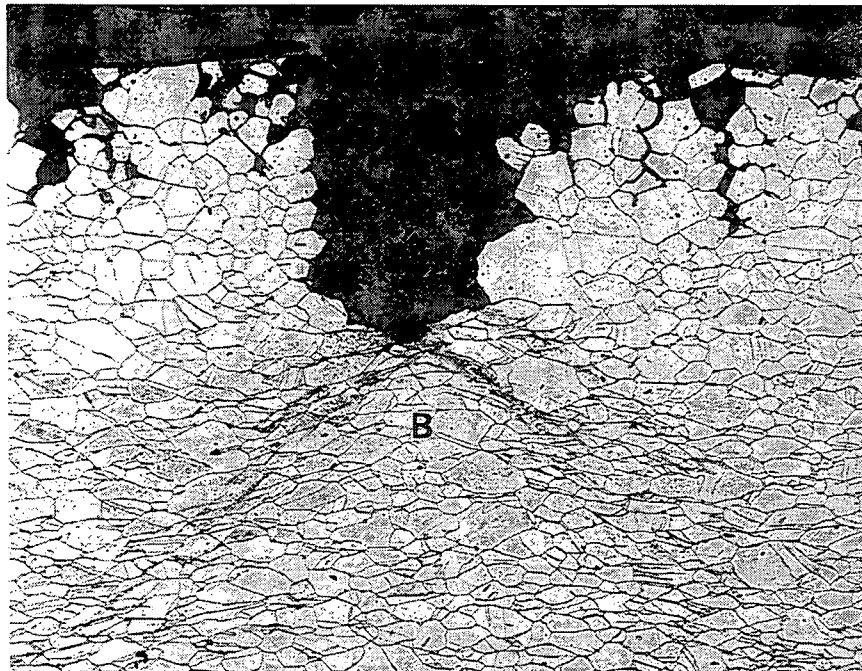
Figure 4-56 TSP2 crevice region Specimen 6B-2C of Tube R15C28. Transverse metallographic sample. Areas A and B from Figure 4-55 showing OD surface cracks at a higher magnification. Mount M2162. Mag. 100X.

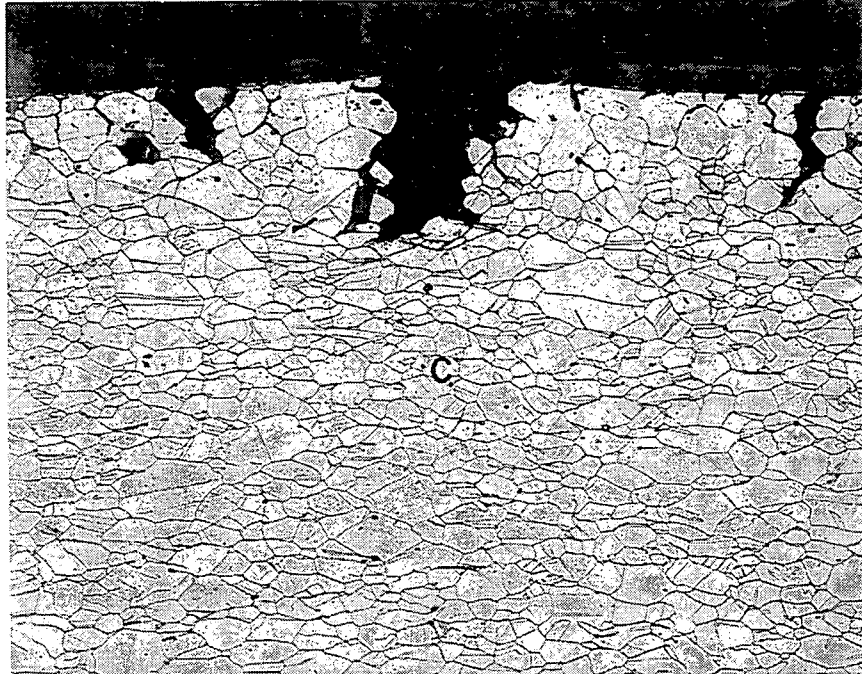
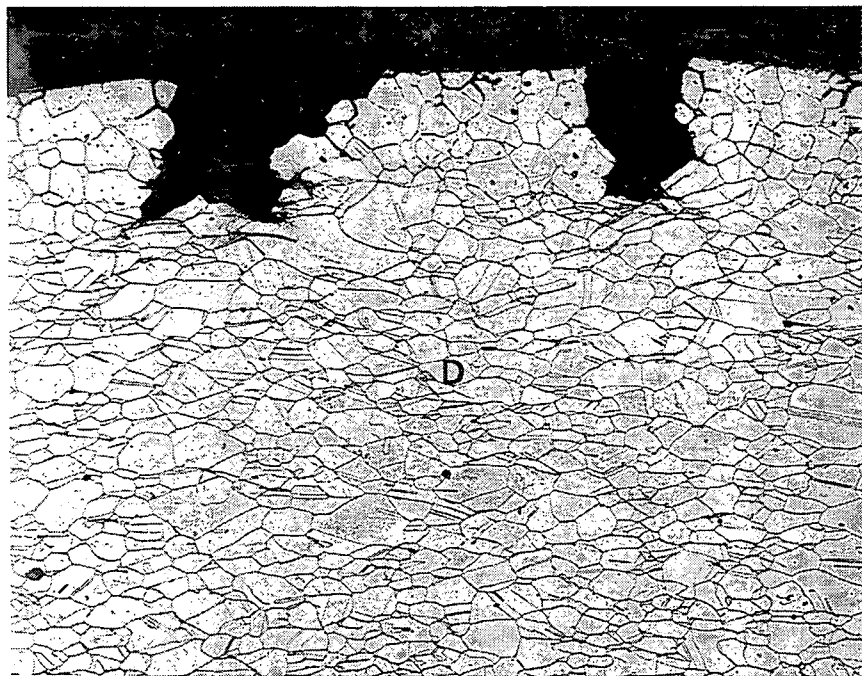
Figure 4-57 TSP2 crevice region Specimen 6B-2C of Tube R15C28. Transverse metallographic sample. Areas C and D from Figure 4-55 showing OD surface cracks at a higher magnification. Mount M2162. Mag. 100X.

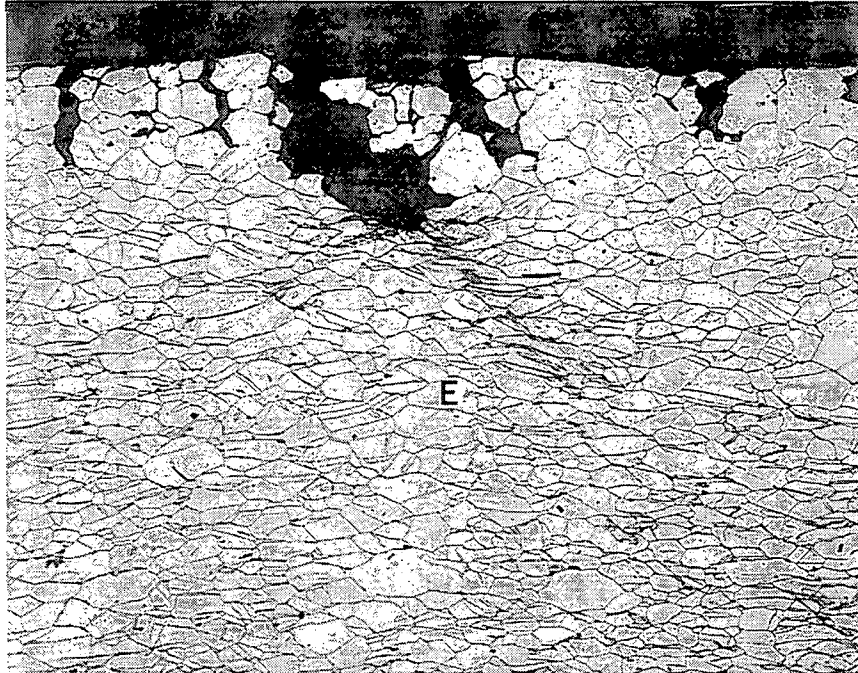
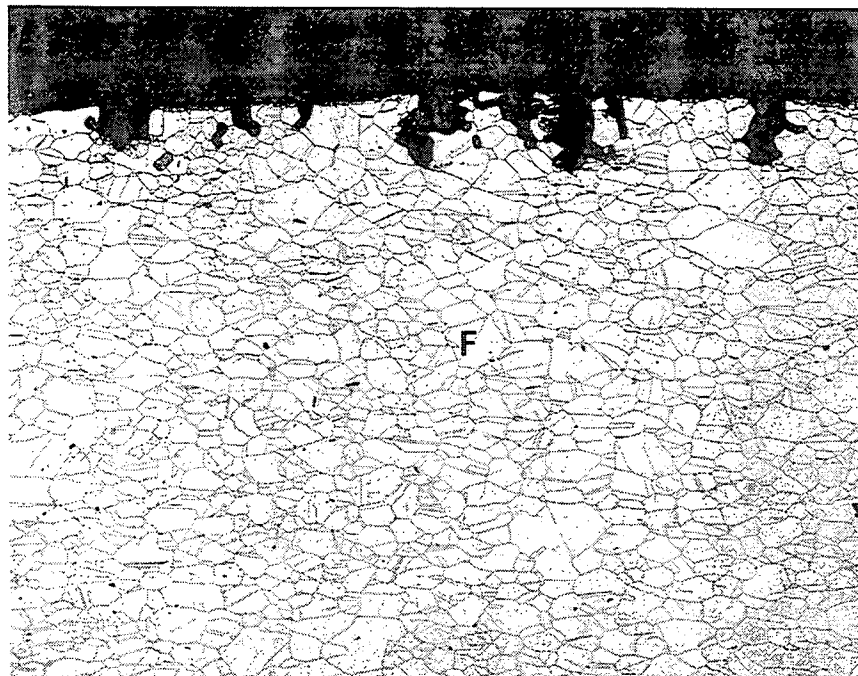
Figure 4-58 TSP2 crevice region Specimen 6B-2C of Tube R15C28. Transverse metallographic sample. Areas E and F from Figure 4-55 showing OD surface cracks at a higher magnification. Mount M2162. Mag. 100X.

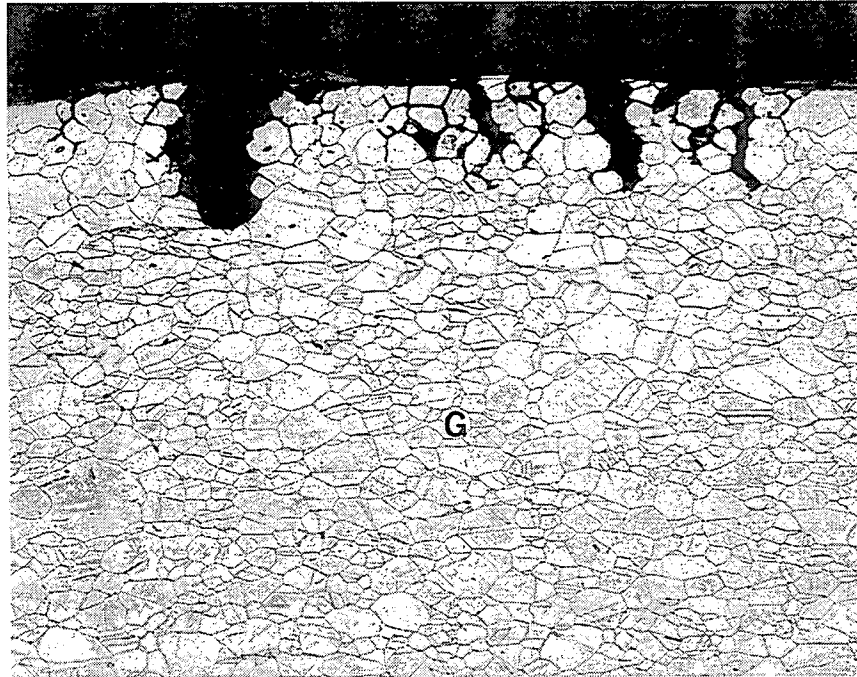
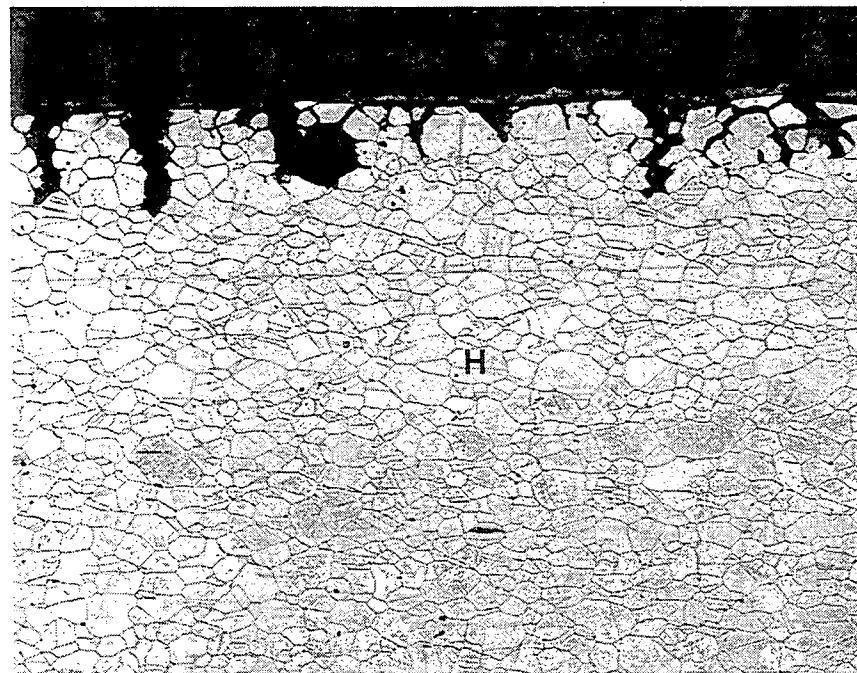
Figure 4-59 TSP2 crevice region Specimen 6B-2C of Tube R15C28. Transverse metallographic sample. Areas G and H from Figure 4-55 showing OD surface cracks at a higher magnification. Mount M2162. Mag. 100X.

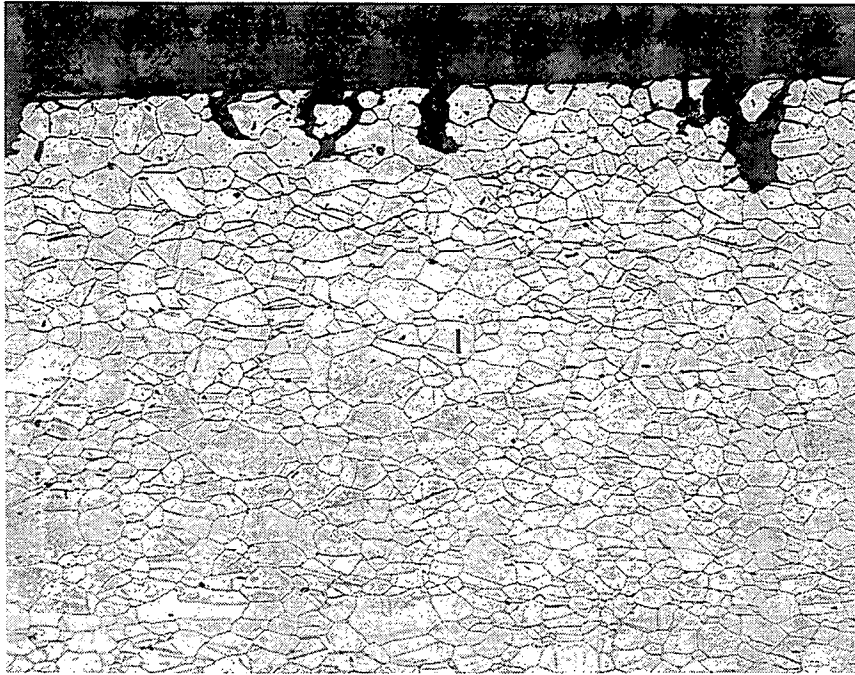
Figure 4-60 TSP2 crevice region Specimen 6B-2C of Tube R15C28. Transverse metallographic sample. Area I from Figure 4-55 showing OD surface cracks at a higher magnification. Mount M2162. Mag. 100X.

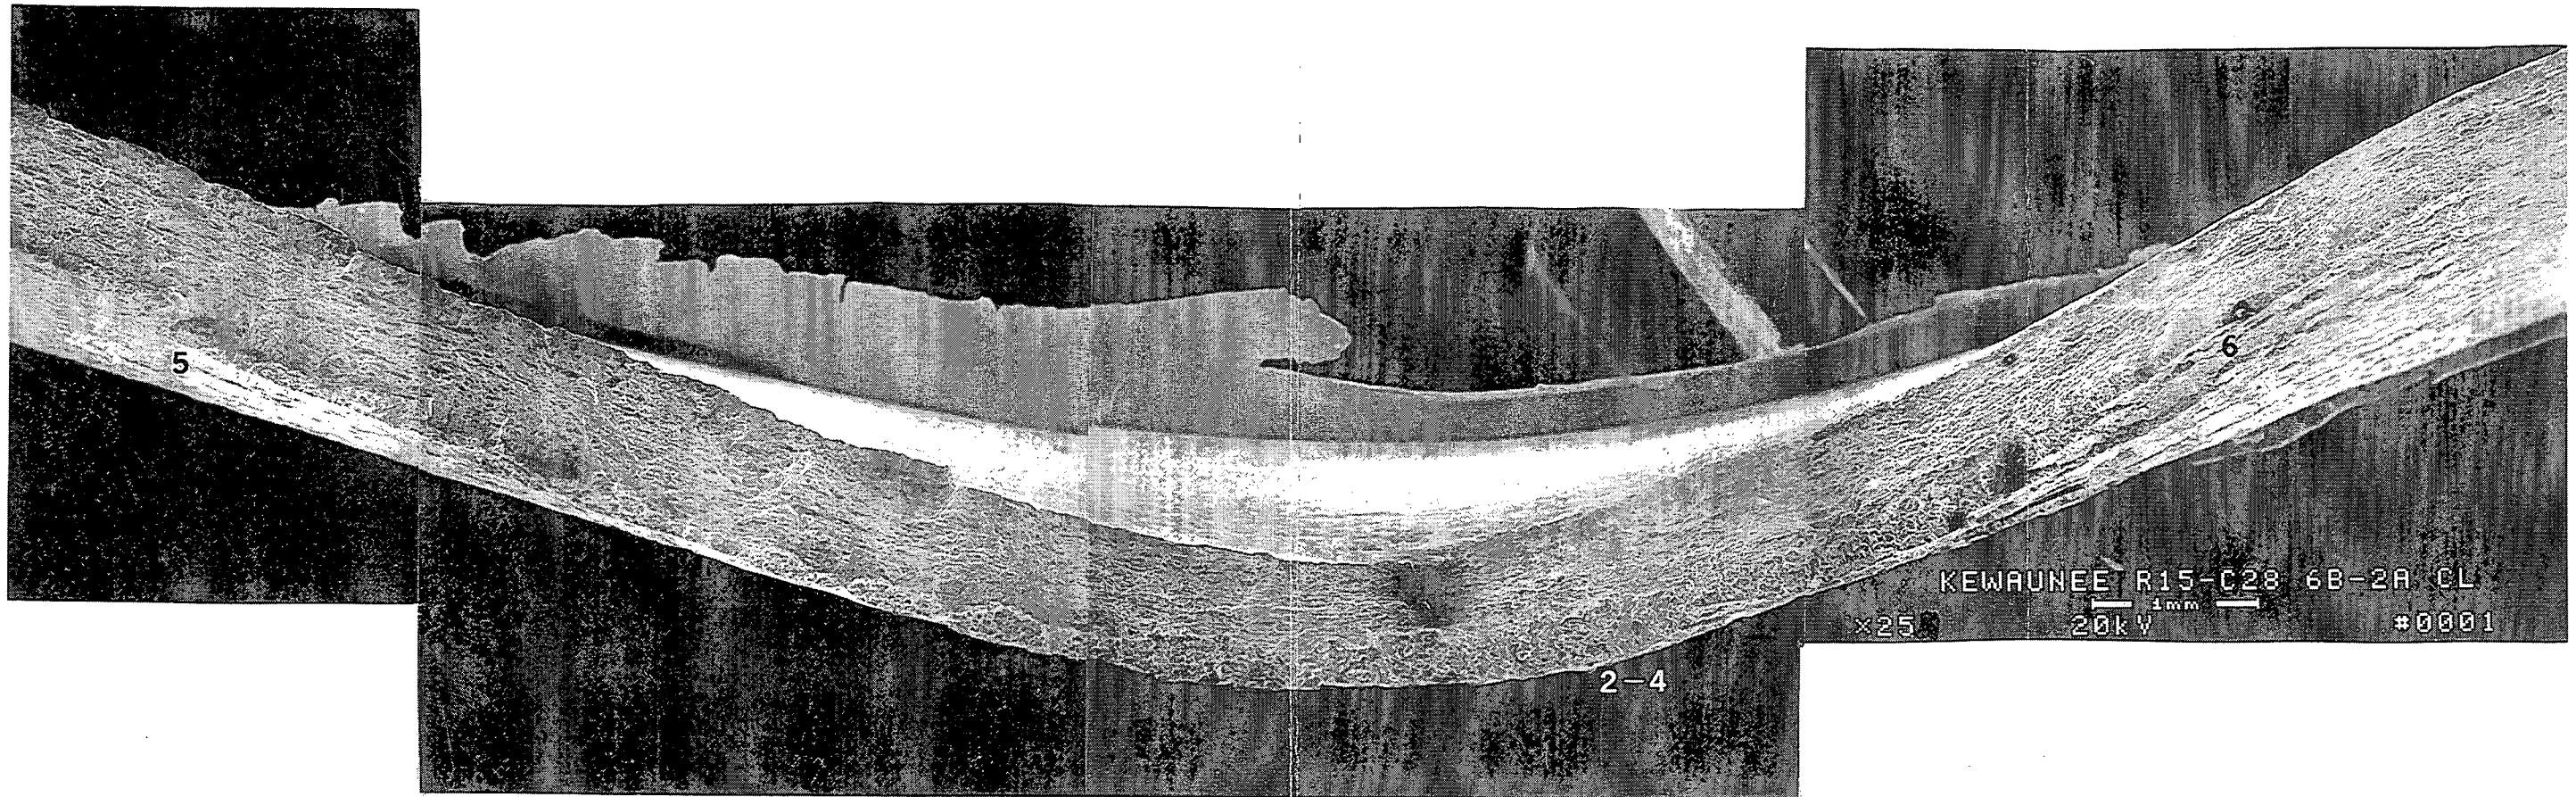
Figure 4-33 TSP2 crevice region Specimen 6B-2A of Tube R15C28. Top view of the opened burst fracture. Areas 2 through 6 of the fracture are shown at higher magnifications in Figures 4-34 through 4-36. Areas 5 and 6 mark the ends of the intergranular corrosion cracking on the OD which started the burst fracture.

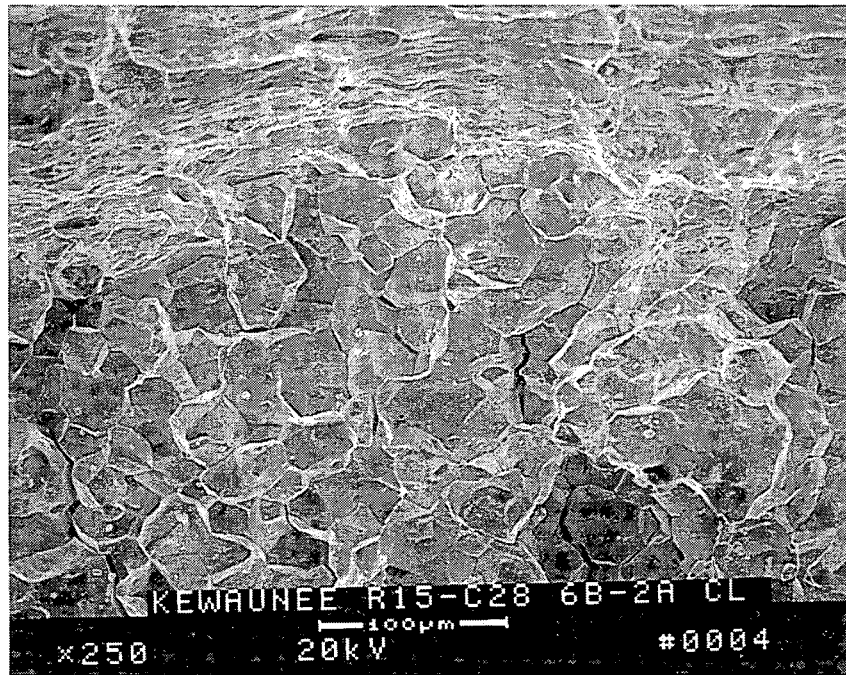
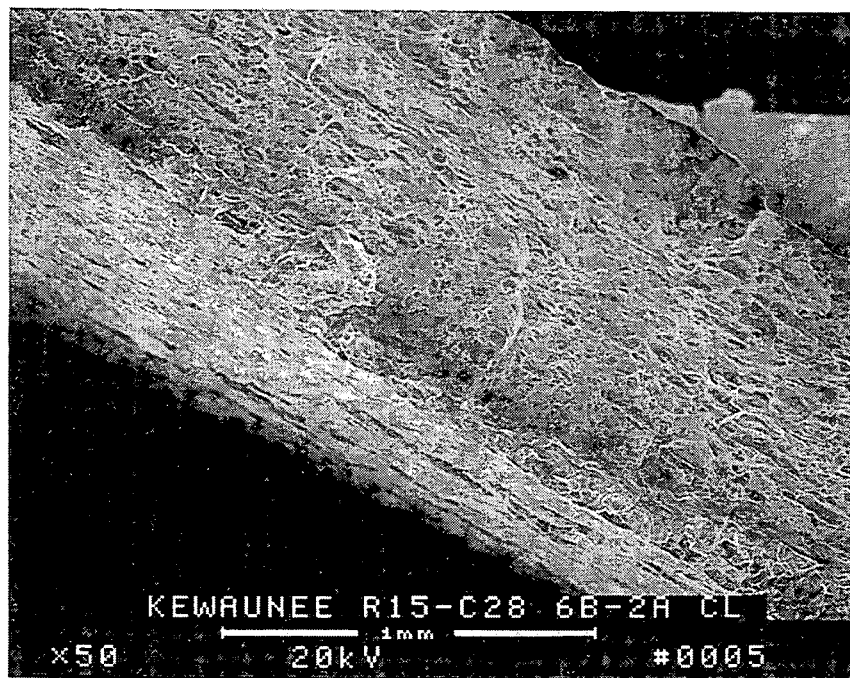
Figure 4-35 TSP2 crevice region Specimen 6B-2A of Tube R15C28. Upper photograph: Area 4 from Figure 4-34 showing the boundary between the field corrosion crack at the point of deepest penetration and the laboratory fracture produced during the burst test.

Lower photograph: Area 5 from Figure 4-33 showing the left end of field corrosion cracking on the burst test fracture.

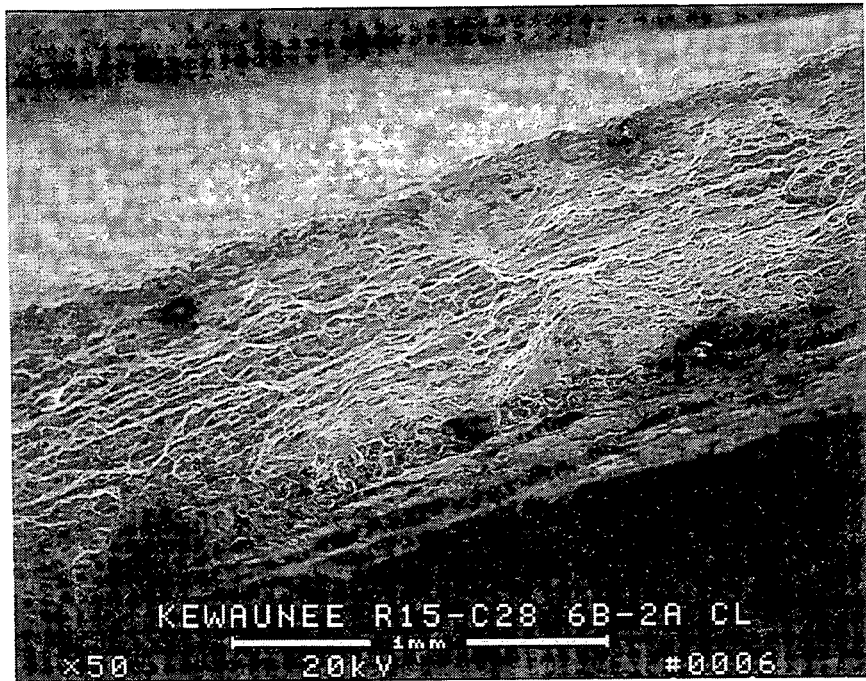
Figure 4-36 TSP2 crevice region Specimen 6B-2A of Tube R15C28. Area 6 from Figure 4-33 showing the right end of field corrosion cracking on the burst test fracture.

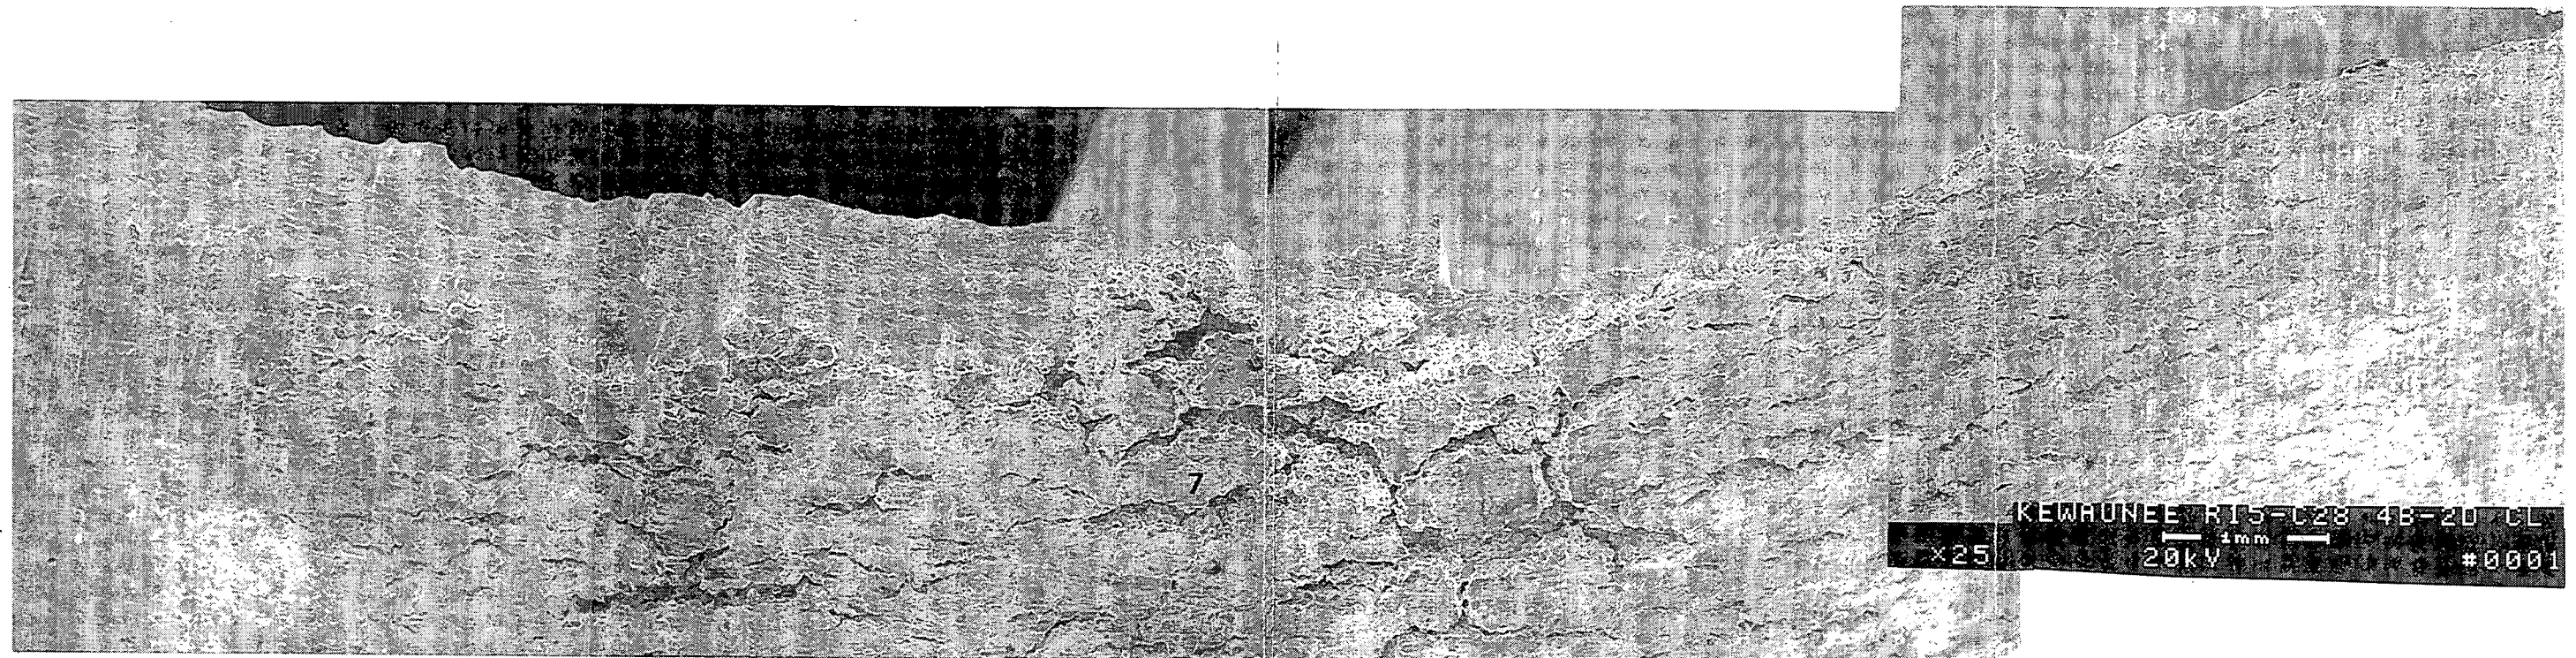
Figure 4-6 TSP1 crevice region Specimen 4B-2D of Tube R15C28. Side view of the opened burst fracture showing OD corrosion cracks opened wider by the burst test. Area 7 on the OD surface is shown at progressively higher magnifications in Figures 4-7 through 4-9.

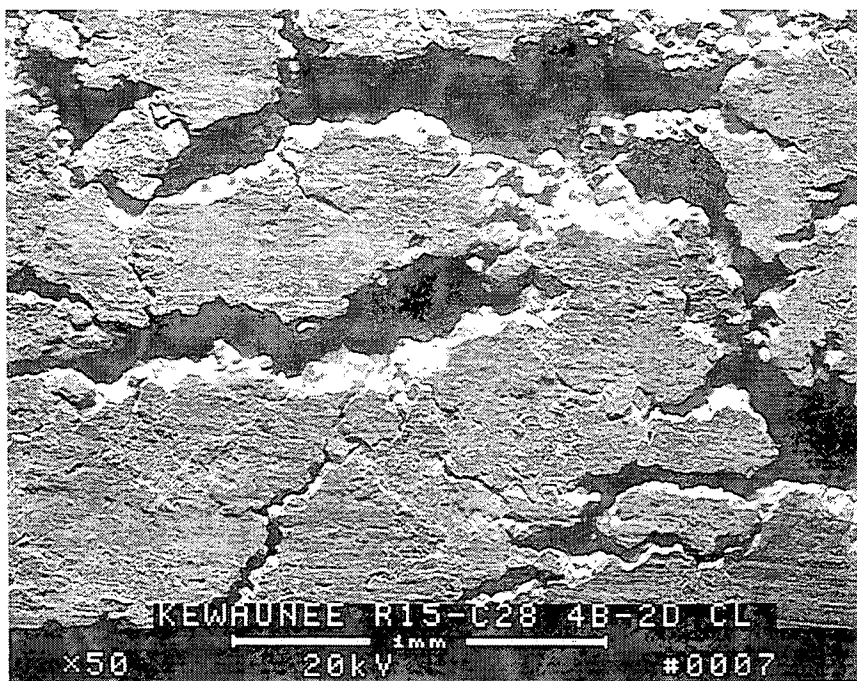
Figure 4-7 TSP1 crevice region Specimen 4B-2D of Tube R15C28. Side view of the opened burst fracture showing OD corrosion cracks opened wider by the burst test. Area 7 on the OD surface from Figure 4-6, shown at a higher magnification.

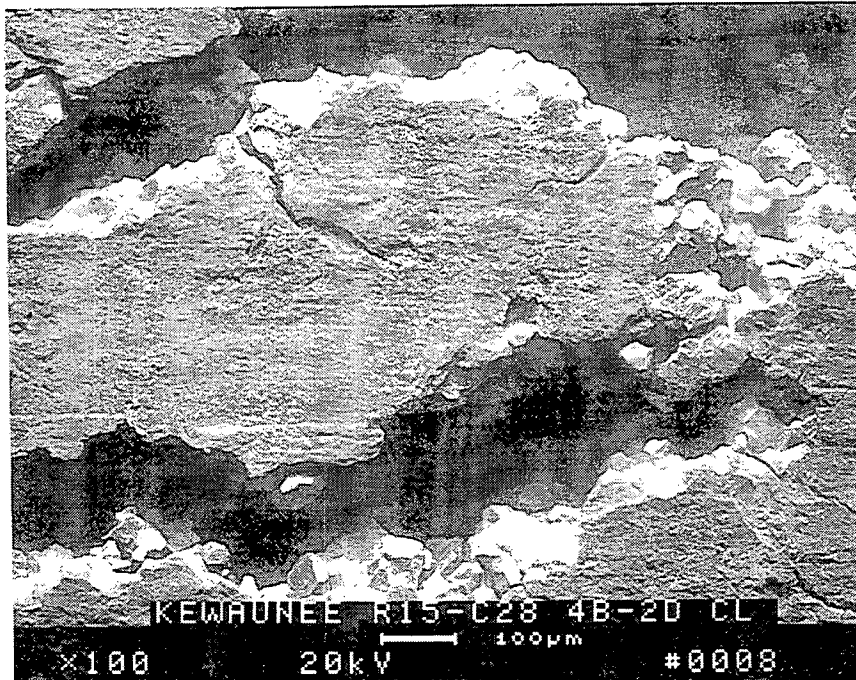
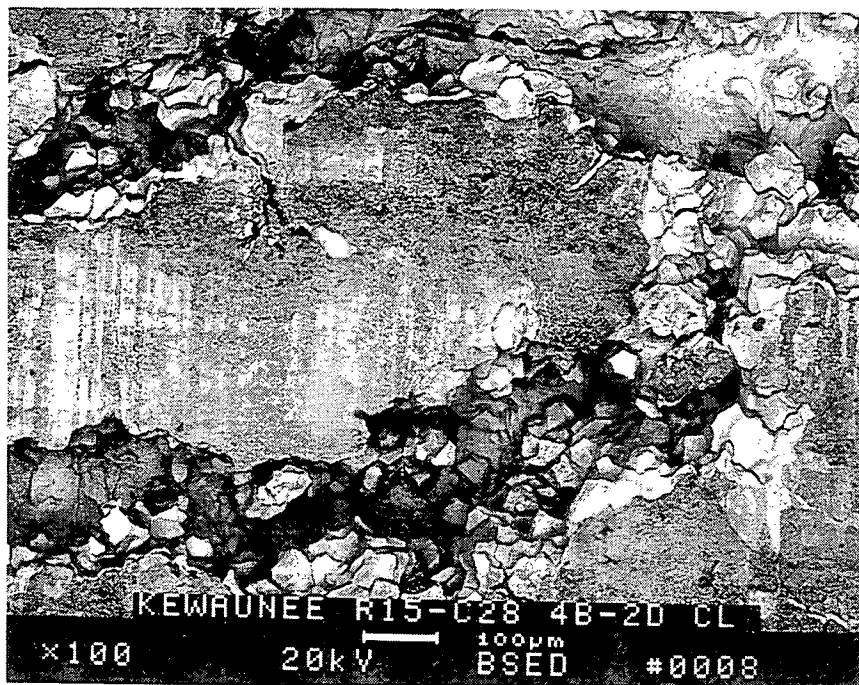
Figure 4-8 TSP1 crevice region Specimen 4B-2D of Tube R15C28. Side view of the opened burst fracture showing OD corrosion cracks opened wider by the burst test. Area 7 on the OD surface from Figure 4-6, shown at a higher magnification. Upper photograph: reflected electron image. Lower photograph: backscattered electron image of the same area.
