Examination of Kewaunee Cold Leg Steam Generator Tube R15C28

P. Kuchirka*, A. Madeyski, and M. Blaszkiewicz

May 8, 1997

The first and second tube support plate crevice regions of cold leg Tube R15C28 from Steam Generator B of Kewaunee were examined by nondestructive and destructive examination techniques. Shallow, but extensively distributed, OD-origin intergranular corrosion was found contained in the tube support plate crevice regions of the mill annealed Alloy 600 tubing.

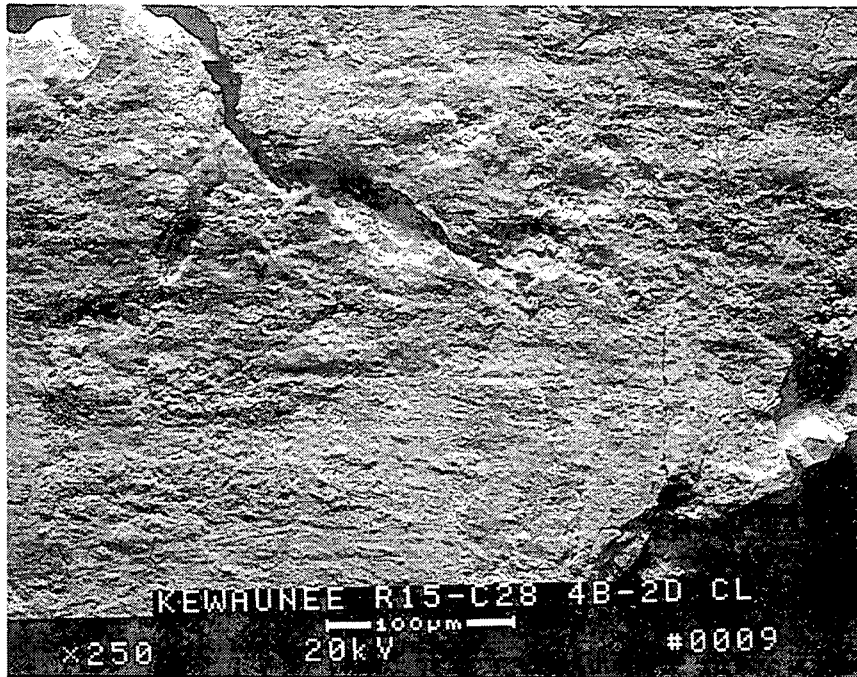
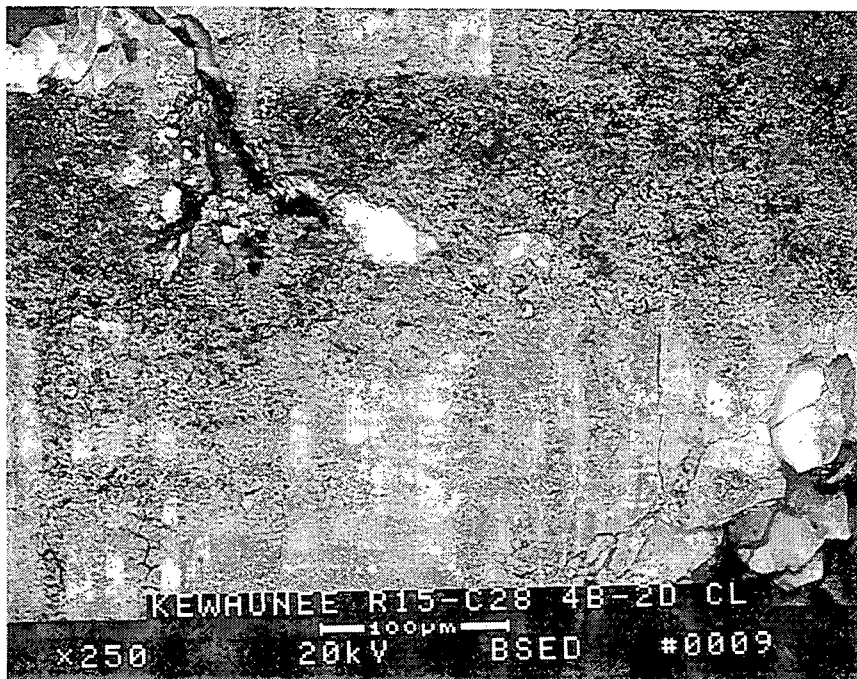
Figure 4-9 TSP1 crevice region Specimen 4B-2D of Tube R15C28. Side view of the opened burst fracture showing OD corrosion cracks opened wider by the burst test. Area 7 on the OD surface from Figure 4-6, shown at a higher magnification. Upper photograph: reflected electron image. Lower photograph: backscattered electron image of the same area.

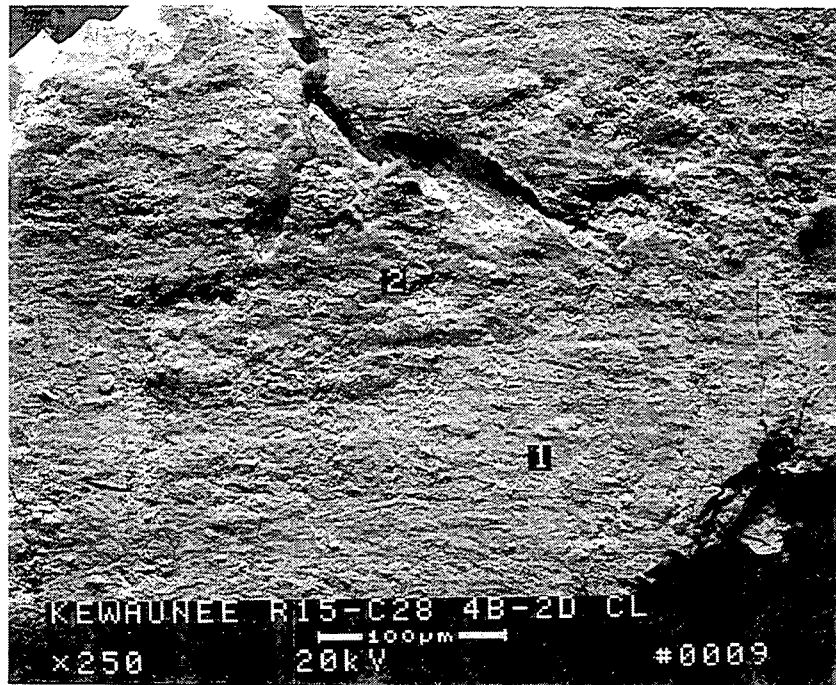
Figure 4-10 TSP1 crevice region Specimen 4B-2D of Tube R15C28. Side view of the opened burst fracture showing OD corrosion cracks opened wider by the burst test. Higher magnification photograph of Area 7 on the OD surface from Figure 4-6, showing the locations of Spots 1 and 2 which were analyzed using the energy dispersive X-ray spectroscopy (EDS) technique. The results of the analyses are shown in Figures 4-11 and 4-12.

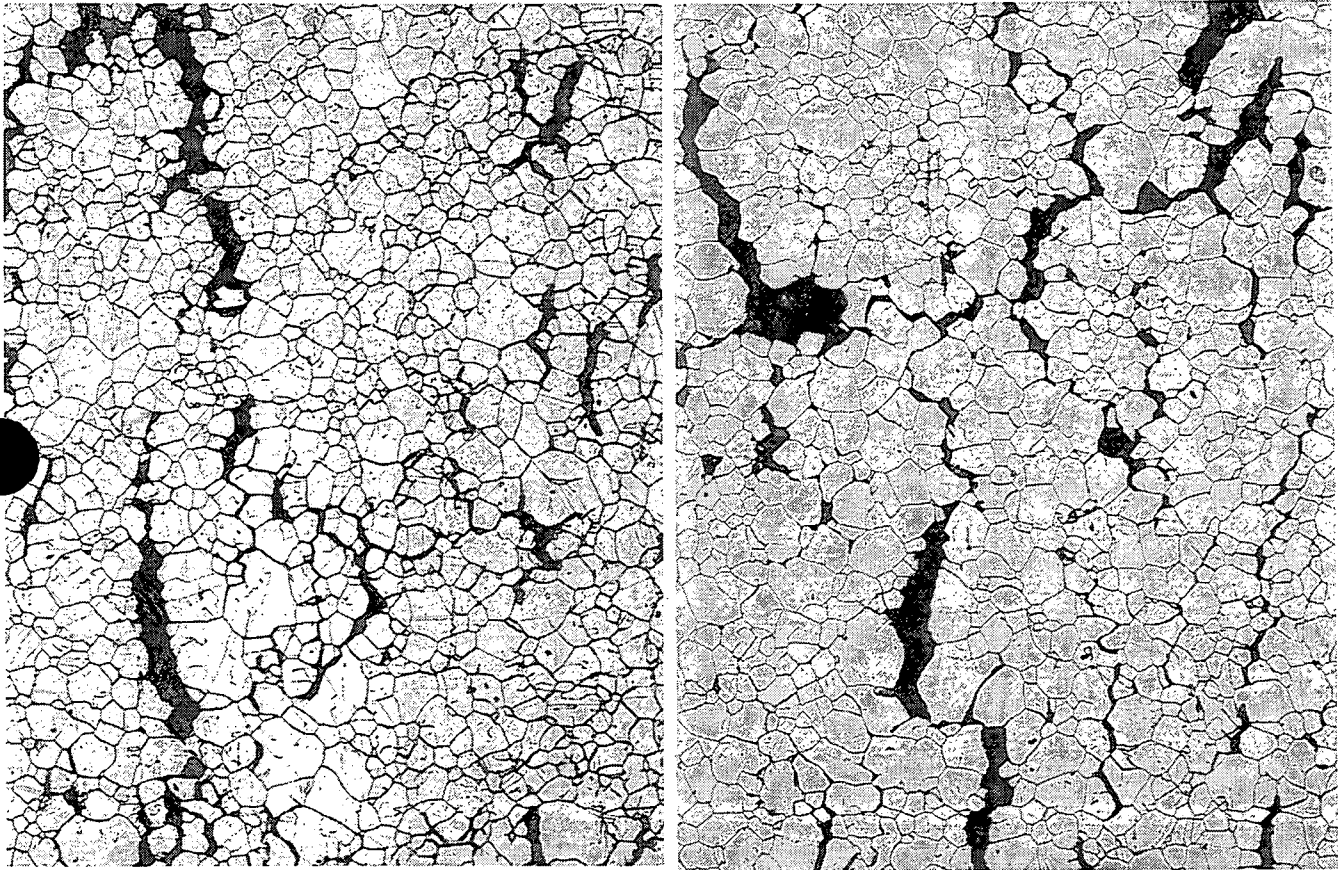
Figure 4-15 TSP1 crevice region Specimen 4B-2C of Tube R15C28. Radial metallographic sample after flattening and polishing to a depth of 0.001 inch below the OD surface. Examples of the corrosion crack pattern at this level of grinding and polishing. Mount M2161. Mag. 100X.

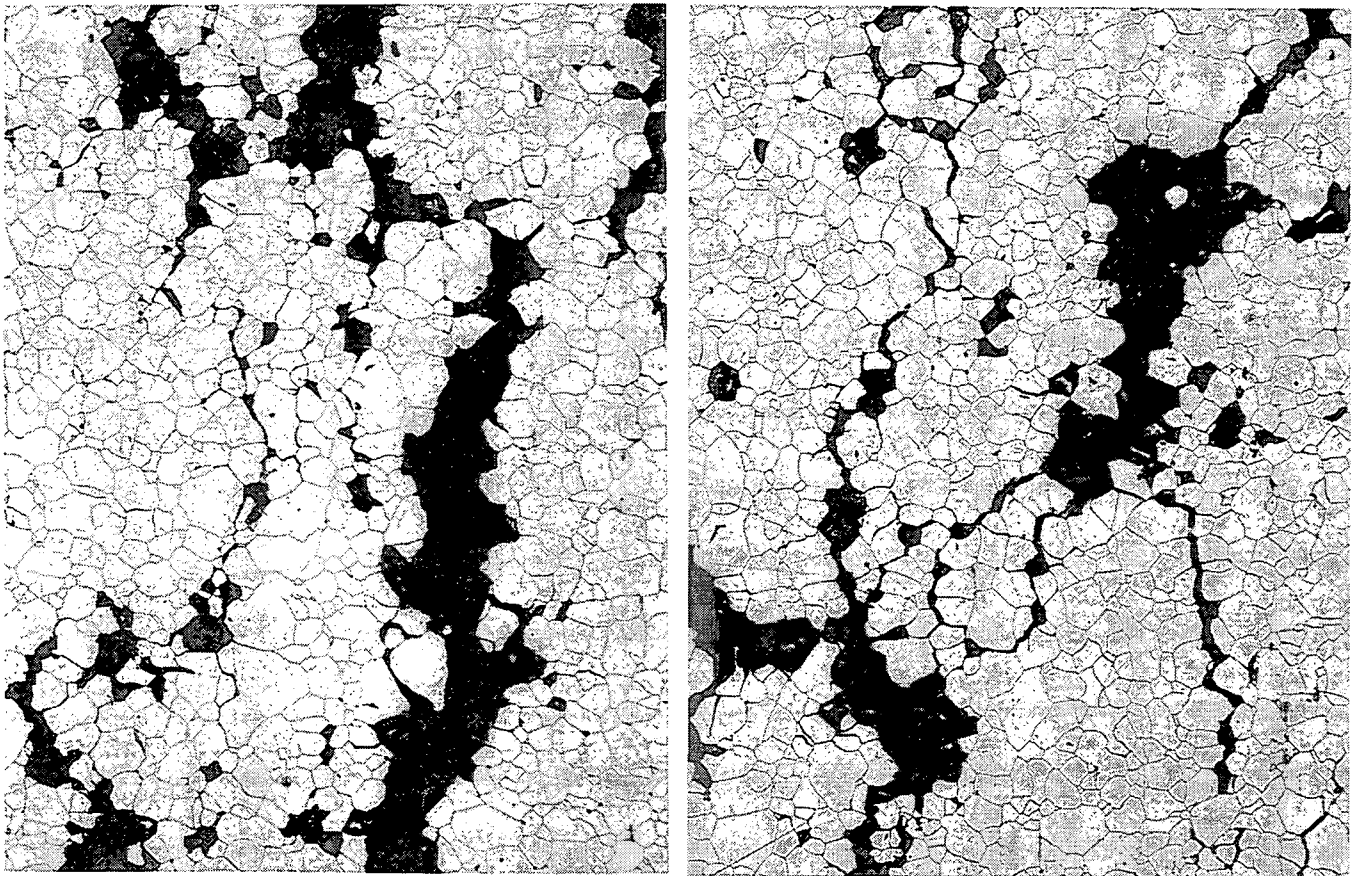
Figure 4-16 TSP1 crevice region Specimen 4B-2C of Tube R15C28. Radial metallographic sample after flattening and polishing to a depth of 0.001 inch below the OD surface. Examples of the corrosion crack pattern at this level of grinding and polishing. Mount M2161. Mag. 100X.

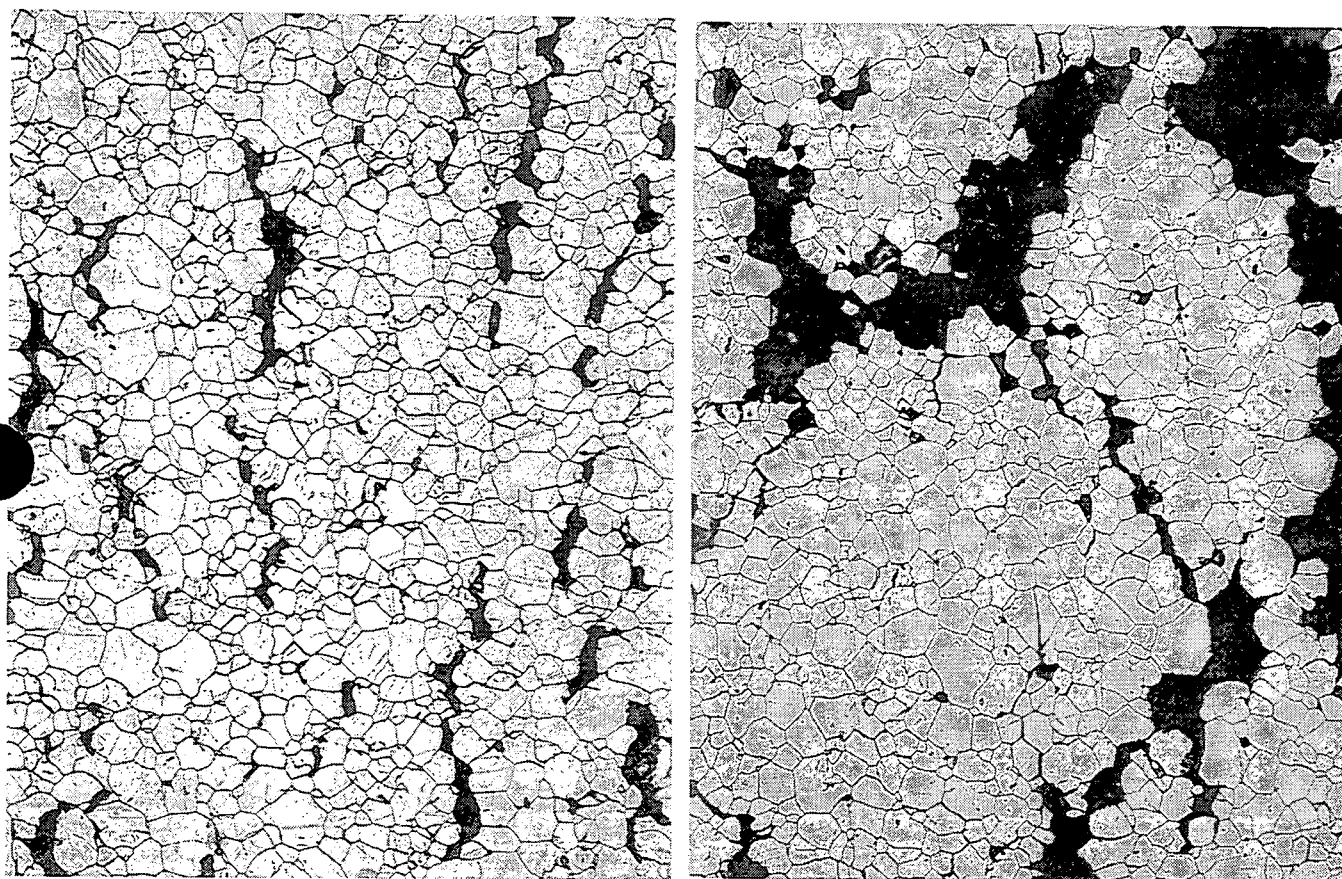
Figure 4-17 TSP1 crevice region Specimen 4B-2C of Tube R15C28. Radial metallographic sample after flattening and polishing to a depth of 0.001 inch below the OD surface. Examples of the corrosion crack pattern at this level of grinding and polishing. Mount M2161. Mag. 100X.

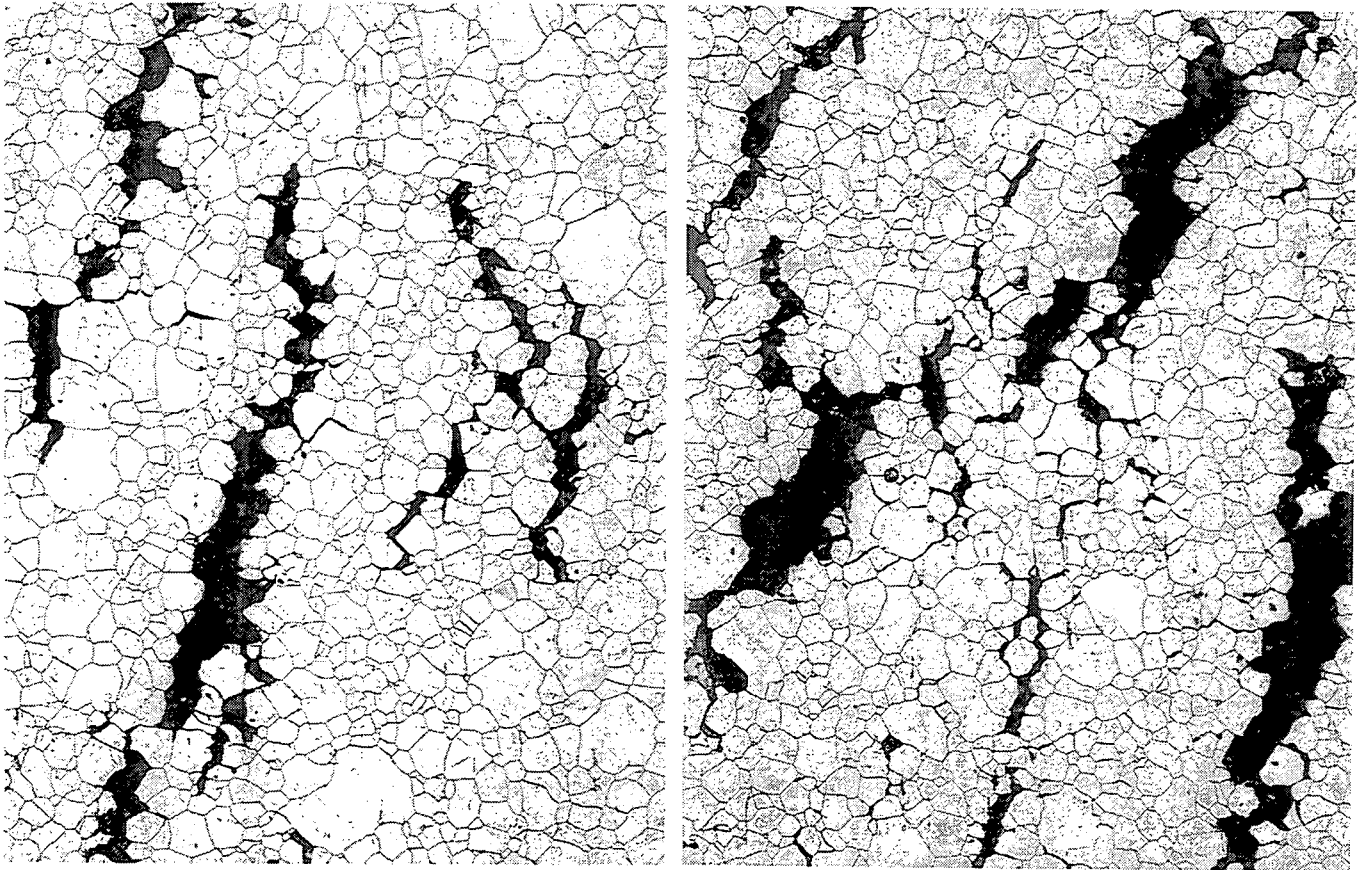
Figure 4-20 TSP1 crevice region Specimen 4B-2C of Tube R15C28. Radial metallographic sample after flattening and polishing to a depth of 0.005 inch below the OD surface. Examples of the corrosion crack pattern at this level of grinding and polishing. Mount M2161. Mag. 100X.

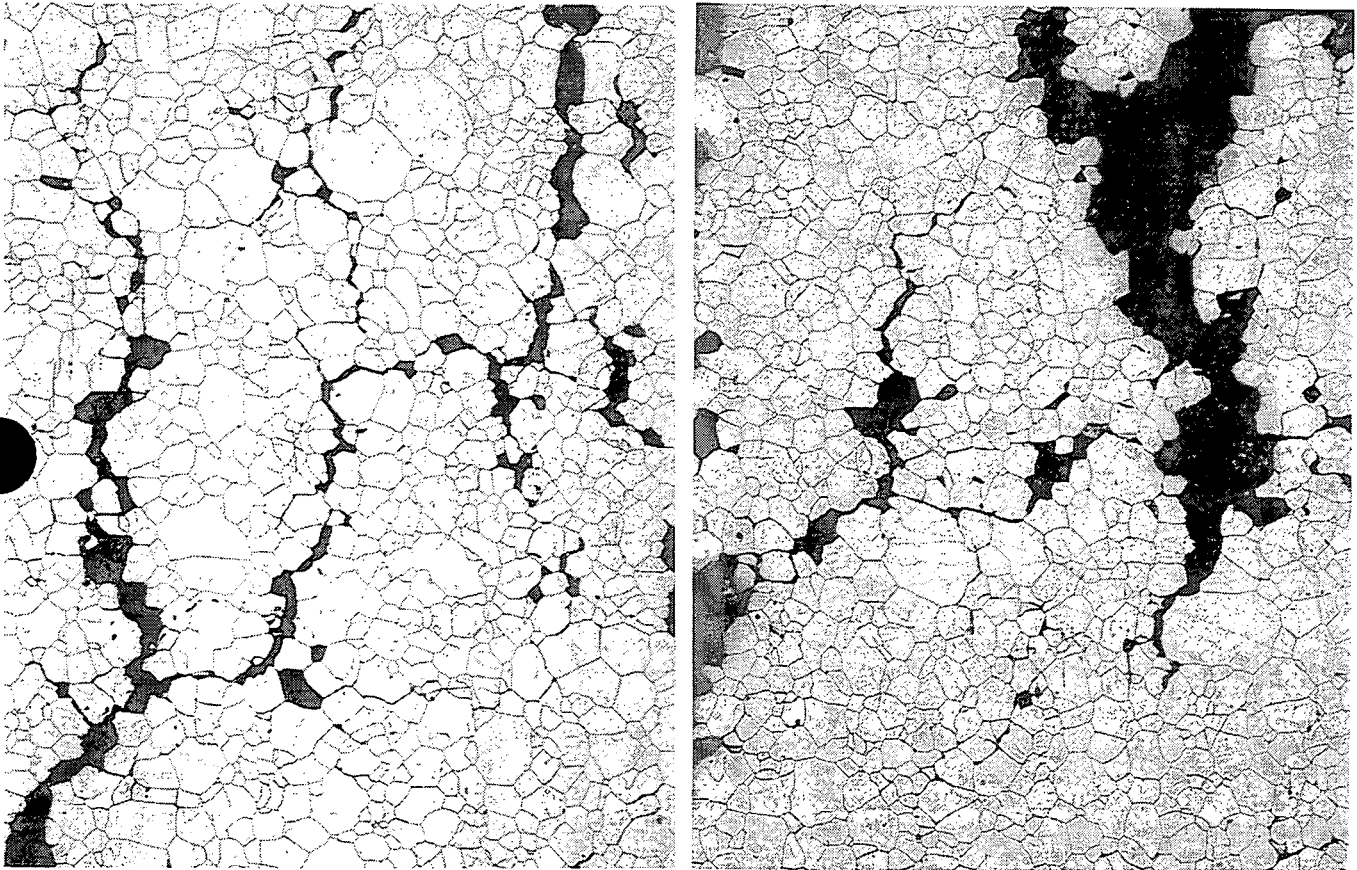
Figure 4-21 TSP1 crevice region Specimen 4B-2C of Tube R15C28. Radial metallographic sample after flattening and polishing to a depth of 0.005 inch below the OD surface. Examples of the corrosion crack pattern at this level of grinding and polishing. Mount M2161. Mag. 100X.

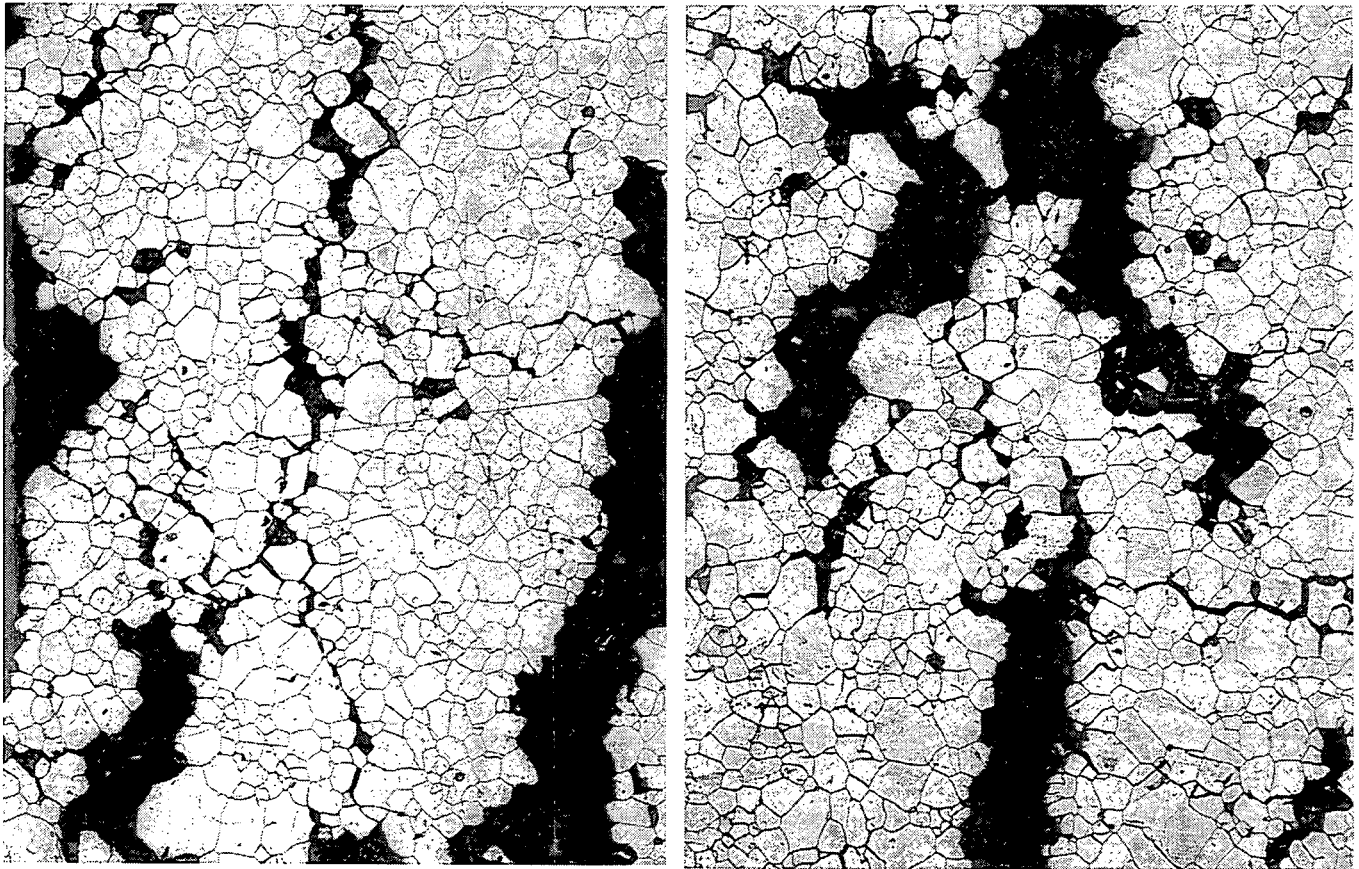
Figure 4-22 TSP1 crevice region Specimen 4B-2C of Tube R15C28. Radial metallographic sample after flattening and polishing to a depth of 0.005 inch below the OD surface. Examples of the corrosion crack pattern at this level of grinding and polishing. Mount M2161. Mag. 100X.

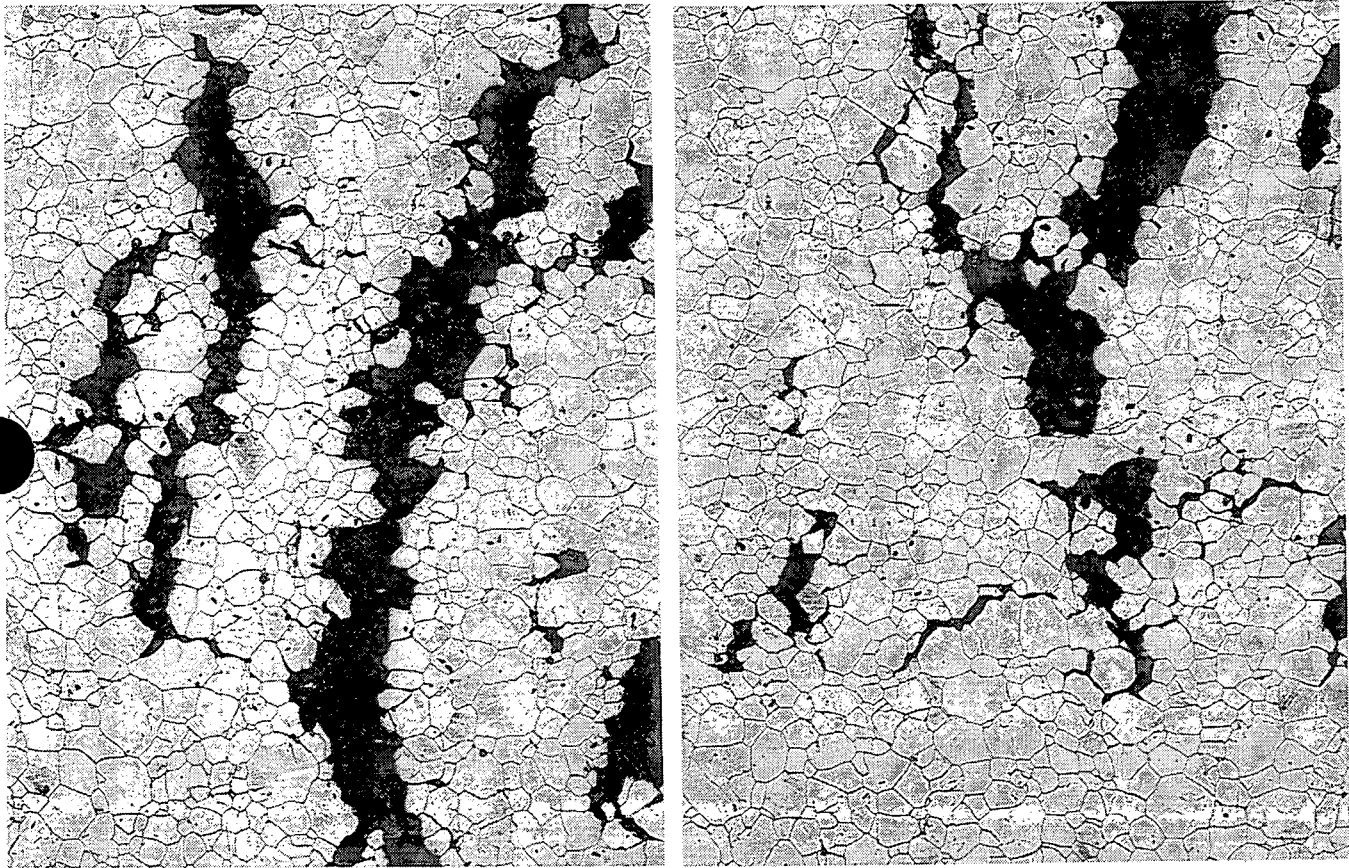
Figure 4-25 TSP1 crevice region Specimen 4B-2C of Tube R15C28. Radial metallographic sample after flattening and polishing to a depth of 0.010 inch below the OD surface. Examples of the corrosion crack pattern at this level of grinding and polishing. Mount M2161. Mag. 100X.

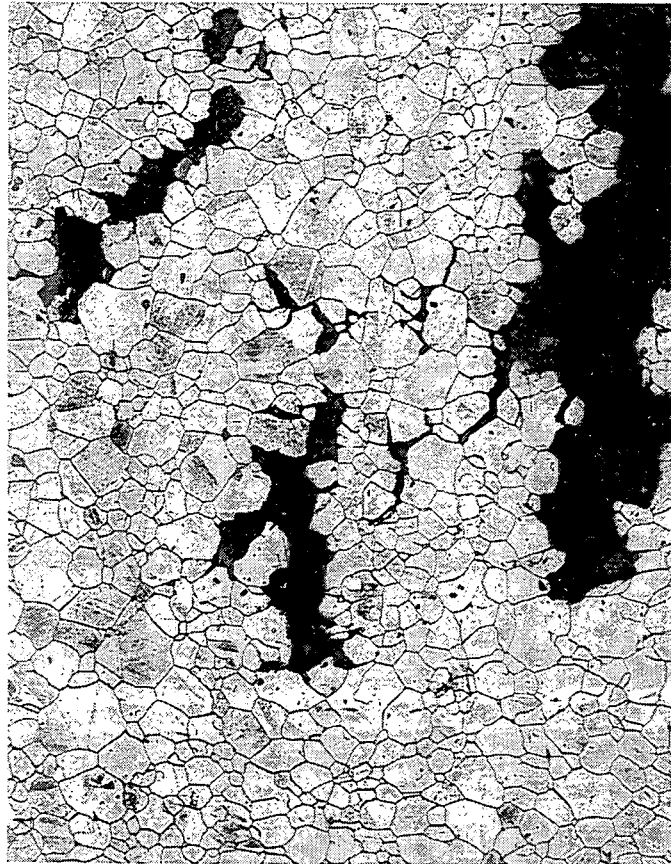
Figure 4-26 TSP1 crevice region Specimen 4B-2C of Tube R15C28. Radial metallographic sample after flattening and polishing to a depth of 0.010 inch below the OD surface. Example of the corrosion crack pattern at this level of grinding and polishing. Mount M2161. Mag. 100X.

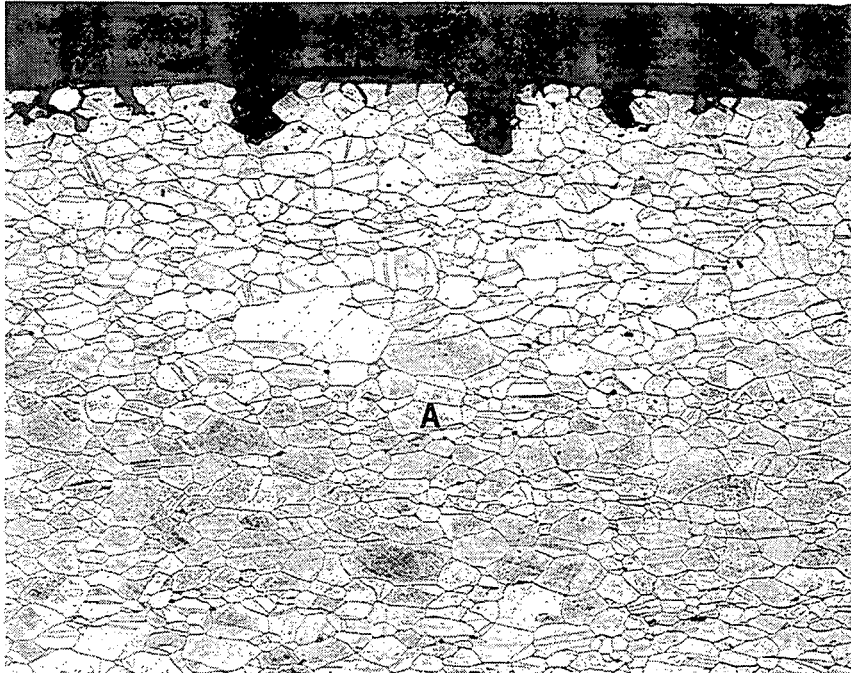
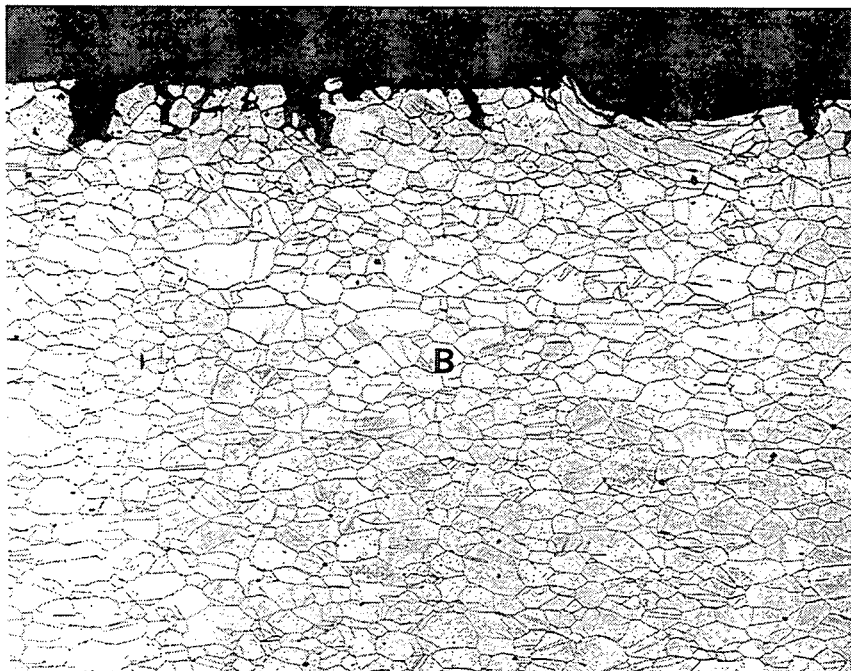
Figure 4-29 TSP1 crevice region Specimen 4B-2B of Tube R15C28. Transverse metallographic sample. Areas A and B from Figure 4-28 showing OD surface cracks at a higher magnification. Mount M2160. Mag. 100X.

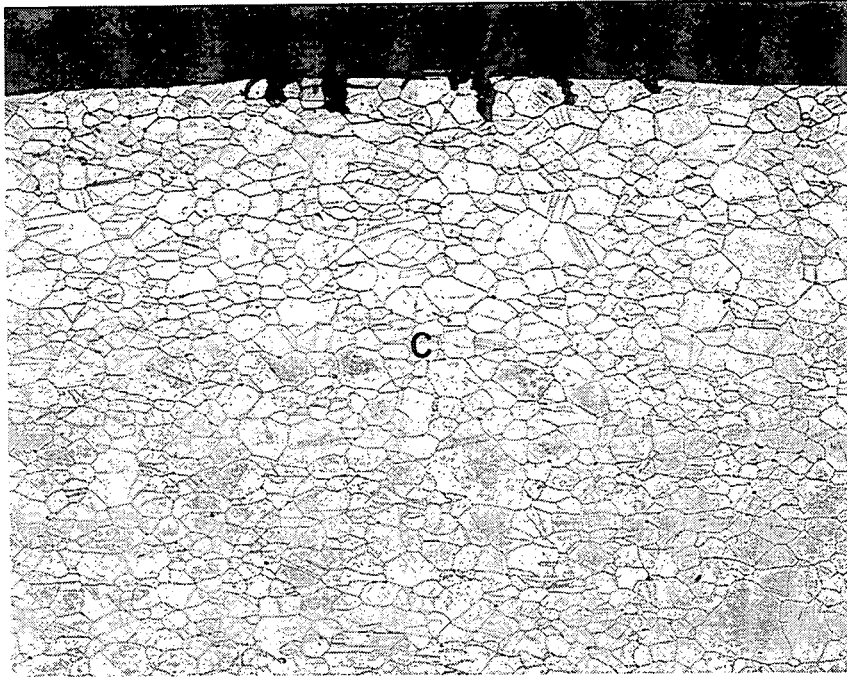
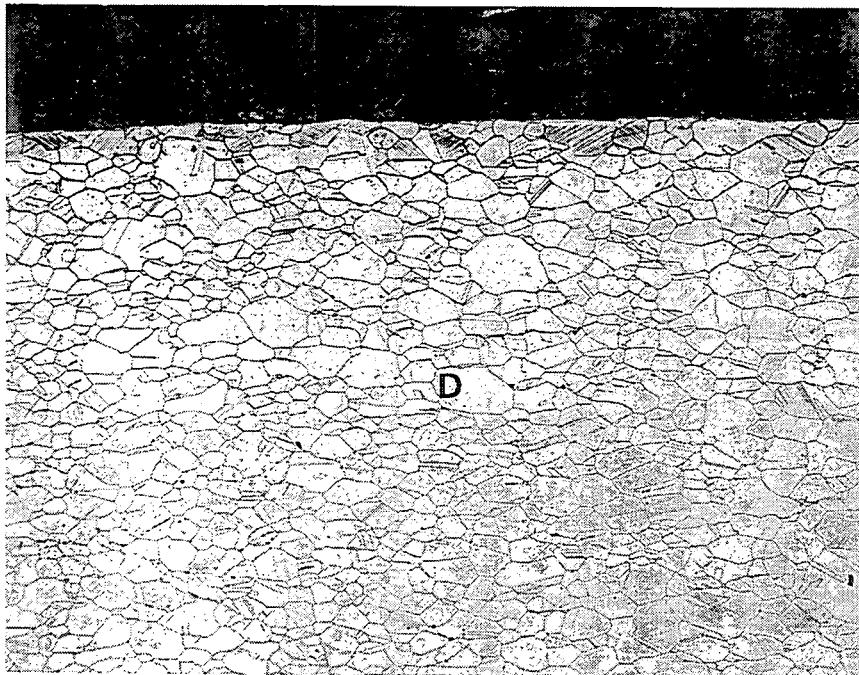
Figure 4-30 TSP1 crevice region Specimen 4B-2B of Tube R15C28. Transverse metallographic sample. Areas C and D from Figure 4-28 showing OD surface cracks at a higher magnification. Mount M2160. Mag. 100X.

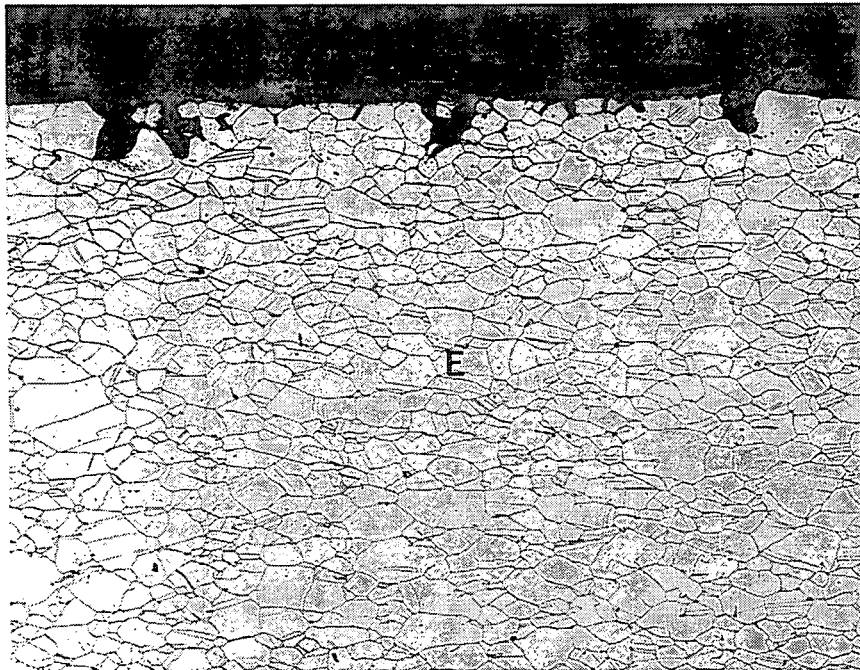
Figure 4-31 TSP1 crevice region Specimen 4B-2B of Tube R15C28. Transverse metallographic sample. Area E from Figure 4-28 showing OD surface cracks at a higher magnification. Mount M2160. Mag. 100X.

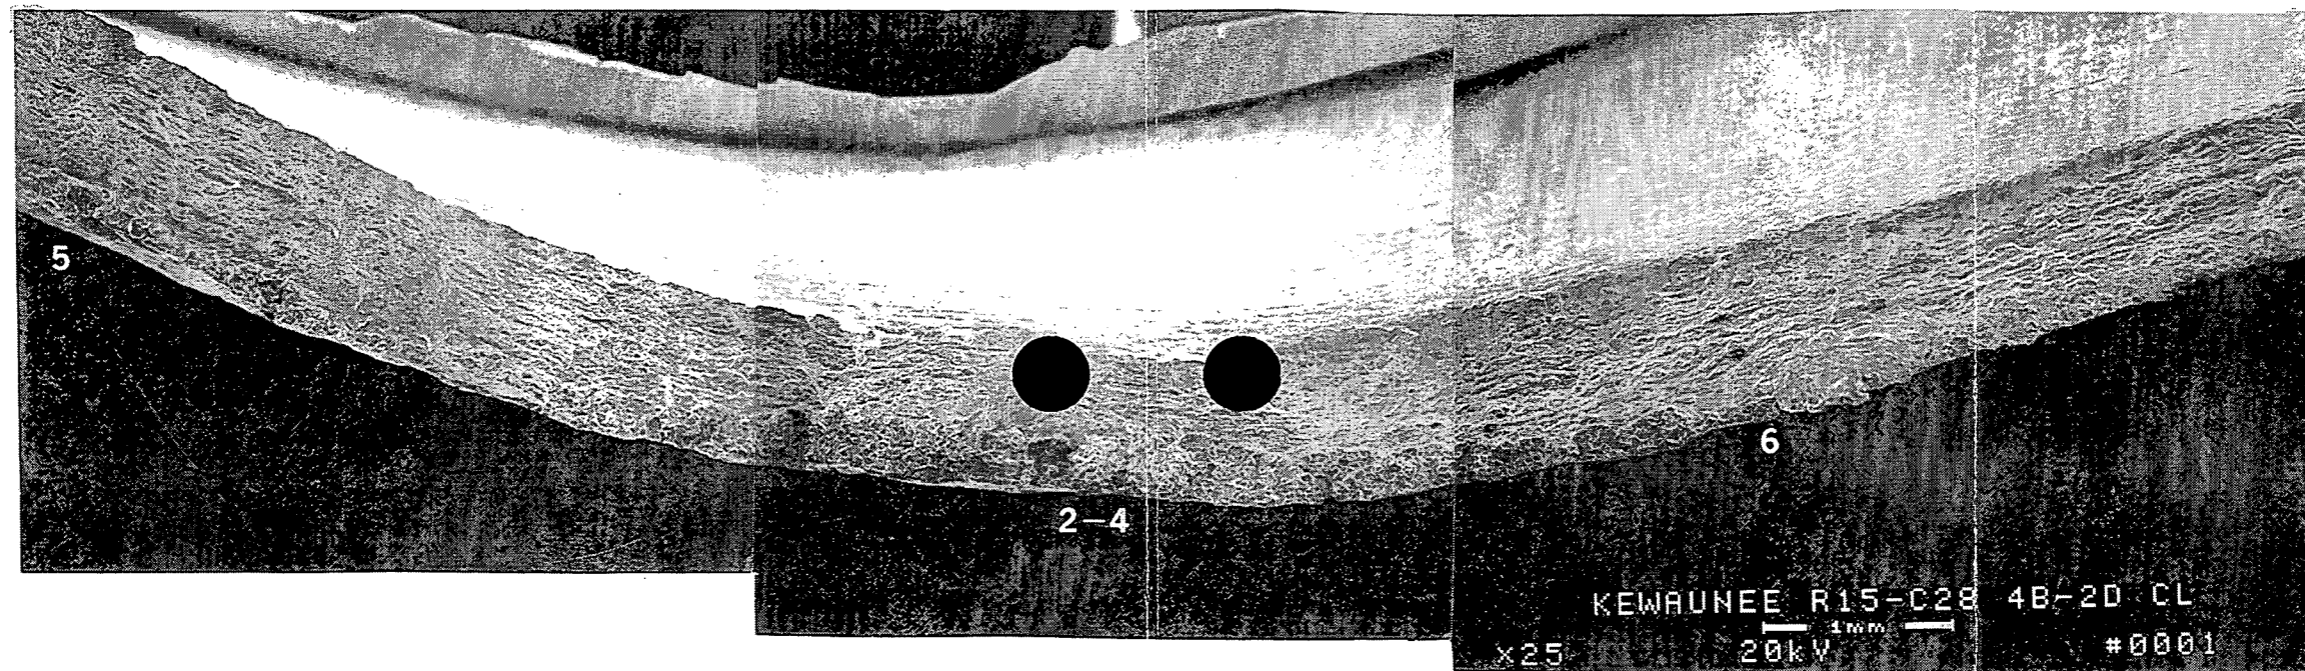
Figure 4-2 TSP1 crevice region Specimen 4B-2D of Tube R15C28. Top view of the opened burst fracture. Areas 2 through 6 of the fracture are shown at higher magnifications in Figures 4-3 through 4-5. Areas 5 and 6 mark the ends of the intergranular corrosion cracking on the OD which started the burst fracture.

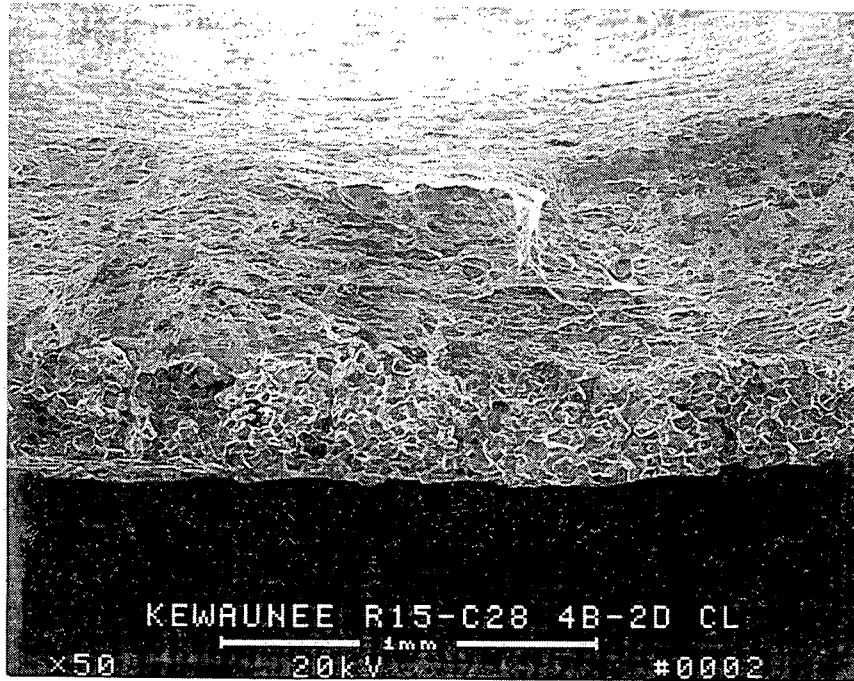
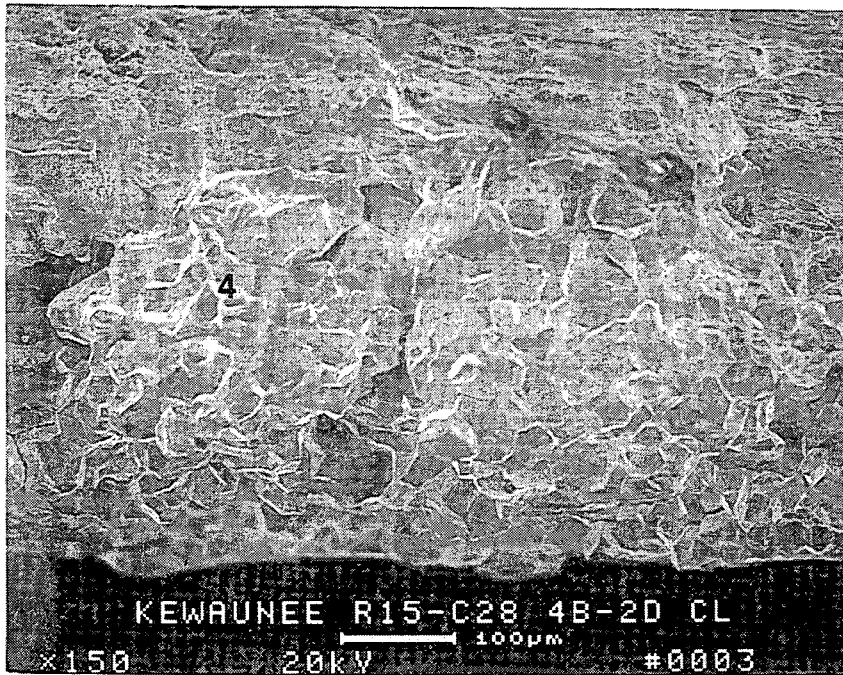
Figure 4-3 TSP1 crevice region Specimen 4B-2D of Tube R15C28. Areas 2 and 3 from figure 4-2, showing the topography of the burst fracture at the location of the deepest corrosion penetration (30% throughwall).

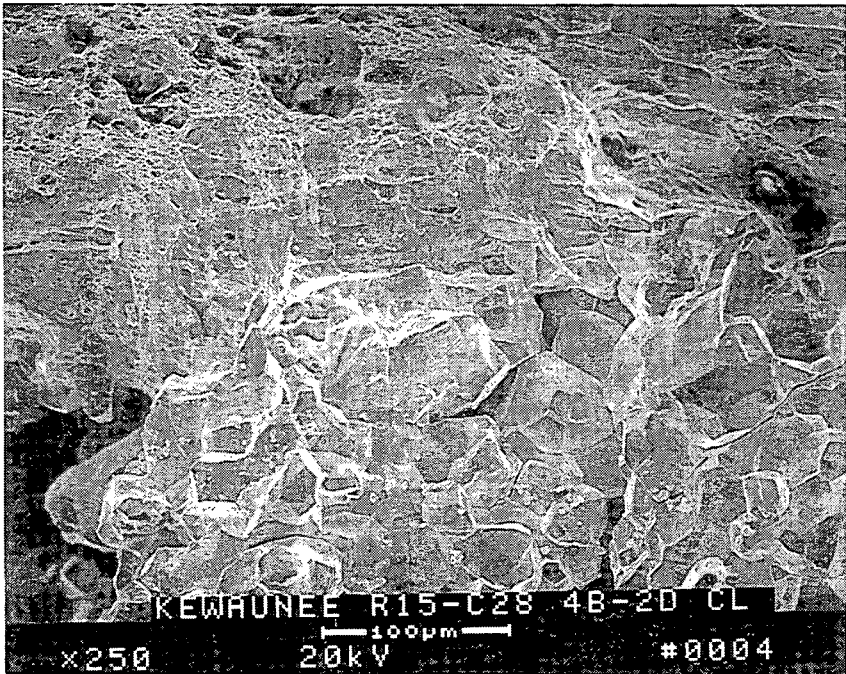
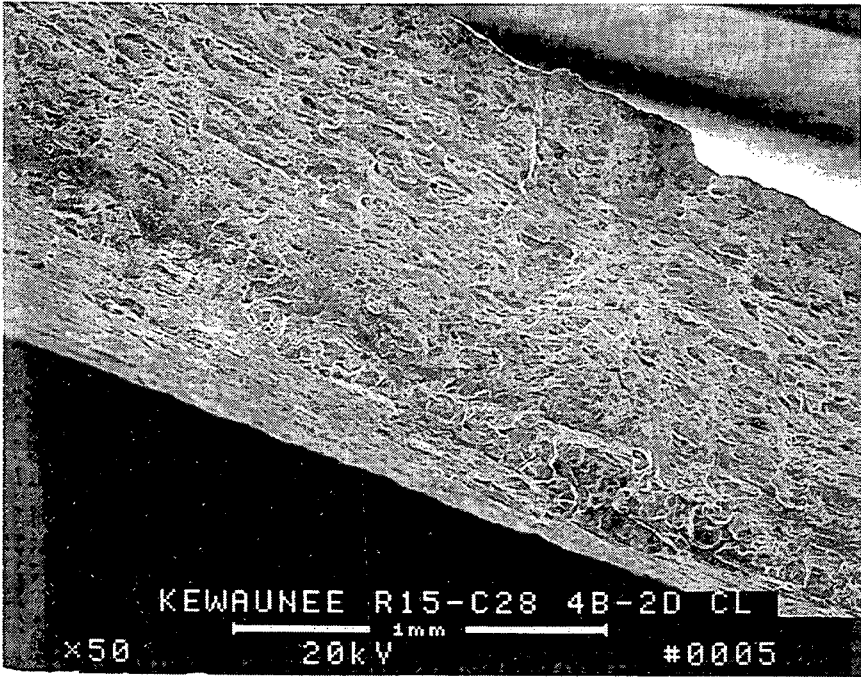
Figure 4-4 TSP1 crevice region Specimen 4B-2D of Tube R15C28. Upper photograph: Area 4 from Figure 4-3 showing the boundary between the field corrosion crack at the point of deepest penetration and the laboratory fracture produced during the burst test.

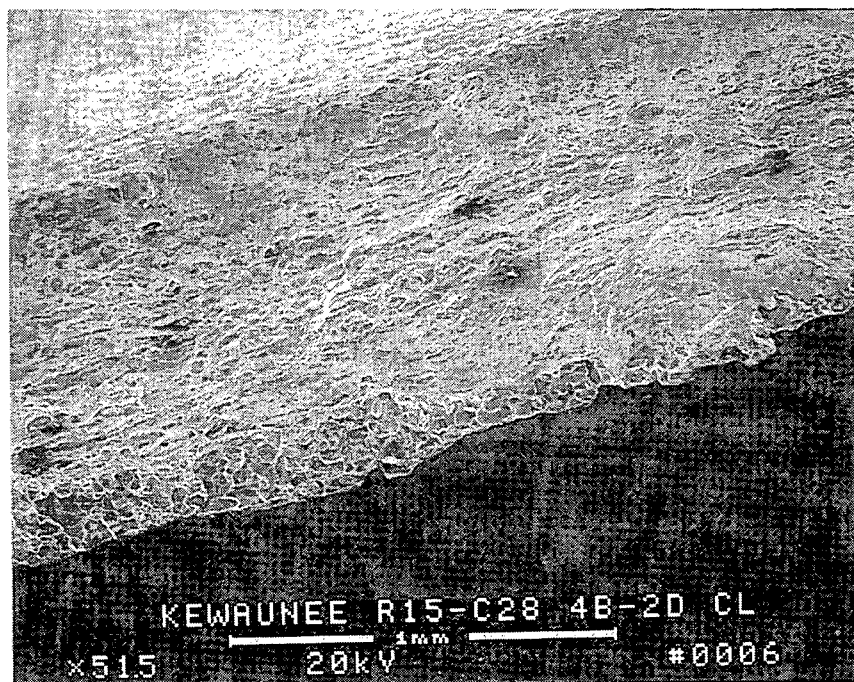
Figure 4-5 TSP1 crevice region Specimen 4B-2D of Tube R15C28. Area 6 from Figure 4-2 showing the right end of field corrosion cracking on the burst test fracture.
