Part 21 (PAR)

Event # 47015

SEAL FAILURE AND LEAKAGE ASSOCIATED WITH MODEL B5497-301 VALVES

10 CFR PART 21 Notification:

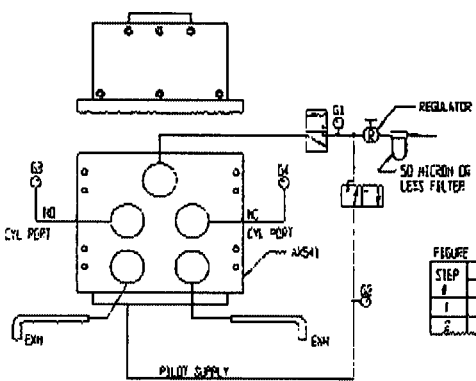
B5491-307 Revision D, Print Sheet 2

Plant staff indicate a low pressure requirement of 50 psig. The valve prints do not specify this pressure. No testing was done by Automatic Valve below 90 psig. Please see print sheet 2 of 3, Notes 5 and 10.			
The only other installation of these valves is at Shearon Harris. Automatic Valve has had no reports of failures from that plant. Three replacement units were purchased by Shearon Harris in October of 2008, after an original installation in 1999.			
Approved by:

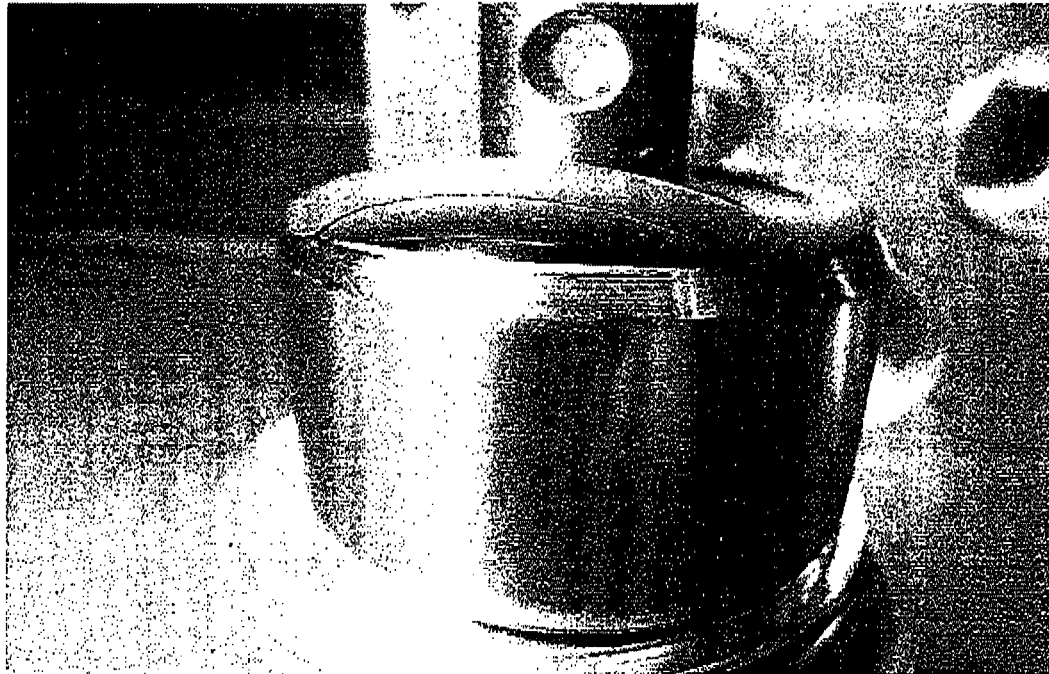
4. Root Cause/s of Problem:	10 CFR Part 21 Report Required: Yes		
A 10 CFR 21is report required based on the statement made by plant staff on June 28 th :			
"when the 4-way for 2CF-26AB failed we drained the tank in a relatively short period of time and we actually started to drain the main nitrogen header the leak was so large. If this happens again during a feedwater isolation we would violate one of our requirements to maintain a minimum of 50 psig in the tank for a 24 hour period."			
The root cause of the valve leakage is seal failure.			
The seal on item 3, A5497-314, is displaced from its retaining groove. (See attached print Sheets 1and 3; photograph 1) This created a condition where the displaced seal was trapped between the poppet face and the valve seat inside the valve body. This creates a gap through which nitrogen passes directly between the inlet port and exhaust port. The exact size of this leak is dependent on several factors including volume and pressure of nitrogen available to force the piston (item 6, attached print sheet 1) into its fully stroked position. This piston, in turn, drives the unsealed seal back into the poppet groove, and creates an (imperfect) seal on the rolled edge or the face of the poppet. At normal operating pressure, above 265 psi, testing shows the displaced seal is forced back (imperfectly) into its retaining groove. The valve leaks but still functions. At lower pressures, the displaced seal will create a larger leak path.

Photograph 1: Displaced, as found, Seal

Time required for compression set and extrusion to occur is unknown. The valve has, however, functioned without failure since 1999. Replacement of seals combined with additional inspection; testing and replacement protocols would prevent an in-service unit from developing the same failure mode.

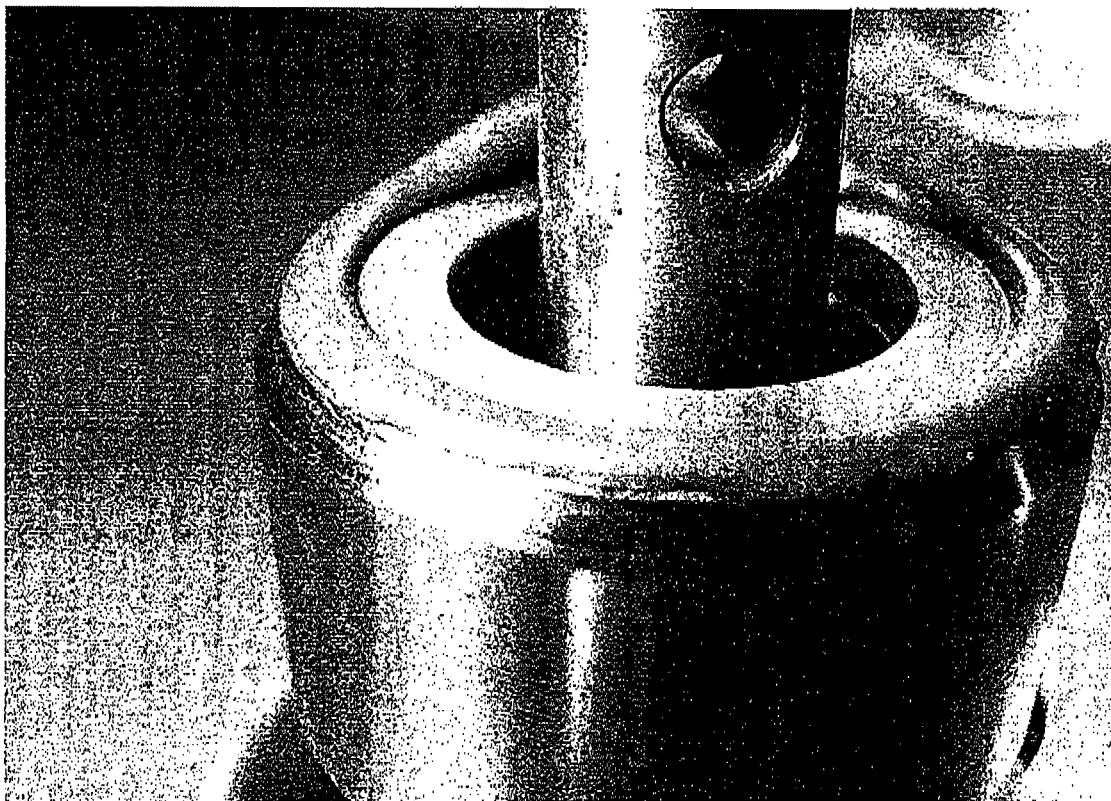
The seal failed due to compression set. It extruded and rolled over the wall of the poppet face (Photograph 2).Note that the extrusion only occurs on the end of poppet which is exposed to ambient pressure (344 psig) around the entire area of an unconstrained seal. The seal on the poppet face which mated to the valve body seat during in-service operation does not extrude. (Photograph 3).			
As the extrusion continues the seal begins to cut. The cut either creates a leak path, which is formed where the high pressure nitrogen can pass under the seal causing it to lift or the cut causes the seal to loose squeeze and high pressure differentials during shift create the lift. Automatic Valve has not been able to duplicate the displacement of an extruded seal.			
Other issues of note not directly related to the failure:			
FME was noted at disassembly of the vale (photograph 4). If the FME is taken into the valve through vent ports it would be expected to degrade lubrication. Degraded lubrication can be expected to both increase minimum operating pressures and slow movement of internal components. This will tend to increase the impact of the displaced seal.

Photograph 2: Seal Extrusion

Additional work is required to modify the seal such that compression set will not impact performance.

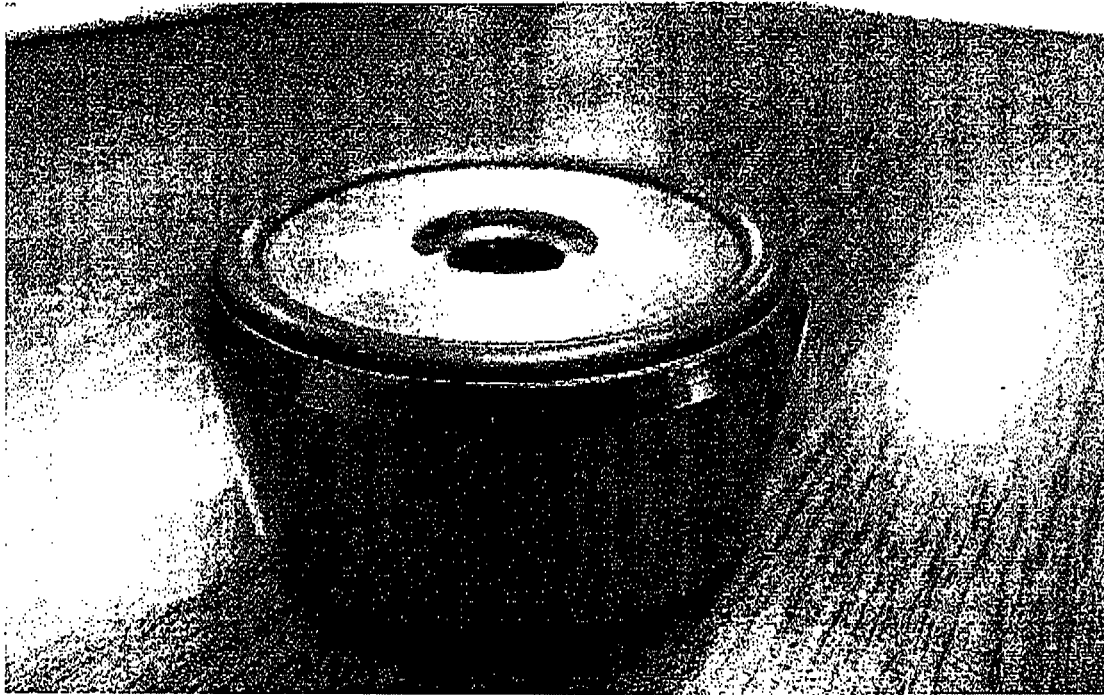
Photograph 3: Seal Face -Without Extrusion - Compressed Against Face In Service

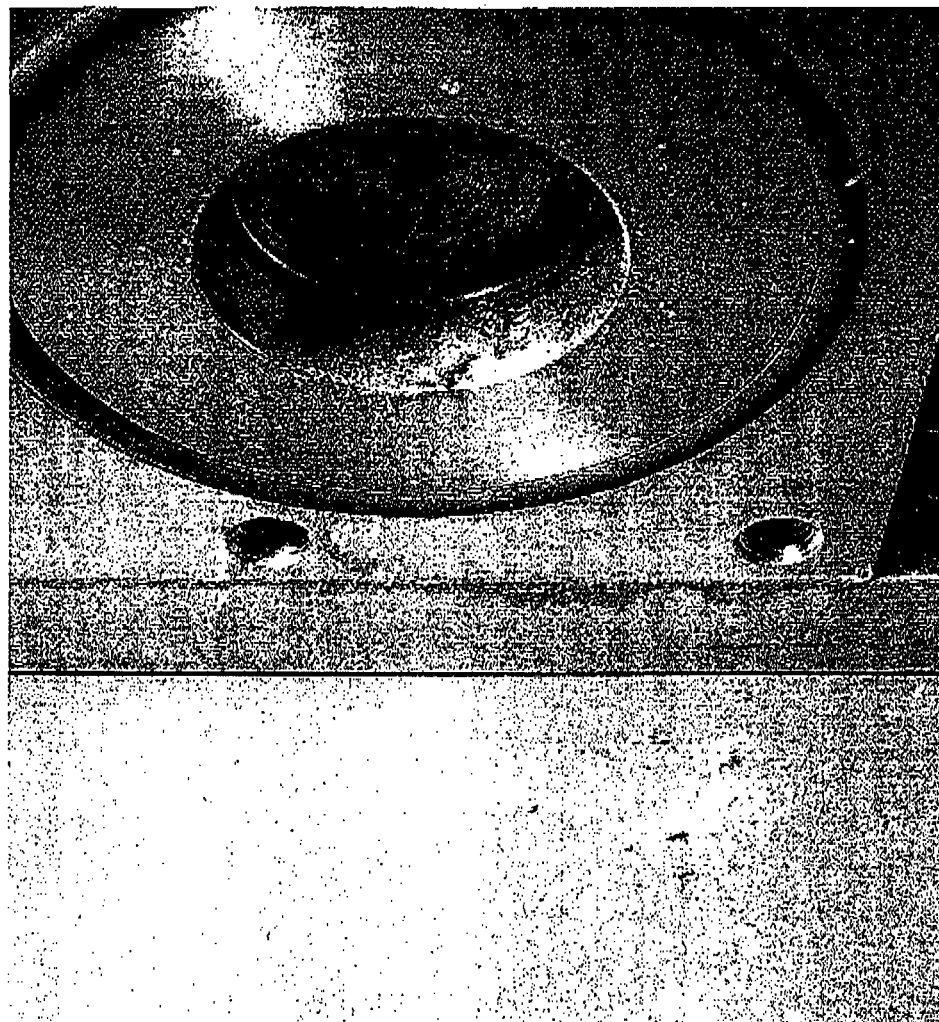
Photograph 4: FME As Found Normally Closed Side, Inlet Face
