Part 21 (PAR)

Event # 47015

SEAL FAILURE AND LEAKAGE ASSOCIATED WITH MODEL B5497-301 VALVES

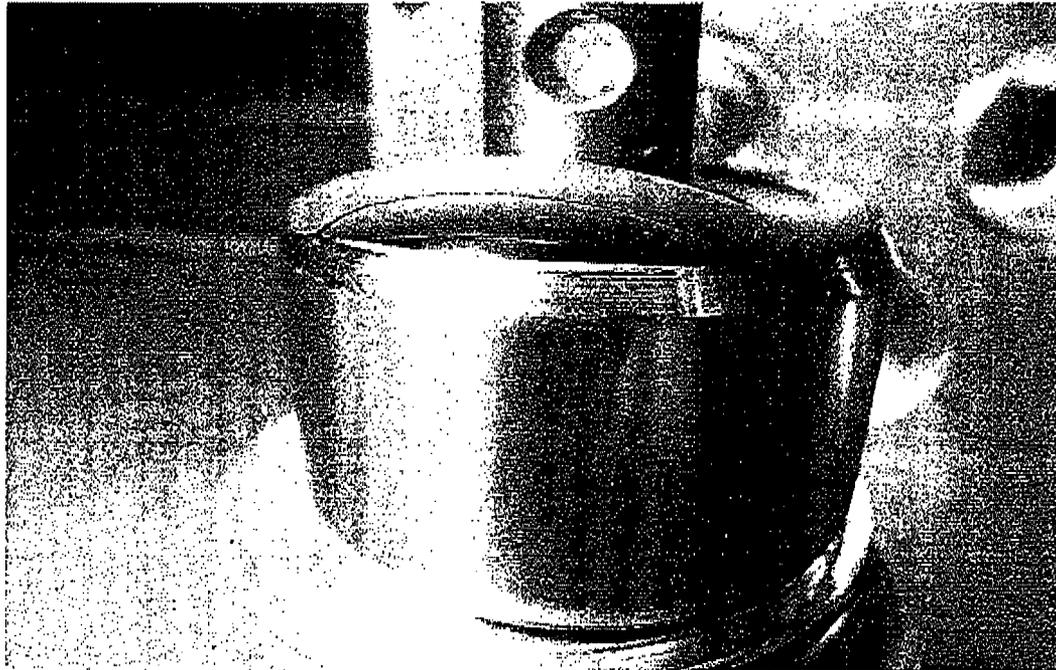
"when the 4-way for 2CF-26AB failed we drained the tank in a relatively short period of time and we actually started to drain the main nitrogen header the leak was so large. If this happens again during a feedwater isolation we would violate one of our requirements to maintain a minimum of 50 psig in the tank for a 24 hour period."			
The root cause of the valve leakage is seal failure.			
The seal on item 3, A5497-314, is displaced from its retaining groove. (See attached print Sheets 1and 3; photograph 1) This created a condition where the displaced seal was trapped between the poppet face and the valve seat inside the valve body. This creates a gap through which nitrogen passes directly between the inlet port and exhaust port. The exact size of this leak is dependent on several factors including volume and pressure of nitrogen available to force the piston (item 6, attached print sheet 1) into its fully stroked position. This piston, in turn, drives the unsealed seal back into the poppet groove, and creates an (imperfect) seal on the rolled edge or the face of the poppet. At normal operating pressure, above 265 psi, testing shows the displaced seal is forced back (imperfectly) into its retaining groove. The valve leaks but still functions. At lower pressures, the displaced seal will create a larger leak path.

Photograph 1: Displaced, as found, Seal

Time required for compression set and extrusion to occur is unknown. The valve has, however, functioned without failure since 1999. Replacement of seals combined with additional inspection; testing and replacement protocols would prevent an in-service unit from developing the same failure mode.

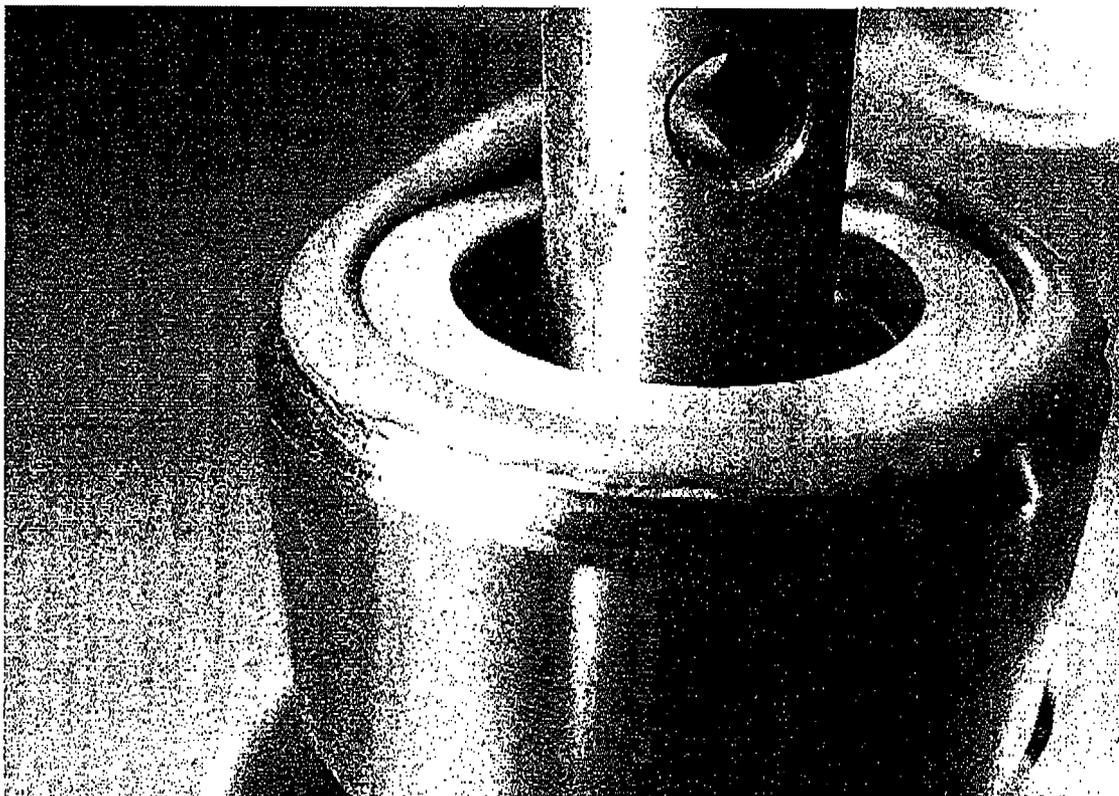
The seal failed due to compression set. It extruded and rolled over the wall of the poppet face (Photograph 2).Note that the extrusion only occurs on the end of poppet which is exposed to ambient pressure ( 344 psig) around the entire area of an unconstrained seal. The seal on the poppet face which mated to the valve body seat during in-service operation does not extrude. (Photograph 3).			
As the extrusion continues the seal begins to cut. The cut either creates a leak path, which is formed where the high pressure nitrogen can pass under the seal causing it to lift or the cut causes the seal to loose squeeze and high pressure differentials during shift create the lift. Automatic Valve has not been able to duplicate the displacement of an extruded seal.			
Other issues of note not directly related to the failure:			
FME was noted at disassembly of the vale (photograph 4). If the FME is taken into the valve through vent ports it would be expected to degrade lubrication. Degraded lubrication can be expected to both increase minimum operating pressures and slow movement of internal components. This will tend to increase the impact of the displaced seal.

Photograph 2: Seal Extrusion

Additional work is required to modify the seal such that compression set will not impact performance.

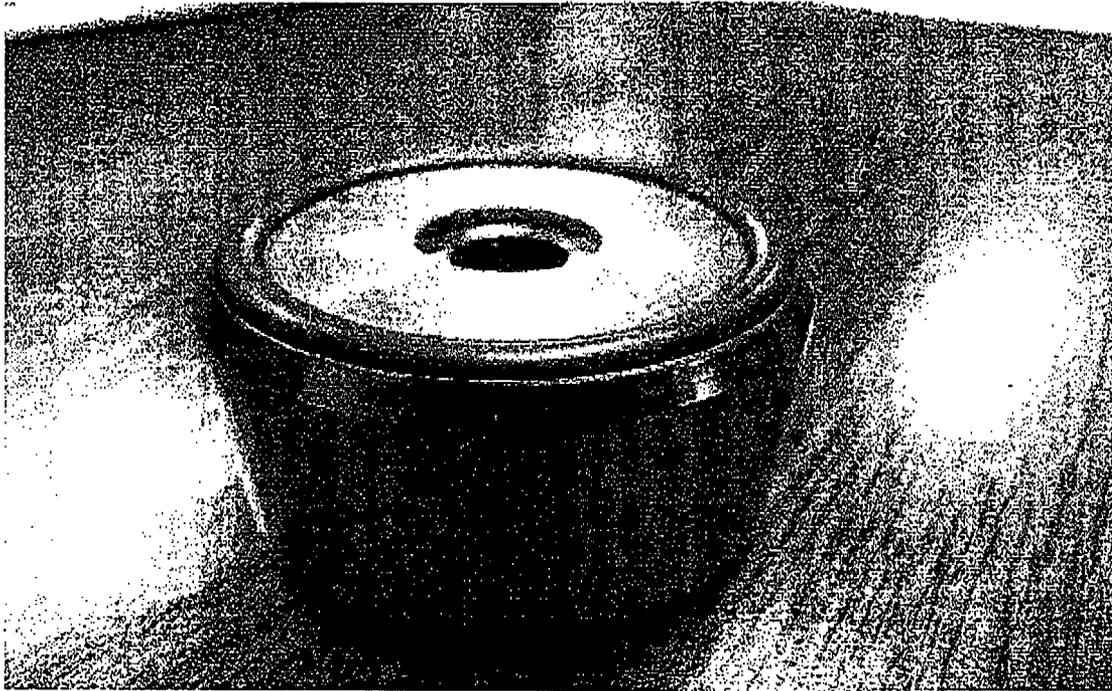
Photograph 3: Seal Face -Without Extrusion - Compressed Against Face In Service

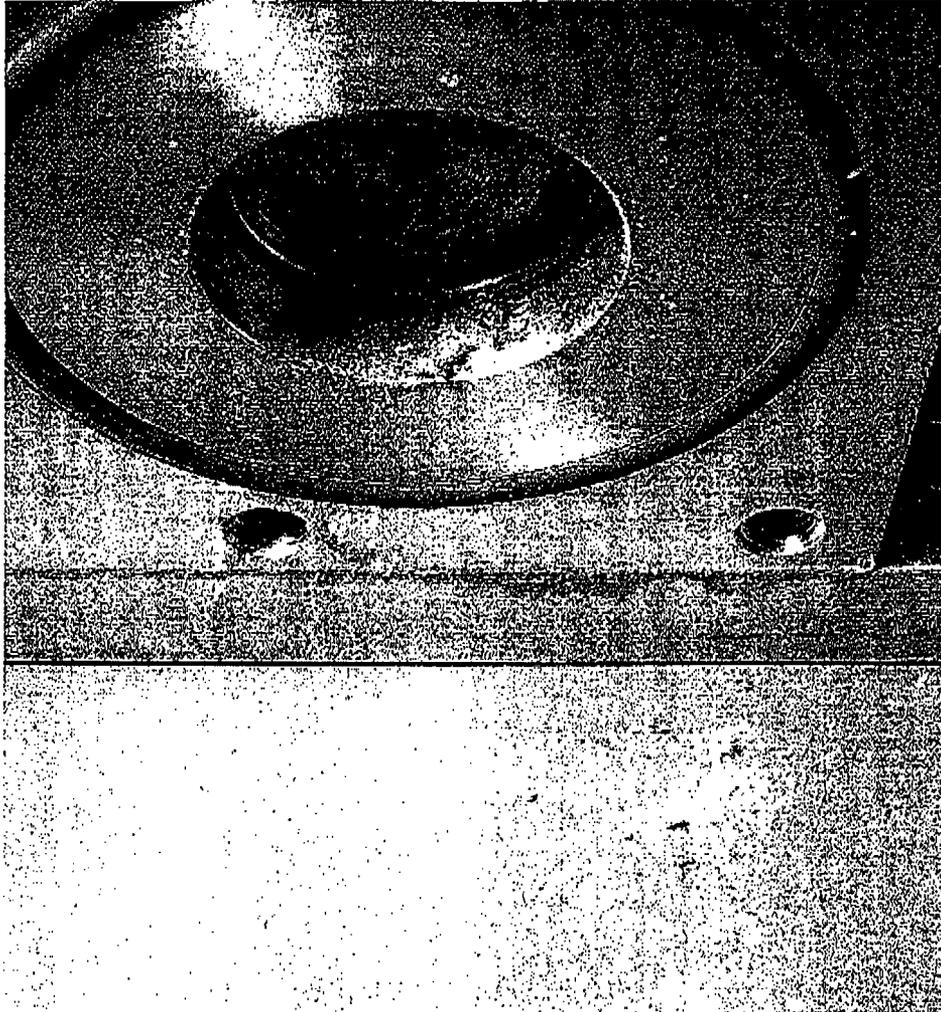
Photograph 4: FME As Found Normally Closed Side, Inlet Face
