**SUBJECT: PERRY NUCLEAR POWER PLANT, UNIT 1 NRC SPECIAL INSPECTION  
TEAM (SIT) REPORT 05000440/2011013 AND PRELIMINARY WHITE FINDING**

Report No: 05000440/2011013

Facility: Perry Nuclear Power Plant, Unit 1

IR 05000440/2011013; 04/25/2011 – 05/25/2011; Perry Nuclear Power Plant, Unit 1; Special Inspection for the April 21, 2011, elevated undervessel radiation dose rates.

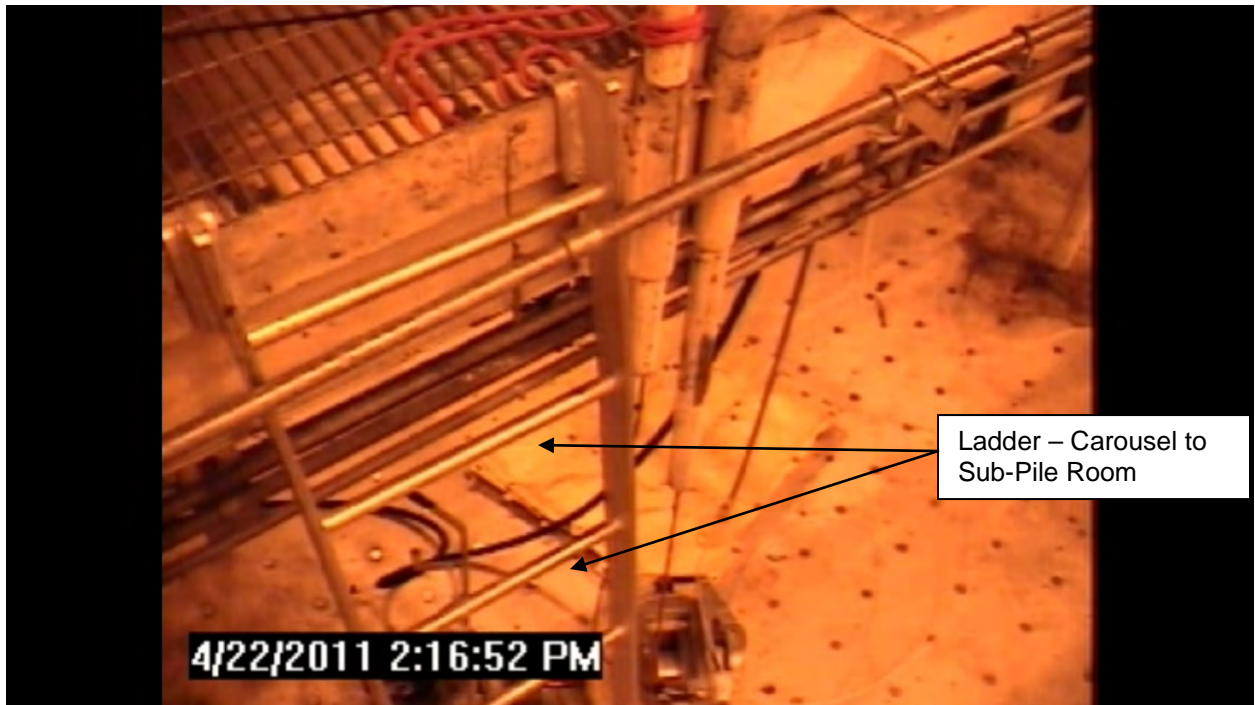
ATTACHMENT 5 - LADDER TO SUB-PILE ROOM

Additionally, the work area was set up without appropriate industrial safety controls, the absence of which could have impacted the radiation doses received by the workers. Specifically, there was an open, unbarricaded, unguarded hole in the grating (floor) that was a nominal 6 foot deep and 36 inches long by 34 inches wide. Several trip hazards were also present at the work site, including a rope, a wire, and a cord on the grating. (Refer to Attachment 8 "Trip Hazards" for pictures of the trip hazards.) Access to the ladder to the sub-pile room was over a hand rail, and conduit was interfering with the ladder rungs. (Refer to Attachment 5 for pictures of the ladder rung interferences.)

Sub-Pile Room Access Ladder Was Installed

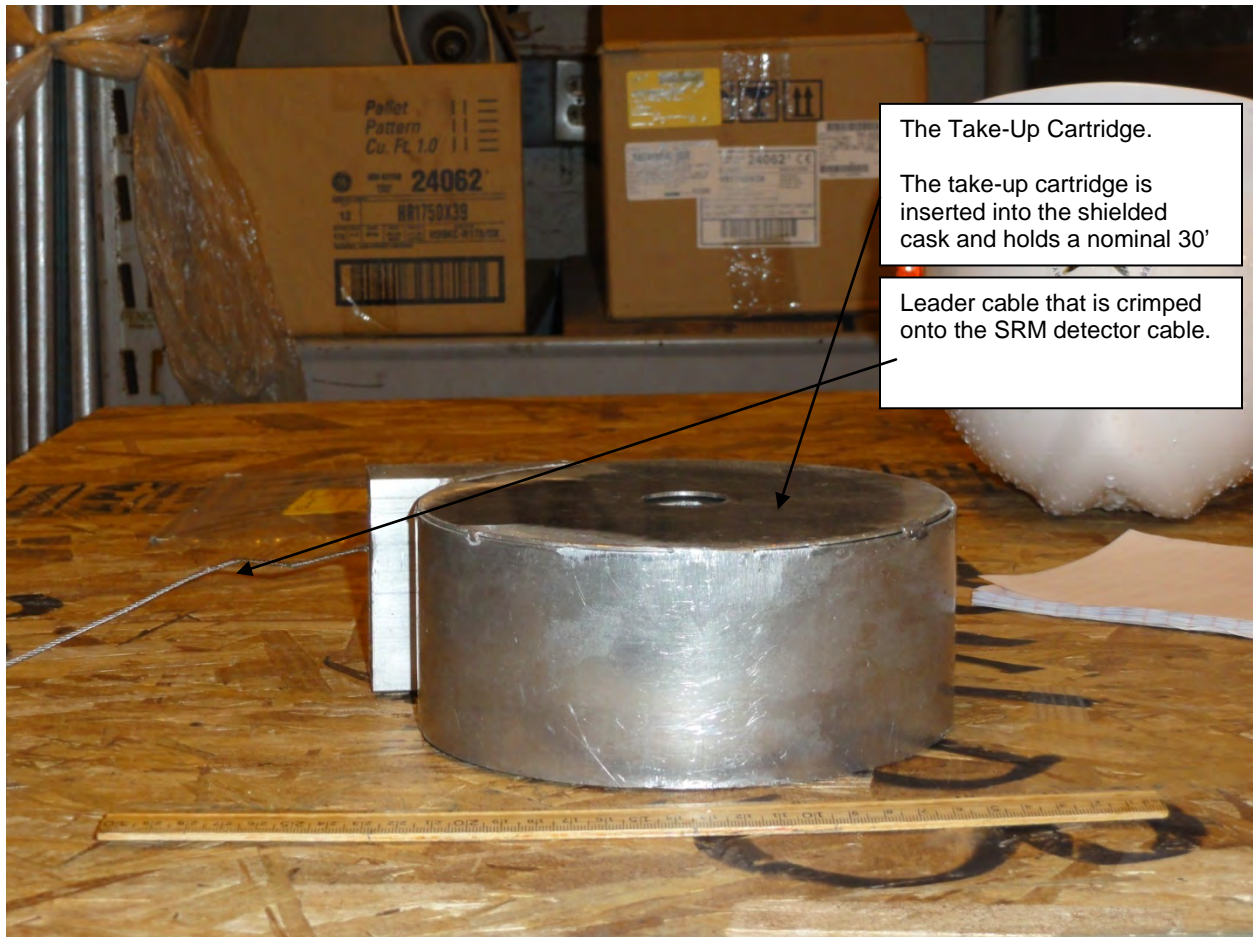
## ATTACHMENT 6 - TAKE-UP CARTRIDGE

licensee did not ensure that personnel followed procedures. The licensee had insufficient detail in its procedure to ensure that the SRM-C cable take-up cartridge was installed correctly. Additionally, the workers failed to follow the procedure in removing a nominal nine feet of excess SRM detector cable. This was a violation of regulatory requirements. Since the licensee documented this issue in its corrective action program (CAP) (Condition Report 11-93247) and because this finding is of very low safety significance, it is being treated as an NCV in accordance with the NRC enforcement policy. (05000440/2011013-01)

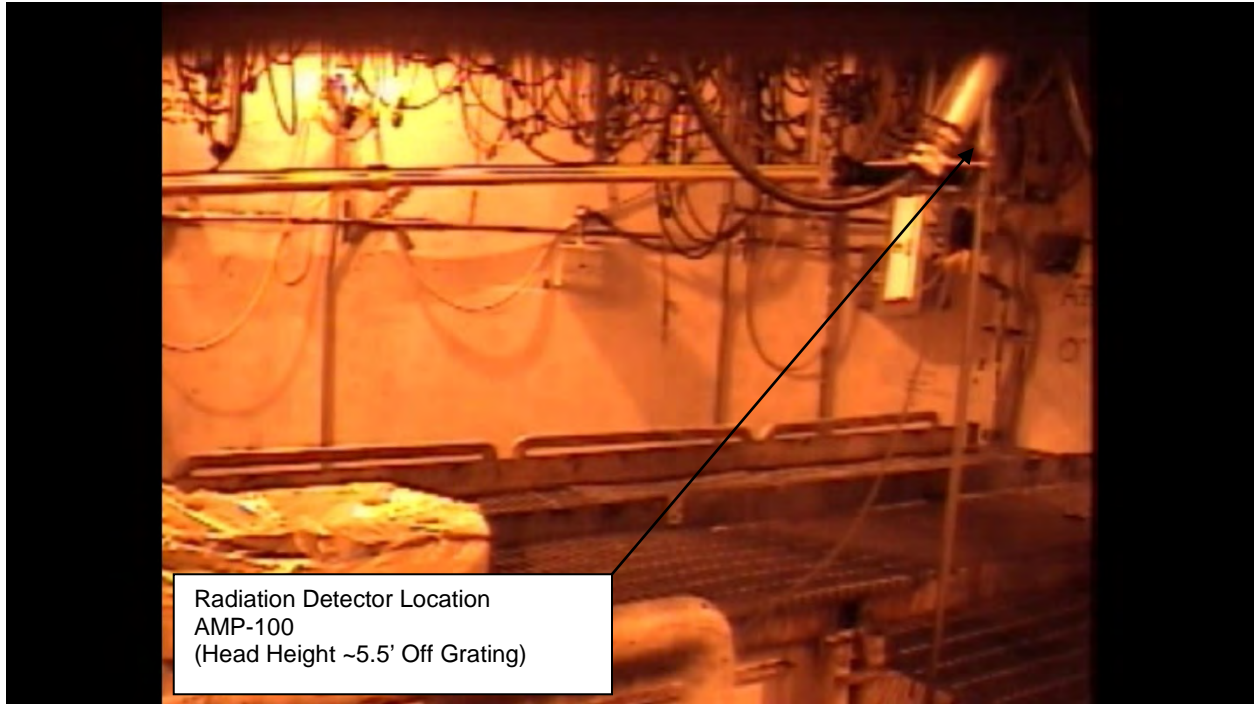
**ATTACHMENT 9 - AMP-100 LOCATION**

- Some of the radiation survey meters used during the SRM-C detector replacement work did not have sufficient ranges for the potential radiological fields that could have been present. The teletector and AMP-100 used on the guide tube went off-scale high during the work activities. (Refer to Attachment 9 “AMP-100 Location” for a picture of the AMP-100 on the drive tube);

Radiation Detector Location  
AMP-100  
(Head Height ~5.5' Off Grating)
