SUBJECT: LER 92-016-00: on 920824, review of surveillance procedure  
 55-167-1 indicated blowdown sampling valve in excess of  
 closing time. Caused by personnel error. Valve BT-31A declared  
 inoperable, BT-32A closed & BT-31A retested. W/920923 ltr.

Docket 50-305  
Operating License DPR-43  
Kewaunee Nuclear Power Plant  
Reportable Occurrence 92-016-00

TITLE (4)  
Steam Generator Blowdown Sample Valve Fails an Inservice Timing Test

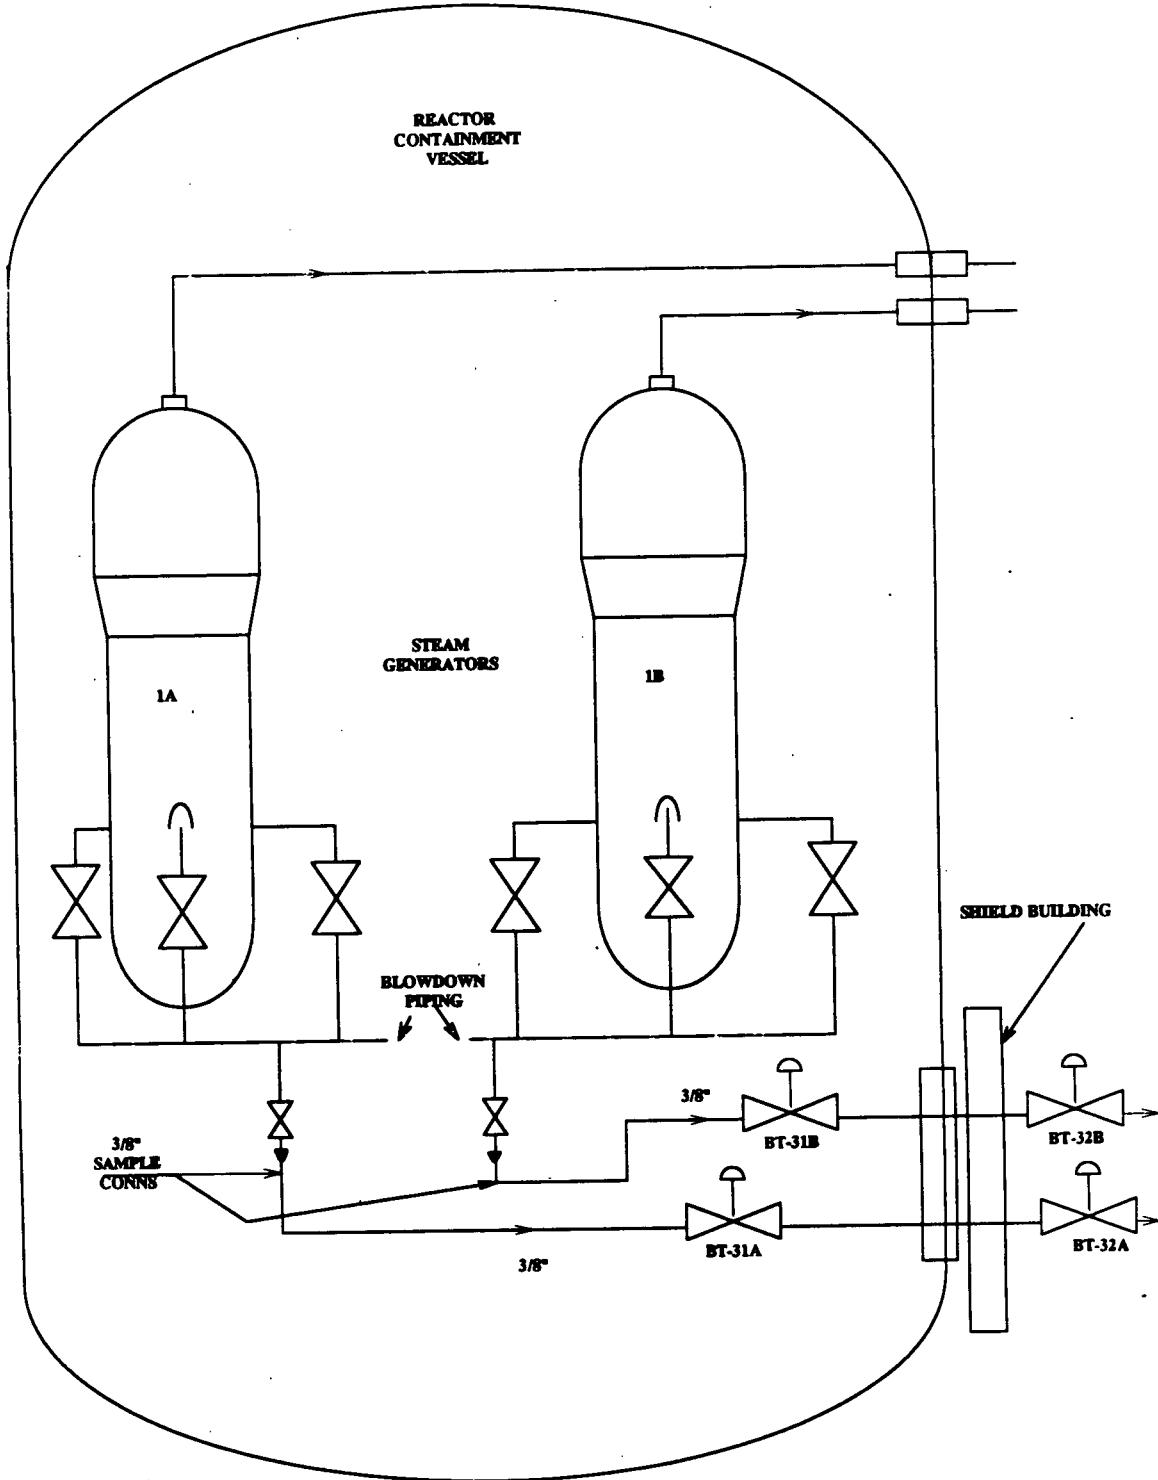
## ATTACHMENT 1 SECONDARY SAMPLING SYSTEM

It should be noted, that during the August 20, 1992 performance of SP 55-167-1 the "B" train steam generator [SG] sample isolation valve, BT-31B, was also found to exceed its 2 second closing time limit and appropriate actions were immediately taken. Reference attachment 1 for the SG sampling valves configuration.
