SUBJECT: LER 92-017-00:on 920915,turbine trip/reactor trip occurred.
 Cause not determined.Bushing replaced & breaker was tested.
 W/921015 ltr.

Docket 50-305
Operating License DPR-43
Kewaunee Nuclear Power Plant
Reportable Occurrence 92-017-00

LICENSEE EVENT REPORT (LER)

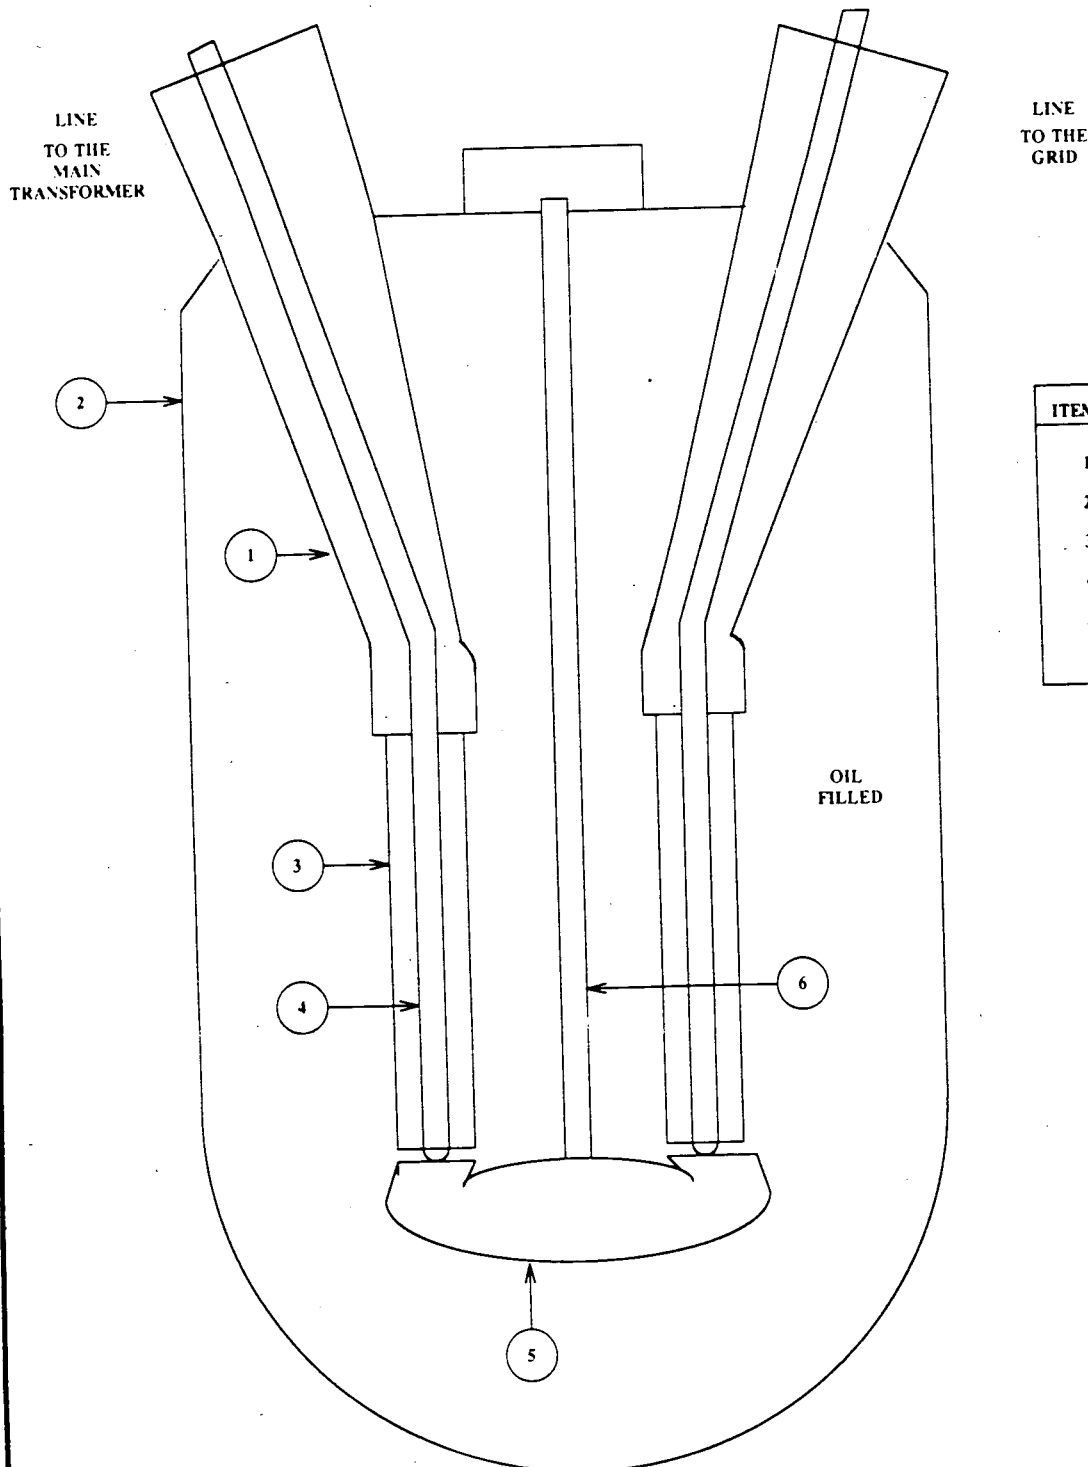
ATTACHMENT 1 OIL CIRCUIT BREAKER

The fire and plant trip were caused by a failure of the number 4 bushing on the B phase OCB for the main generator. Attachment 1 provides a simplified diagram of an OCB tank. G-1 OCB is comprised of three individual OCB tanks mechanically connected to operate as a three phase circuit breaker. Each tank has two condenser type bushings, which provide electrical insulation between the OCB housing and the current carrying conductor running inside the bushing. The bushing failure caused the conductor to arc to ground. The arcing ignited the oil in the B phase bushing and damaged the number 6 bushing located on A phase.

1. A post trip review was performed to verify that the plant responded as designed and that nothing occurred that was not understood.
2. G-1 OCB was repaired and post maintenance testing was performed to ensure proper mechanical and electrical operation. The number 4 bushing and the number 6 bushing were replaced. The lift rod assembly for the B phase, which was damaged during the event, was also replaced. Prior to returning the breaker to service, power factor testing, micro-ohm testing, and functional tests were completed on all three phases.
3. Oil samples from the main transformers were taken and analyzed to ensure that the fault on G-1 OCB had not damaged the transformer.

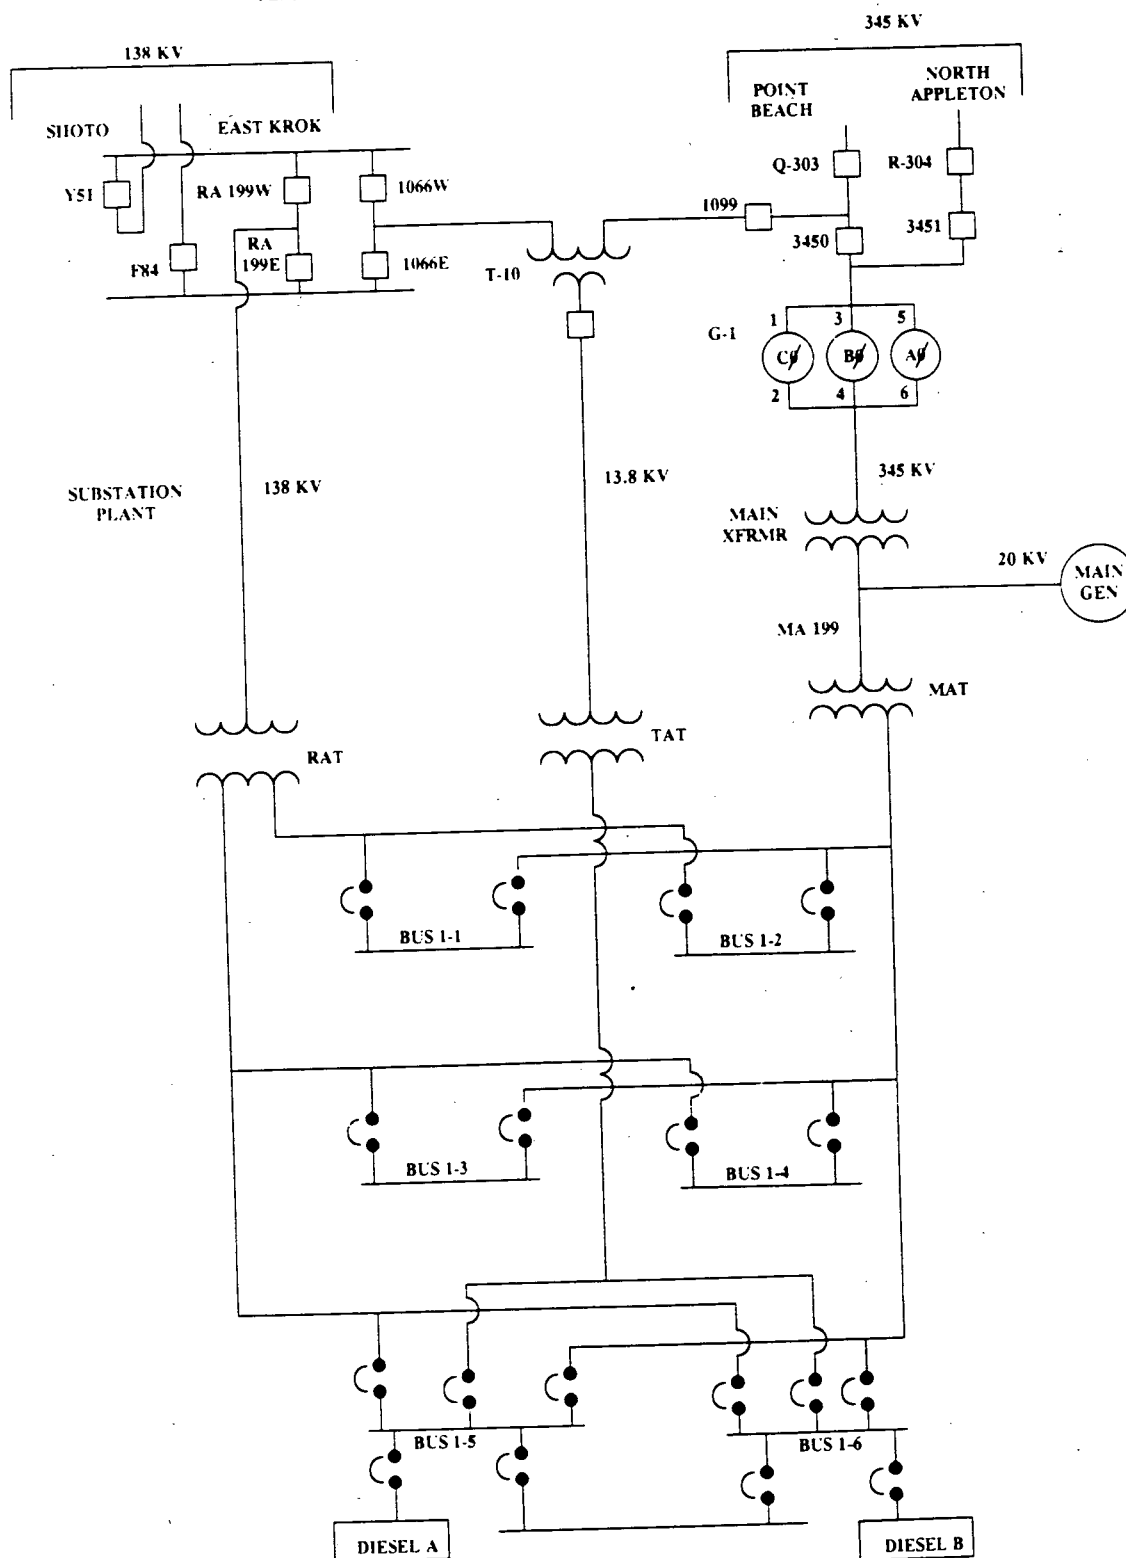
ATTACHMENT 2

1. The fault on G-1 OCB caused a generator trip, which as designed resulted in a turbine/reactor trip.
2. All three auxiliary feedwater pumps started .
3. The protective relaying for G-1 OCB opened breakers Q-303, R-304, 3450, 3451, 1099, and G-1 as designed (refer to attachment 2). This isolated the fault by isolating the 345 KV power supplies to the substation and the plant.
4. Offsite power continued to be supplied to the plant by the two 138 KV offsite supplies (refer to attachment 2).
