SUBJECT: LER 91-002-02: on 910220, determined that second level undervoltage trips of safeguards buses did not meet design basis. Caused by inadequate design evaluation. Design mods made during 1991 refueling outage. W/930215 ltr.

Docket 50-305
Operating License DPR-43
Kewaunee Nuclear Power Plant
Reportable Occurrence 91-002-02

TITLE (4) Safety System Functional Inspection Discovers that the Safeguards Bus Undervoltage Protection is Outside of its Design Basis as a Result of an Inadequate Design Evaluation

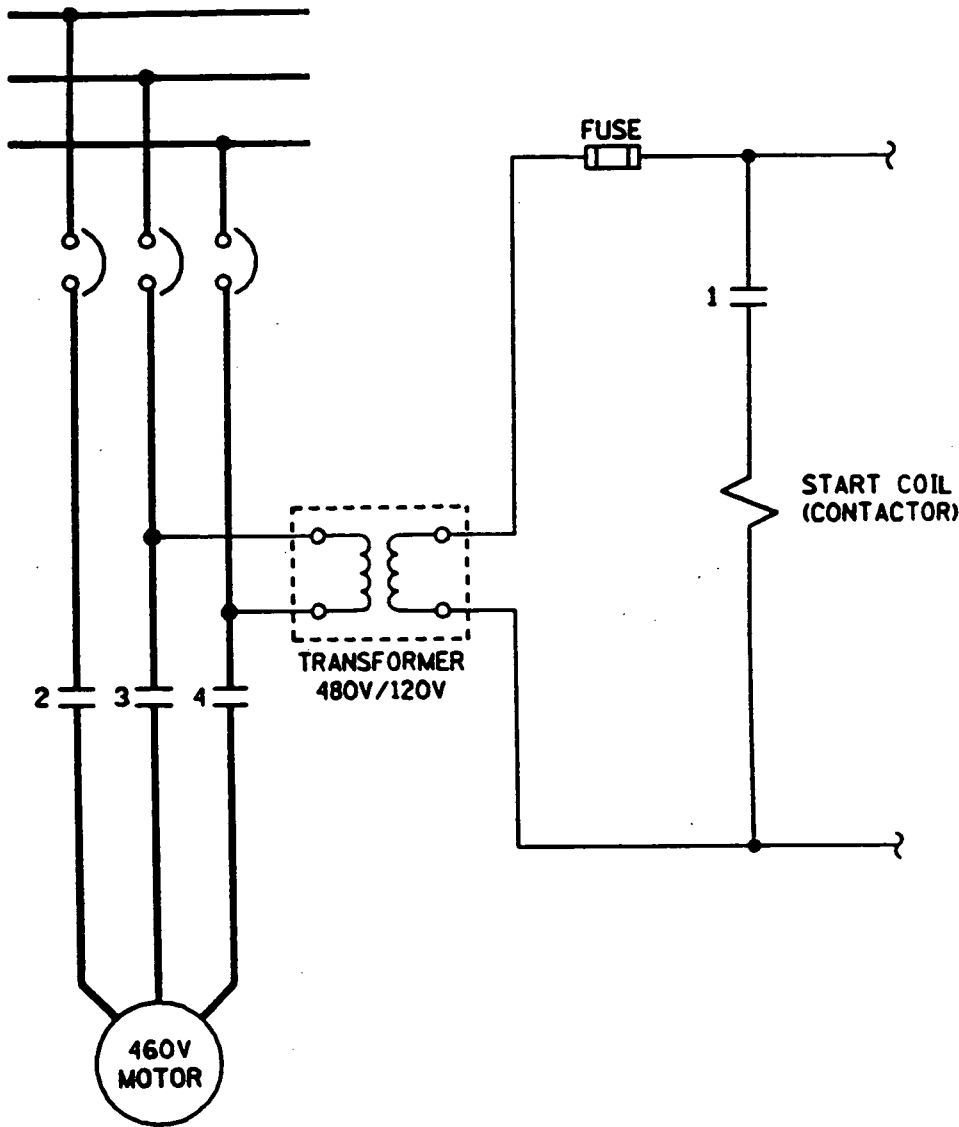
FIGURE 1

However, the SSFI identified a concern with the contactors for the motors [MO] fed by the 480 volt motor control centers (MCCs), e.g., safeguard ventilation fans [FAN] and motor operated valves [V]. To protect against motor damage during degraded grid conditions, 460V motors are connected to the 480V MCCS. Figure 1 provides a simplified diagram of a typical 460 volt motor connected to a 480 volt MCC. Initiation of a safety injection signal closes contact 1, energizing the start coil (contactor) [MSTR]. The start coil or contactor in turn closes contacts 2, 3, and 4, which starts the motor. A concern arose when it was discovered that the manufacturer's minimum recommended voltage for reliable operation of the contactors is 85% of rated voltage. The second level undervoltage trip could allow operation at 80% of the motor's rated voltage for up to five minutes. Therefore, if a safety injection signal had occurred during degraded grid conditions, there may have been insufficient voltage to actuate the 460V safeguard motor contactors.

A secondary concern arose if a safety injection signal occurs closing contact 1 and the contactor fails to actuate due to undervoltage conditions. If the contactor fails to actuate, the fuse [FU] in the circuit will be exposed to the actuation (in-rush) current for up to five minutes. The in-rush current is approximately five times higher than the operating current. It is doubtful that the fuse could maintain continuity for five minutes while exposed to the in-rush current.

TYPICAL 480 VOLT MOTOR STARTING CIRCUIT

On February 23, 1991 a temporary design change to the second level undervoltage trip was completed. The design change removed a time delay set at four minutes from the second level undervoltage trip and set a new total time limit of 6 seconds. The 6 second time limit ensures that the fuses will not open the circuit during degraded grid conditions.
