SUBJECT: LER 93-013-00: on 930604, both motor driven AF pumps actuated due to feedwater regulating valve failing to completely close & subsequent operator actions. FW-7A adjusted & monitored. W/930702 ltr.

Docket 50-305
Operating License DPR-43
Kewaunee Nuclear Power Plant
Reportable Occurrence 93-013-00

TITLE (4) Actuation of Both Motor Driven Auxiliary Feedwater Pumps Due to Feedwater Regulating Valve Failing to Completely Close and Subsequent Operator Actions

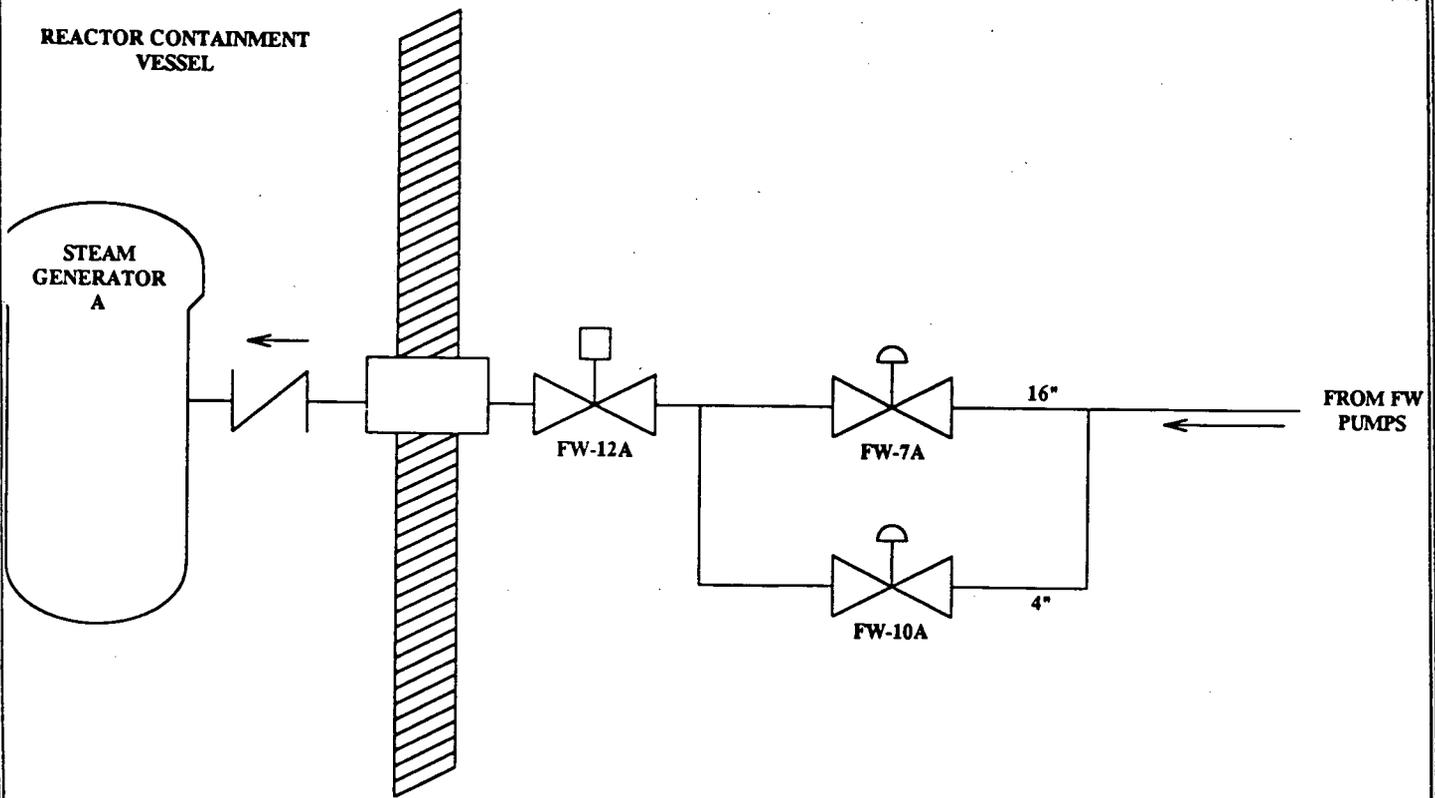
FIGURE 1

As the demand for feedwater to the SGs diminished, valves FW-7A and FW-7B automatically throttled closed as designed. An additional operator, who was monitoring SG levels, noted that the FW-7s indicated fully closed. The operator also noted that A SG level was still increasing while B SG level had stabilized. The balance of the plant (BOP) operator recalled that FW-7A or FW-10A had leaked by its seat in the past. In order to stop the A SG level increase and avoid an automatic trip of the A main FW pump at 67% SG narrow range level, the BOP operator decided to shut off the A main FW pump. Prior to shutting off the A main FW pump the BOP operator announced the action being taken, but shut off the A main FW pump before the additional operator could respond. Shutting down the A main FW pump initiated an automatic start signal for the motor driven auxiliary feedwater (AFW) pumps. When the A main FW pump was shut off the A SG

The additional operator was preparing to transfer SG level control from the main feedwater regulating valves to the bypass valves in accordance with operating procedure N-FW-05A when the event occurred. The SG automatic level controller had closed both feedwater regulating valves, however, the A SG level continued to increase. The BOP operator, cognizant of the automatic trip of the main feedwater pumps and the automatic closure of feedwater isolation valve [ISV], FW-12A, at 67% SG level, decided to manually stop the main FW pump prior to the trip actuation. This decision was based on the following:

1. FW-7A was adjusted and is being monitored.
2. Although the operator actions taken did not compromise safety, other actions that could have prevented the automatic start of the motor driven AFW pumps were discussed with the personnel involved. The actions discussed include:
 - A. Isolate the FW flow to the SG using main feedwater isolation valve FW-12A (reference Figure 1.)
 - B. Manually start the motor driven AFW pumps prior to stopping the main feedwater pump.
3. This report will be required reading for the operations group.
