SUBJECT: LER 93-015-00: on 930618, high radiation area found closed but unsecured & unattended. Caused by personnel error. Individual involved w/incident counseled on potential safety consequences of error. W/930719 ltr.

Docket 50-305
Operating License DPR-43
Kewaunee Nuclear Power Plant
Reportable Occurrence 93-015-00

FACILITY NAME (1)
Kewaunee Nuclear Power PlantDOCKET NUMBER (2)
05000 305PAGE (3)
1 OF 6TITLE (4)
High Radiation Area Gate Left Unsecured Due to Personnel Error

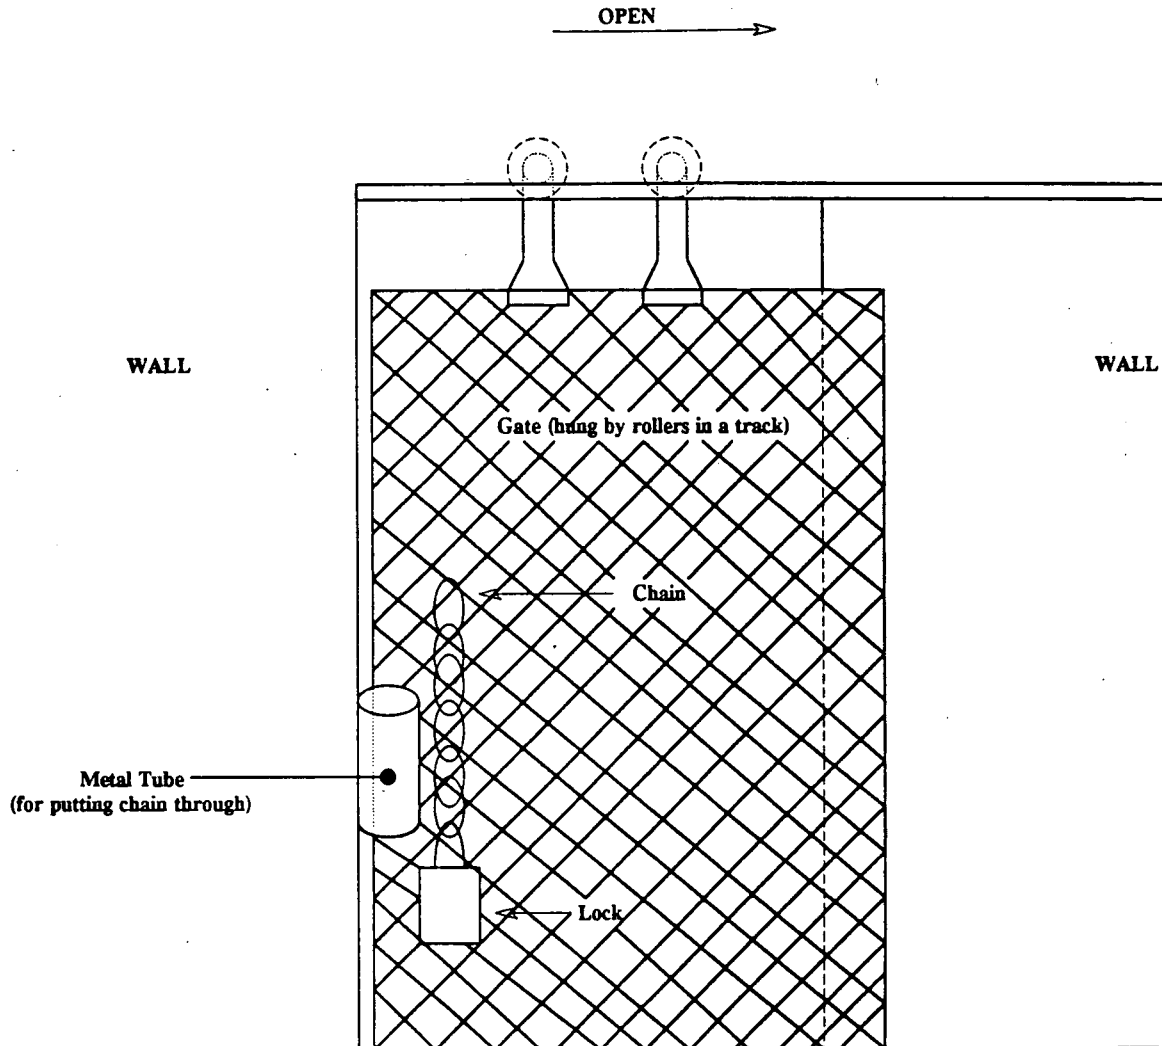
**FIGURE 1
(GATE 18 AS FOUND)**

At approximately 1500 hours on June 18, 1993, with the plant at 87 percent power, a Nuclear Auxiliary Operator (NAO) found gate [GATE] 18 closed but unsecured and unattended (see Figure 1). Gate 18 provides access to the low level radioactive waste (radwaste) drumming area, which is currently posted as a "High Radiation Area, (potential of $\geq 10,000$ mrem/hr)". After checking the area, the NAO immediately secured the gate and notified the Shift Supervisor of the condition.

At approximately 1500 hours, while performing routine plant rounds, a Nuclear Auxiliary Operator (NAO) found that the chain on gate #18 was not routed through the metal tube. Consequently the gate was unsecured, even though the lock was engaged and hanging on the end of the chain. The NAO did not find anyone in the area and determined that the gate had been left unsecured and unattended. He promptly secured the gate and reported the condition to the Shift Supervisor.

The cause of this event has been determined to be personnel error. The error was failure to route the chain through the wall-mounted metal tube prior to engaging the lock, which resulted in the gate being unsecured.
