SUBJECT: LER 96-002-00:on 960331,2 RTs occurred.Caused by spring
 loaded check valve failure & not recognizing impact of
 changing plant conditions.Valve replaced & training module
 addressing operations instituted.W/960430 ltr.

Docket 50-305
Operating License DPR-43
Kewaunee Nuclear Power Plant
Reportable Occurrence 96-002-00

TITLE (4) **Two Reactor Trips Result from Turbine Control System Check Valve Failure and Inadequate Control of Steam Generator Inventory**

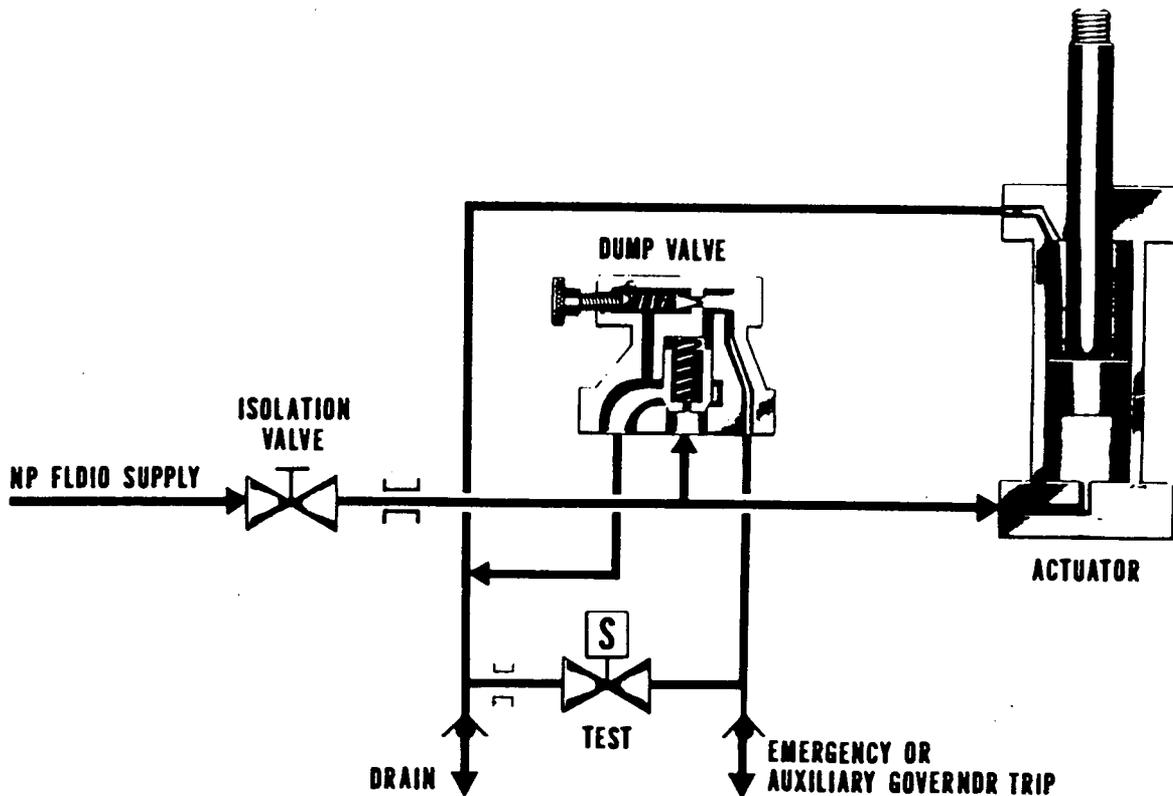
FIGURE 1

During the performance of SP 54-086, on March 17, 1996 a solenoid valve [TV] in the Electrohydraulic (EH) fluid drain line was believed to have failed, see figure 1. The solenoid valve in question is required to open when the test pushbutton is depressed in the control room. When the solenoid valve opens EH fluid is allowed to drain, closing RHSV 1B2.

When STP-TB-54-1 directed the NCO to depress the test pushbutton for RHSV 1B2, the valve did not change position. Personnel were stationed at the solenoid valve to take in-rush current and voltage data to ensure the solenoid valve was receiving an open signal. It was determined that the solenoid valve was receiving an open signal, but in-rush current was slightly lower than expected. In accordance with the STP, the solenoid coil was replaced and the pushbutton test was repeated. RHSV 1B2 still did not close. Continuing with the STP, personnel were directed to use the local EH fluid dump valve to close RHSV 1B2. The EH fluid dump valve was cracked open with no observed indication of RHSV 1B2 changing positioning. The EH fluid dump valve was opened incrementally and RHSV 1B2 moved to mid-position. The EH fluid dump valve was opened further with the expectation of RHSV 1B2 fully closing. When the EH fluid dump valve was opened the emergency trip fluid header depressurized causing RHSVs 1A1, 1A2, 1B1, 1B2 and Turbine Stop Valves (TSV)[ISV] MS-3A and MS-3B to go closed. The two TSVs closing caused a reactor trip.

It was determined that the root cause of the depressurization of the emergency trip fluid header was the failure of a spring loaded piston check valve upstream of the RHSV IB2 in the emergency trip fluid header. This check valve is designed to keep the emergency trip fluid header pressurized when RHSV IB2 is tested. This design is common to the RHSVs, the Intercept Valves (IVs), and the TSVs.

The spring loaded check valve which allowed the emergency trip fluid header to depressurize and caused a reactor trip was replaced. RHSV 1B2 was tested operable by performing partial SP 54-086, "Turbine Stop and Governor Valve Operability Test," on April 1, 1996. The cause of the spring loaded check valve failure will be evaluated.
