SUBJECT: LER 97-004-00: on 970409, unanalyzed condition existed during safety injection accumulator filling operations. Cause is unknown. Alternate path from SI pumps will be used to fill accumulators. W/970509 ltr.

Docket 50-305  
Operating License DPR-43  
Kewaunee Nuclear Power Plant  
Reportable Occurrence 97-004-00

Unanalyzed Condition Exists During Safety Injection Accumulator Filling Operations

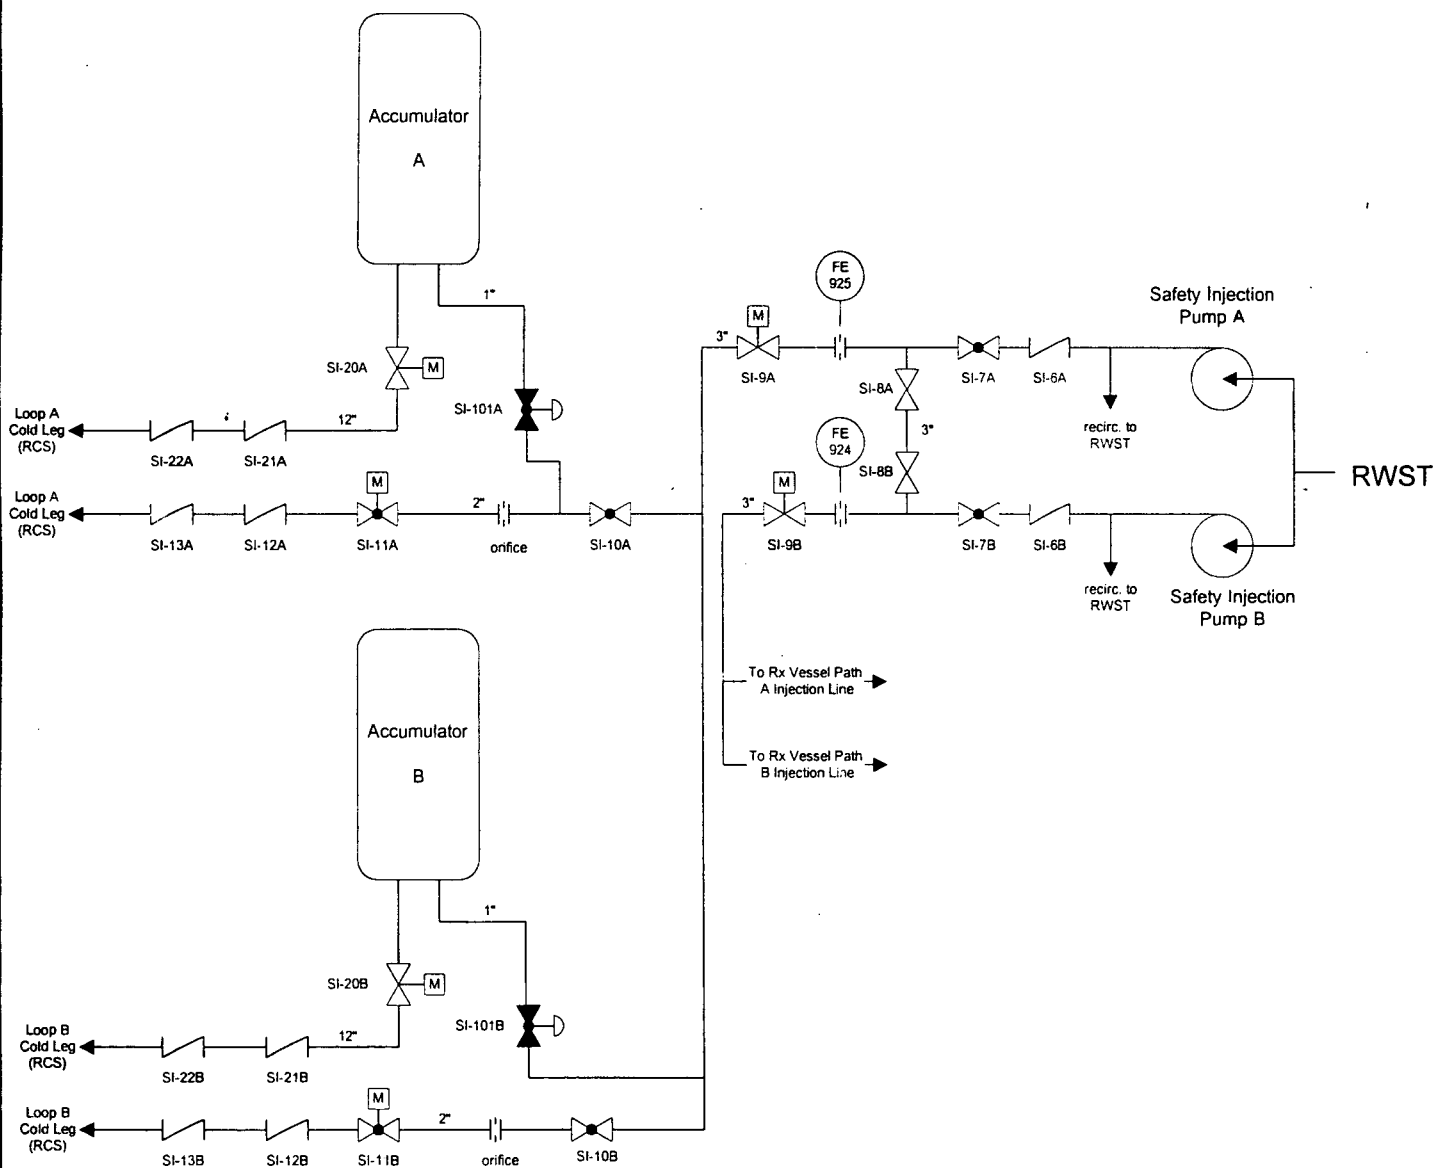
**Attachment 1**  
**Simplified Safety Injection/Accumulator Flow Diagram**

Attachment 1 shows a simplified diagram of the Safety Injection/Accumulator system. SI-10A [FCV] and SI-10B [FCV] are throttle valves used to balance the flow between the two reactor coolant system (RCS) [AB] cold leg injection lines.

- 1) Single failure criteria assumes that one SI pump will not be available upon a SI signal during a LOCA. Therefore, only one SI pump will be available to provide accident mitigation which can be assumed to occur during accumulator filling. Because the amount of flow through the accumulator fill line under accident conditions is unknown, the operating SI pump has the potential for exceeding the design runout flow limit. If the pump is operated at runout conditions, the pump could be damaged which would result in a loss of the only available SI pump.

- 2) If one of the above accidents were to occur during the filling operation of either accumulator, the amount of water injected into the RCS will be reduced by the amount of water being diverted into an accumulator. The amount of water diverted during the progression of the accident will vary and depends upon several factors; i.e. the accident type (location and size of the break), RCS pressure, containment pressure and accumulator pressure. This potentially affects SI system accident analysis assumptions and results.

- 1) Use an alternate path from the SI pumps to fill the accumulators. The proposed path would allow the accumulator fill flow to be throttled by a common valve and prevent the possibility of pump runout. This will also ensure the analyzed amount of injection flow to the RCS during an accident is maintained.
- 2) Modify the control circuit for SI-101A & B such that, if an accident were to occur during accumulator filling, the fill valve would automatically close when the operator released the switch, thus terminating the flow diversion.
- 3) Throttle SI-101A and B to reduce the amount of flow diverted to the accumulators.
