SUBJECT: LER 97-002-01: on 970205, determined that potential defect in process used to laser weld repair of previously sleeved SG tubes during on-going refueling outage. Caused by tubes were found to be leaking. Joints were re-insp. W/971024 ltr.

Docket 50-305  
Operating License DPR-43  
Kewaunee Nuclear Power Plant  
Reportable Occurrence 97-002-01

Kewunee Nuclear Power Plant

Potential Defect in the Process Used to Perform a Laser Welded Repair of Previously Sleeved Steam Generator Tubes

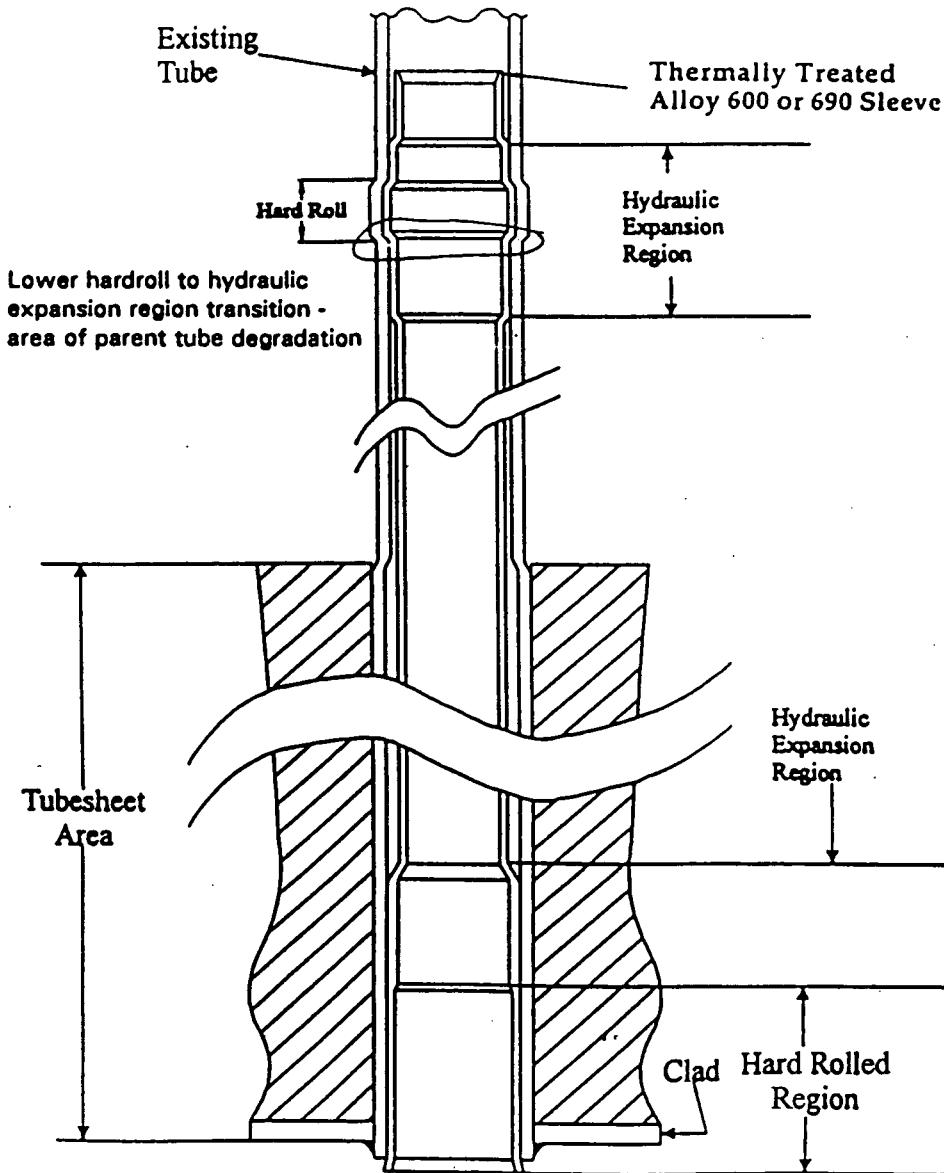
### Westinghouse HEJ (hybrid expansion joint) Steam Generator Tube Sleeve

On February 5, 1997, with the plant in a cold shutdown condition, plant management determined that there was a potential defect in the process used to laser weld repair a number of previously sleeved steam generator [SG] tubes [TBG] during the on-going refueling outage. The refueling outage started on September 21, 1996, and was extended until June 12, 1997, due to the number of steam generator (SG) tubes found with indications of degradation in the Westinghouse mechanical hybrid expansion joint (HEJ) sleeved tubes. Figure 1 shows a typical HEJ sleeve as installed in the SG. The degradation is occurring in the parent tube at the upper most, or free span joint, within the lower hardroll to hydraulic expansion transition region (circled area on the Figure).

Based on the change in UT data, all of the tubes that received a laser welded repair in either the HE or HR location were re-inspected with UT. The results of the re-inspection showed that a number of the welds located in the HE region which were initially acceptable (UT and ET) exhibited insufficient weld width, or an apparent lack of fusion between the sleeve and tube following the post-weld stress relief application.

The destructive examination of the pulled tubes revealed the presence of small hot cracking at the weld/sleeve/tube interface. The cracking was the result of imposed stresses at high temperature conditions possibly exacerbated by the presences of contaminants in the weld pool. In the case of the welds located in

the HR, the far-field stresses were evenly distributed across the weld and the weld remained intact during the post-weld stress relief. For the HE welds, the stress level was not evenly distributed across the weld and some of the welds mechanically sheared during the post-weld stress relief process.

In accordance with KNPP's TS's, all tubes classified as defective are required to be plugged or repaired. Accordingly, all the laser weld repaired tubes were re-inspected using both UT and ET and those with unacceptable welds were either plugged or repaired prior to placing the SG in service. The details on the tube plugging and repair were reported to the NRC in LER 96-006-01, dated June 30, 1997.
