SUBJECT: Forwards addl info re review of relief request RR2-1 to allow continued plant operation w/two pin hole leaks in 3/4 inch ASME Code Class 2 chemical injection weldment per 960814 & 15 verbal requests.

Docket 50-305
 Operating License DPR-43
 Kewaunee Nuclear Power Plant
Relief Request No. RR2-1 Request for Additional Information

Additional Information Relief Request RR2-1

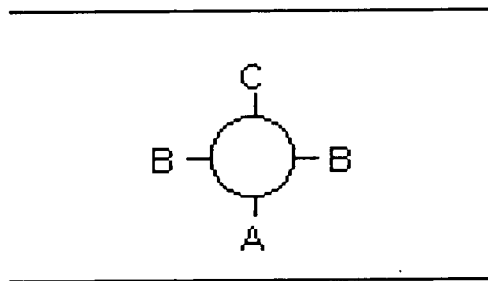
1. Gap the sockolet as required by the Welding Procedure Specifications, align the fitting and tack weld at a minimum of 2 places.
2. The tack welds are cleaned of slag and the ends visually inspected by the welder for soundness.
3. The root pass is usually started at point "A" with progression to points "B", both sides of the joint.
4. The welder then moves to the opposite side of the 16" pipe and continues the pass from points "B" to point "C".

5. This process sequence is continued until completion of the weld.
6. The final assembly was post weld heat treated.

As can be noted, all starts and stops (root, intermediate, and final weld passes) are typically in the same area of the weldment. This is due to the configuration of the socket relative to the main run. The included joint angle at point "B" is minimal with the curvature of the main run causing the bevel angle to be tighter at point "B".

Cluster porosity was identified by visual examination of the leak. The pin hole indications appear in the area of the starting or stopping point of the final weld pass at a location consistent with the weld procedure described above. All previous weld passes would have started and/or stopped at the A, B and C locations noted above which could give rise to porosity or slag inclusion at these locations. Insufficient cleaning would have resulted in covering slag or porosity in the subsequent weld passes. Porosity may be small enough to go unnoticed by the welder subsequent to the next pass of weld. A review of the fabrication traveler leaves the number of weld passes indeterminate. The Weld Procedure Specification allowed as few as two (2) passes and as many as ten (10) passes dependent upon the pipe wall thickness.

The postulated cause of the leak is an alignment of cluster porosity in the final pass and subsurface weld flaws at the start/stop point. The subsurface weld flaws are postulated to be slag inclusions based on the above discussion of fabrication techniques and flaw characterization.
