**Subject: June 22, 2011 Wellfield Injection Solution Spill
Christensen Ranch Site, Mine Unit 7**

Uranium One Americas, Inc. - Spill Report Summary

Christensen Ranch Site; Mine Unit 7

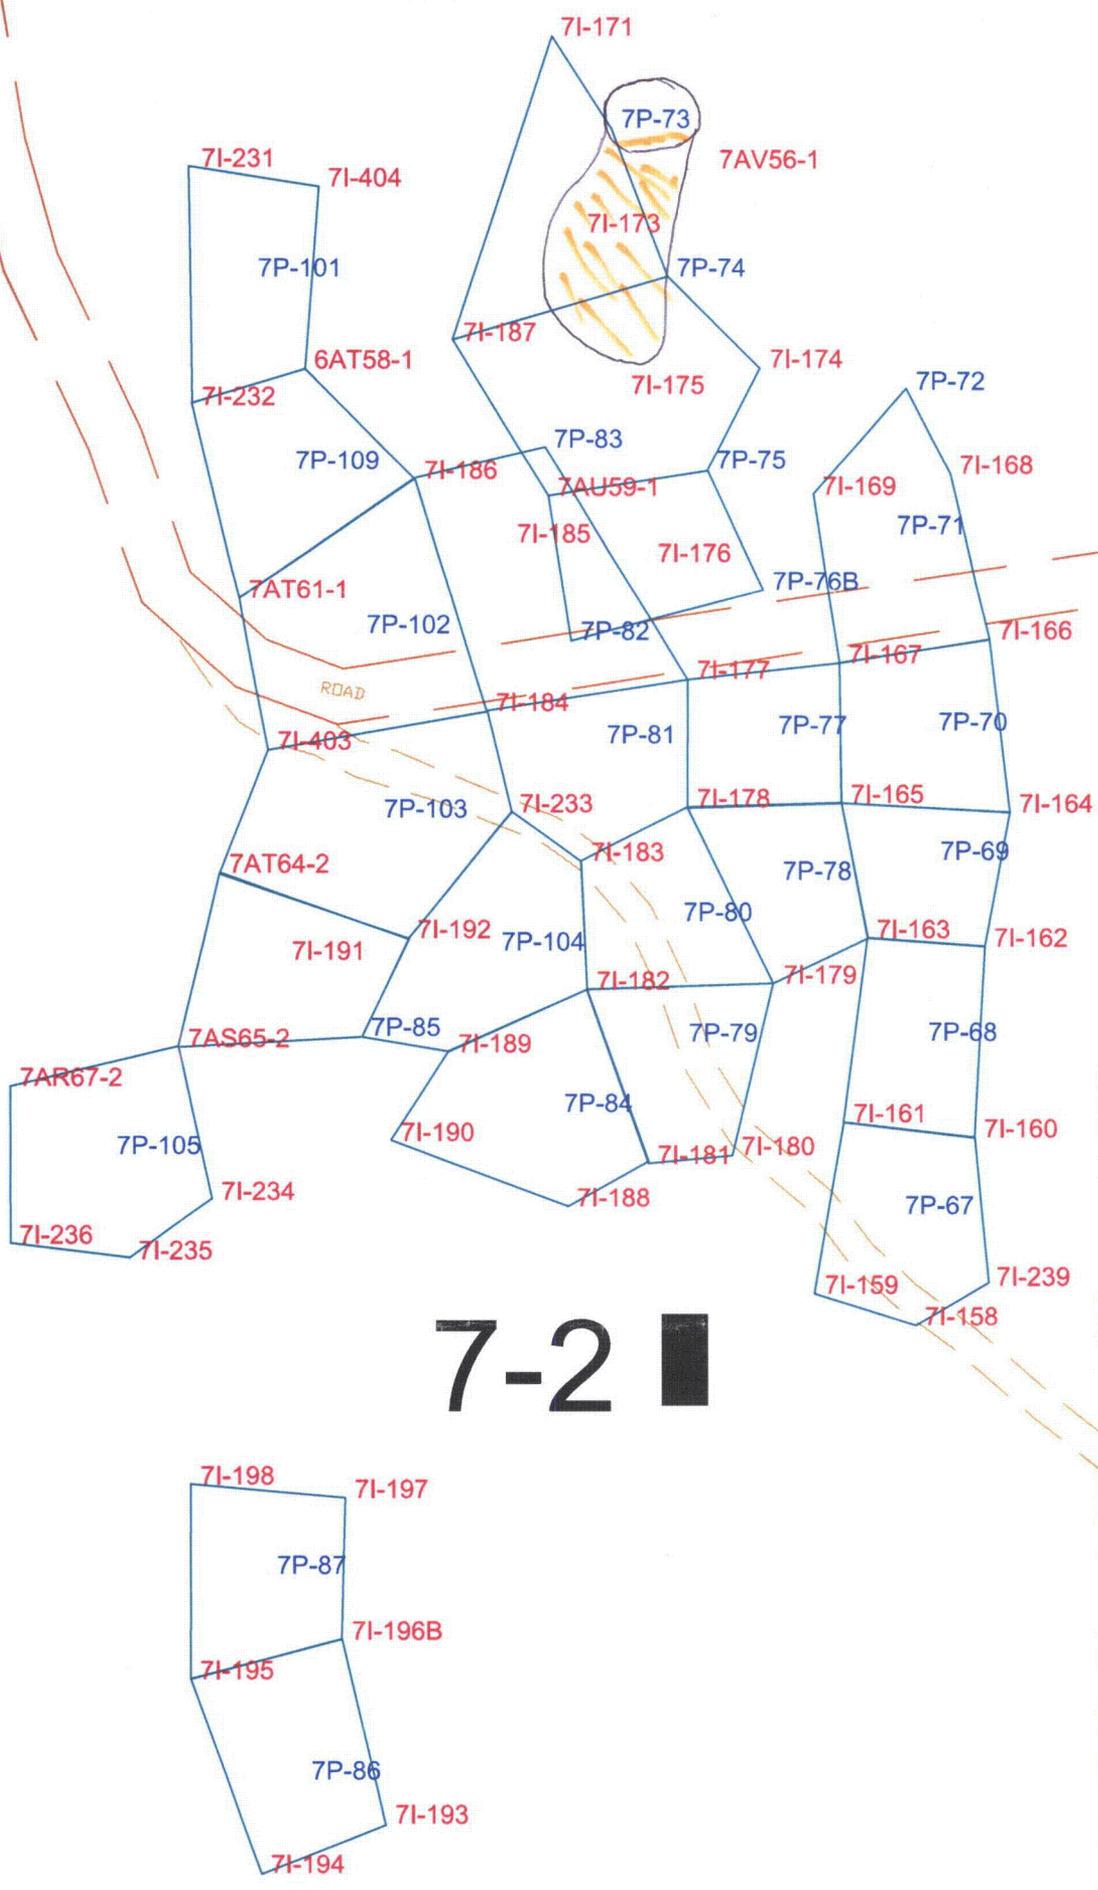
Map of Spill Location and Impacted Area

Inject ion Well 7P-73

No adverse impacts were observed or are anticipated to the environment or the public. No significant erosion resulted from the spill which soaked into an area of ground that covered <0.1 acres. Although some of the spill reached a small dry drainage, it never contacted surface water.
