Containment Liner Corrosion Operating Experience Summary Technical Letter Report – Revision 1

Darrell S. Dunn, April L. Pulvirenti, and Matthew A. Hiser

U.S. Nuclear Regulatory Commission
Office of Nuclear Regulatory Research

August 2, 2011

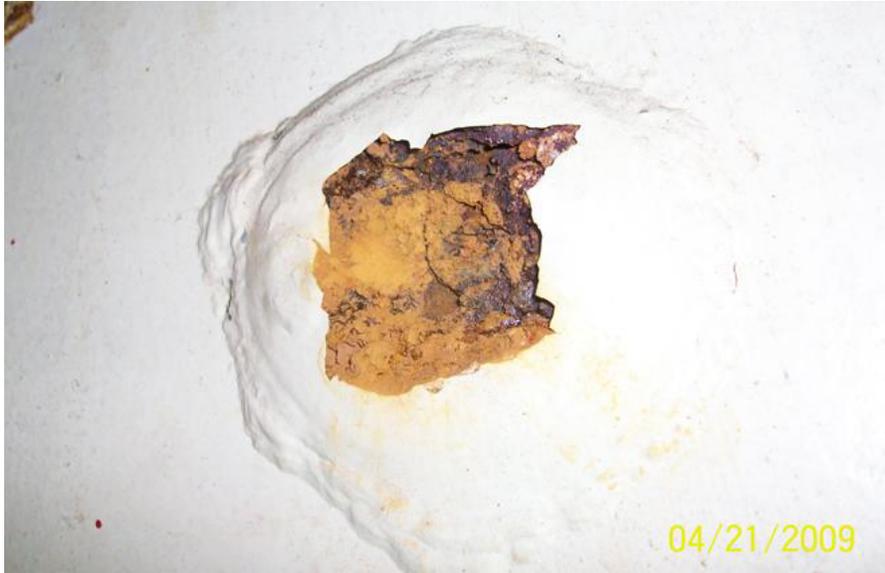
In June 2009, Beaver Valley Unit 1 was conducting an ASME XI IWE general visual examination of the reactor containment building during a refueling outage. A suspect area about 3 inches in diameter with blistered paint (Figure 1) was identified on the steel liner at the 227.4 m [746 ft] elevation. After paint removal and cleaning, rectangular-shaped corrosion penetration measuring about 2.5 x 1 cm [$1 \times \frac{3}{8}$ in] was observed (Figure 2). Thickness measurements conducted using UT indicated a local area around the penetration where thinning of the liner had occurred (Figure 3). A section of the liner plate was removed and a piece of wood, which was about 5 x 10 x 15 cm [2 x 4 x 6 in], was discovered to be embedded in the concrete (Figure 4). The wood was subsequently removed and the concrete was repaired with grout. The liner was repaired by installing a replacement section.

Figure 1. Paint Blister with Corrosion Products Identified at Beaver Valley Unit 1 in 2009 (FirstEnergy, 2009).

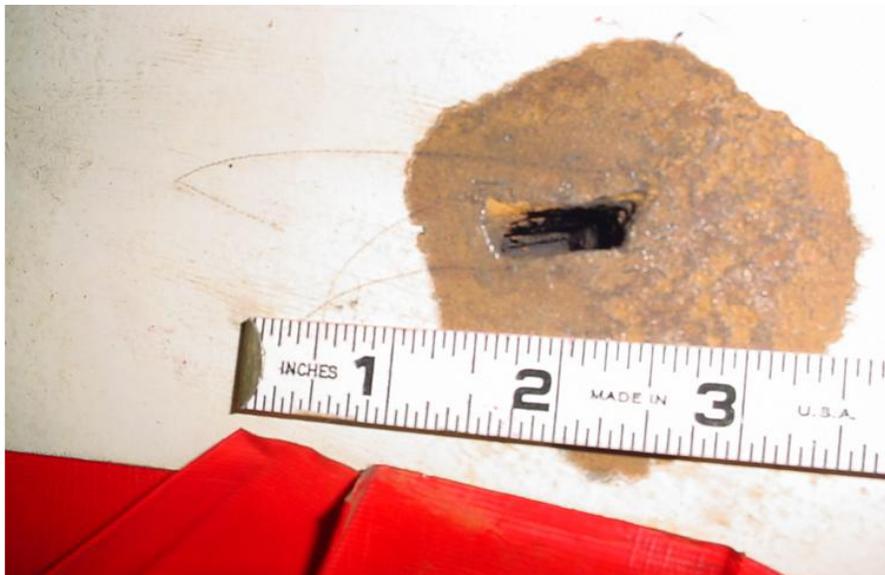
Figure 2. Perforation in the Containment Liner of Beaver Valley Unit 1 (2009) Observed After the Paint Blister and Corrosion Products Were Removed (FirstEnergy, 2009).

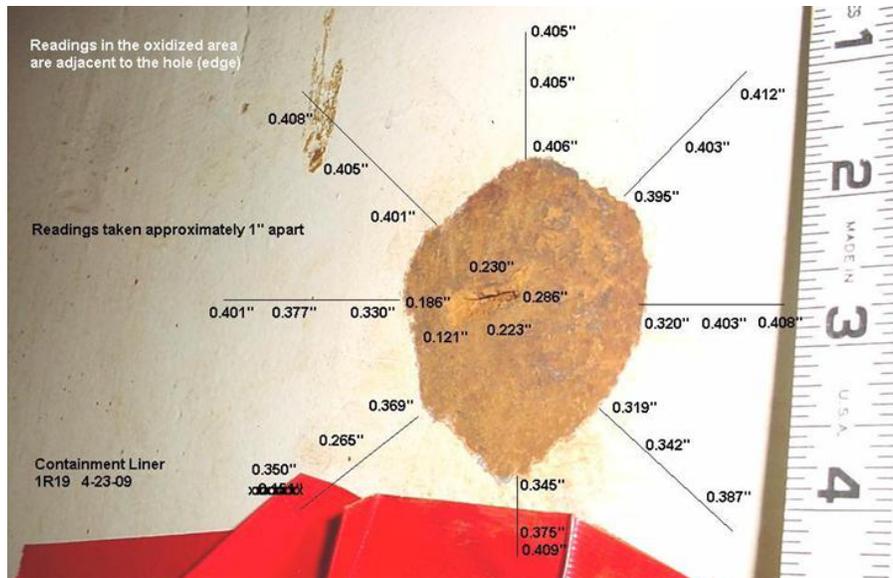
Figure 3. Perforation in the Containment Liner of Beaver Valley Unit 1 (2009) Showing the Results of Ultrasonic Thickness Measurements (FirstEnergy, 2009).

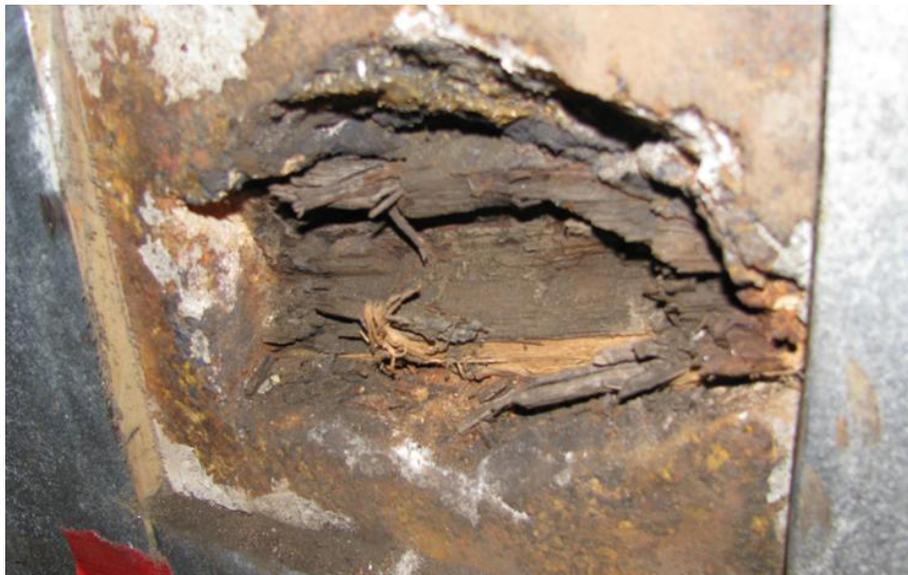
Figure 4. Wood Embedded in the Concrete Discovered at Beaver Valley Unit 1 in 2009 After a Section of the Containment Liner with Through-Liner Corrosion Was Removed (FirstEnergy, 2009).

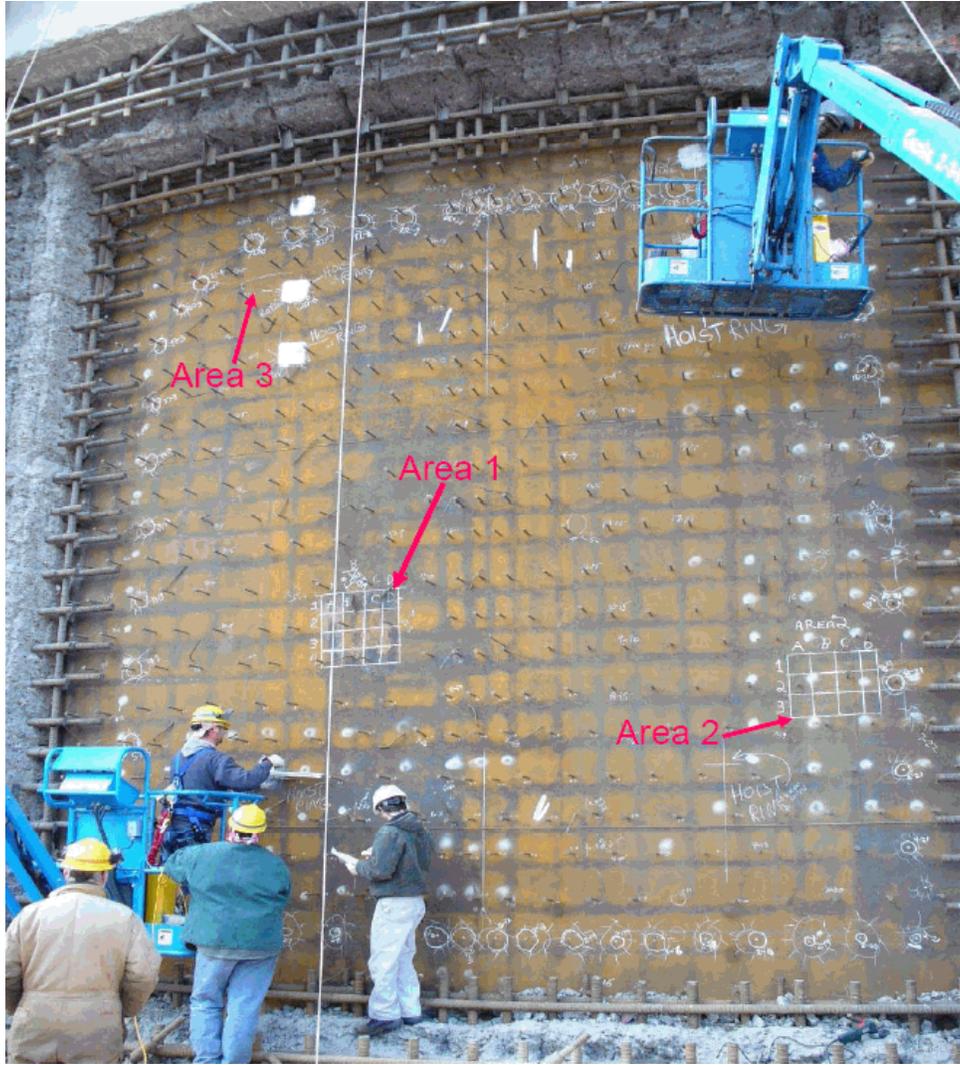
In March 2006, Beaver Valley Unit 1 was found to have three areas of corrosion in the containment liner plate during the creation of a temporary construction opening in the containment structure for the replacement of the steam generators and reactor vessel head. Three areas of corrosion were identified with local measured metal loss (corrosion depth) between 1.1 and 5.8 mm [45 to 227 mils] (Figures 5 to 8). The sections of the liner removed for analysis were replaced with new plate material. The root cause of the corrosion was indeterminate; however, the probable cause reported was that the corrosion of the liner occurred during the construction phase because of exposure to oxygen and water that has since abated. Several pieces of wood were found during a subsequent inspection of the concrete debris pile; however, no clear evidence is available to confirm that the corrosion damage to the liner was a result of contact with embedded foreign material. Foreign material that may have been in contact with the liner could have been destroyed by the hydroblasting operation. The affected liner plate sections were replaced.

Figure 5. Beaver Valley Unit 1 Containment Liner with Three Areas of Corrosion Identified (FirstEnergy, 2006).

| Reactor | Year | SG/RPVH | Containment | Liner Damage | Liner corrosion | Additional Information |
|---|---|---|---|---|---|---|
| Beaver Valley 1 | 2006 | SG | Sub Atm, Reinforced | Yes | Yes | Corrosion of containment liner observed in three locations. No foreign objects identified. |

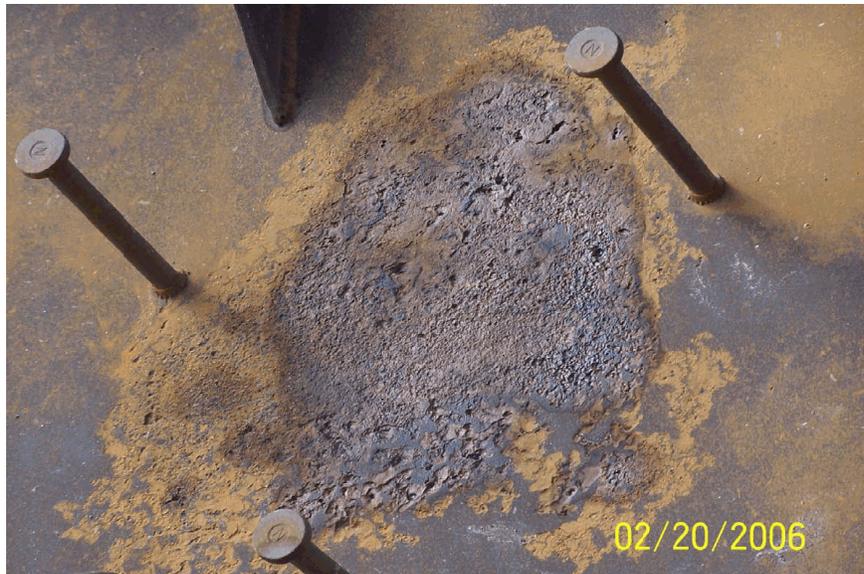
Figure 6. Closeup of Corrosion Area 1 Observed at Beaver Valley Unit 1 in 2006 (FirstEnergy, 2006).

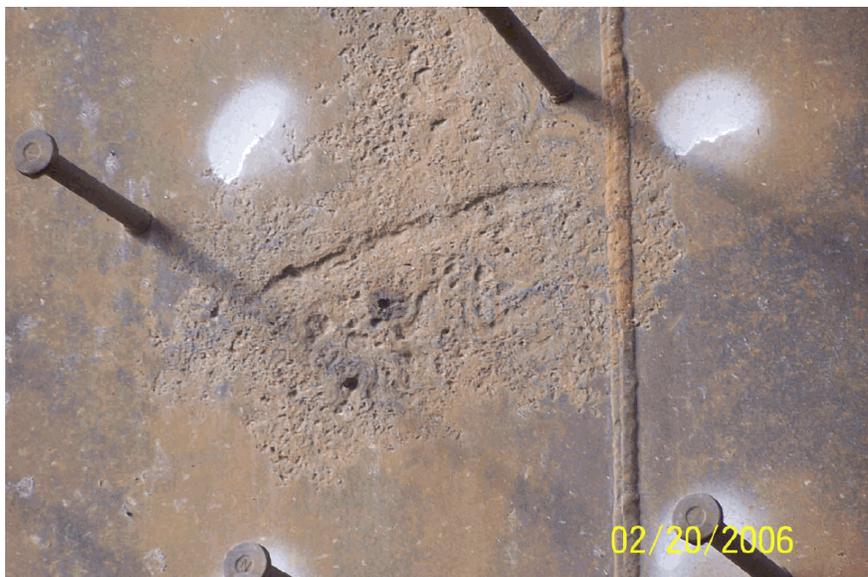
Figure 7. Closeup of Corrosion Area 2 Observed at Beaver Valley Unit 1 in 2006 (FirstEnergy, 2006).

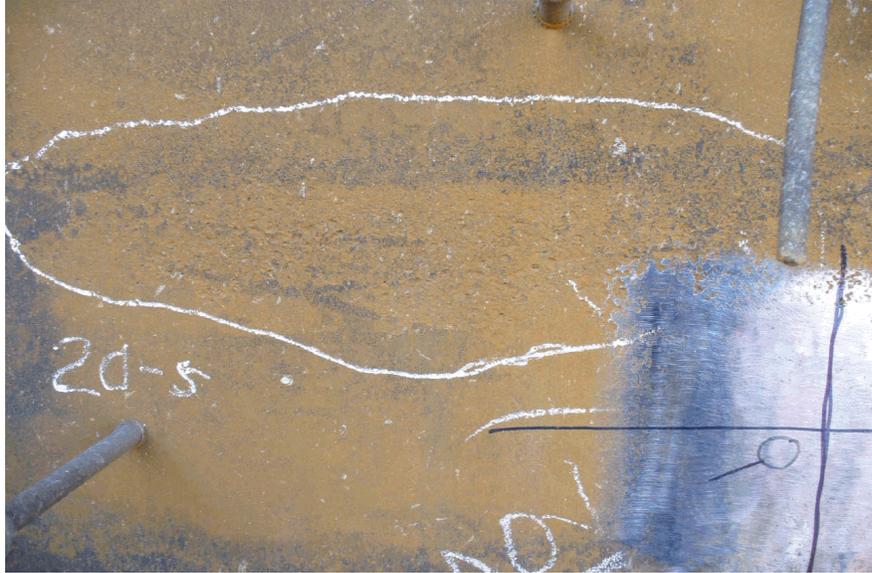
Figure 8. Closeup of Corrosion Area 3 Observed at Beaver Valley Unit 1 in 2006 (FirstEnergy, 2006).
