Containment Liner Corrosion Operating Experience Summary Technical Letter Report – Revision 1

Darrell S. Dunn, April L. Pulvirenti, and Matthew A. Hiser

U.S. Nuclear Regulatory Commission
Office of Nuclear Regulatory Research

August 2, 2011

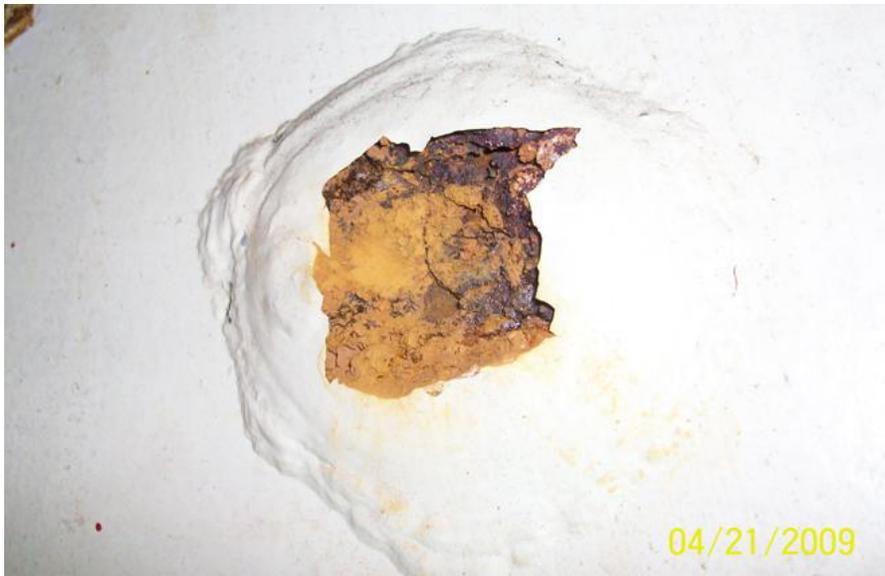
In June 2009, Beaver Valley Unit 1 was conducting an ASME XI IWE general visual examination of the reactor containment building during a refueling outage. A suspect area about 3 inches in diameter with blistered paint (Figure 1) was identified on the steel liner at the 227.4 m [746 ft] elevation. After paint removal and cleaning, rectangular-shaped corrosion penetration measuring about 2.5 x 1 cm [$1 \times \frac{3}{8}$ in] was observed (Figure 2). Thickness measurements conducted using UT indicated a local area around the penetration where thinning of the liner had occurred (Figure 3). A section of the liner plate was removed and a piece of wood, which was about 5 x 10 x 15 cm [2 x 4 x 6 in], was discovered to be embedded in the concrete (Figure 4). The wood was subsequently removed and the concrete was repaired with grout. The liner was repaired by installing a replacement section.

Figure 1. Paint Blister with Corrosion Products Identified at Beaver Valley Unit 1 in 2009 (FirstEnergy, 2009).

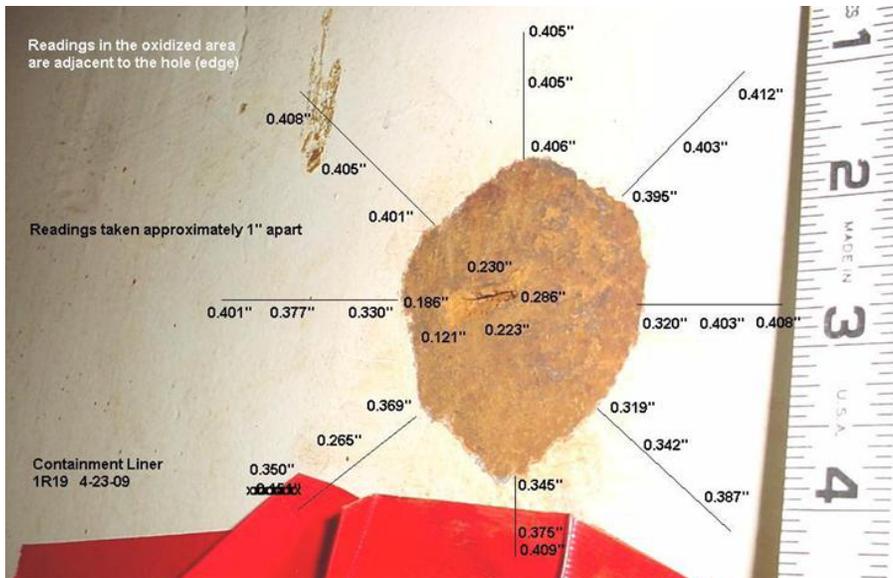
Figure 3. Perforation in the Containment Liner of Beaver Valley Unit 1 (2009) Showing the Results of Ultrasonic Thickness Measurements (FirstEnergy, 2009).

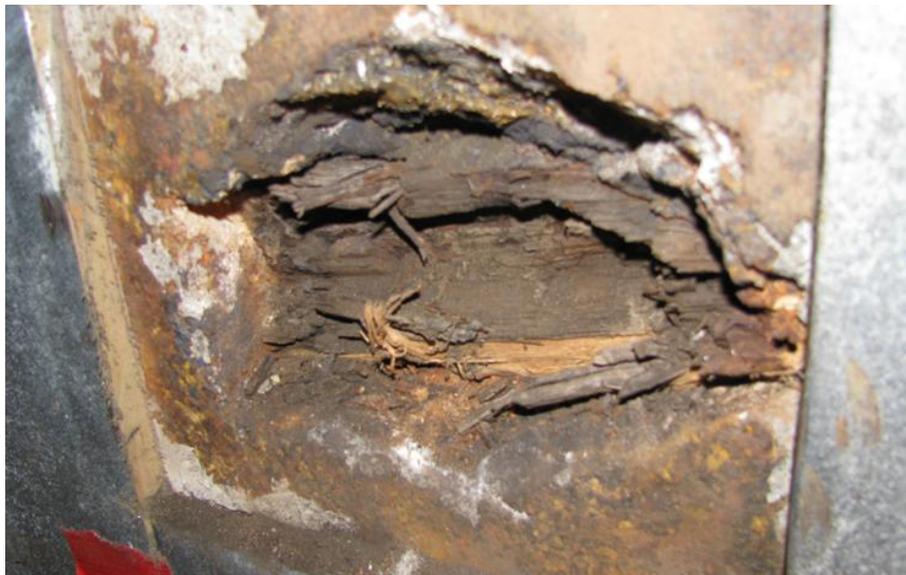
Figure 4. Wood Embedded in the Concrete Discovered at Beaver Valley Unit 1 in 2009 After a Section of the Containment Liner with Through-Liner Corrosion Was Removed (FirstEnergy, 2009).

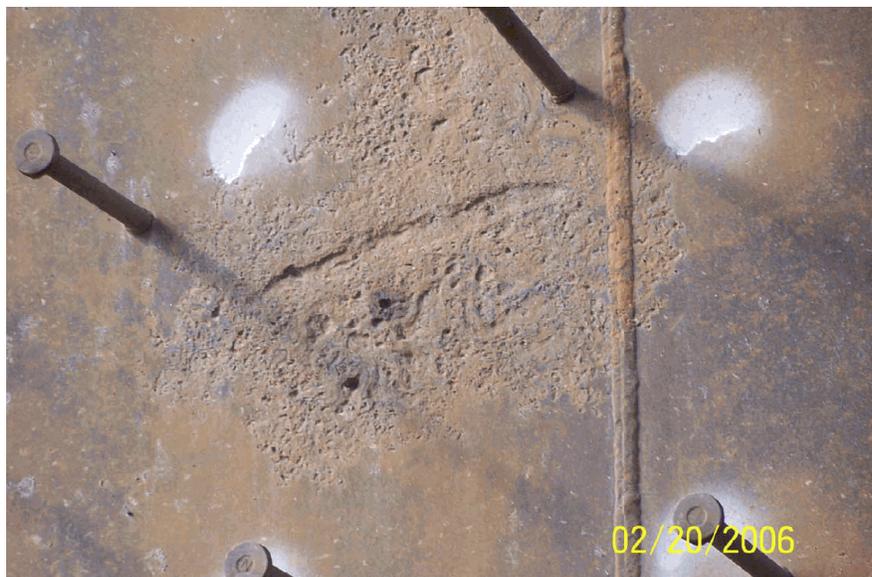
Figure 7. Closeup of Corrosion Area 2 Observed at Beaver Valley Unit 1 in 2006 (FirstEnergy, 2006).
