RE: DOCKET NO. 40-1162, LICENSE NO. SUA-56, LICENSE CONDITION
NO. 27C, TAILING RECLAMATION PLAN, COMPLETION REPORT

**SPLIT ROCK TAILING RECLAMATION
CONSTRUCTION COMPLETION REPORT**

Prepared By:
SHEPHERD MILLER, INC.
3801 Automation Way, Suite 100
Fort Collins, CO 80525

April 1999

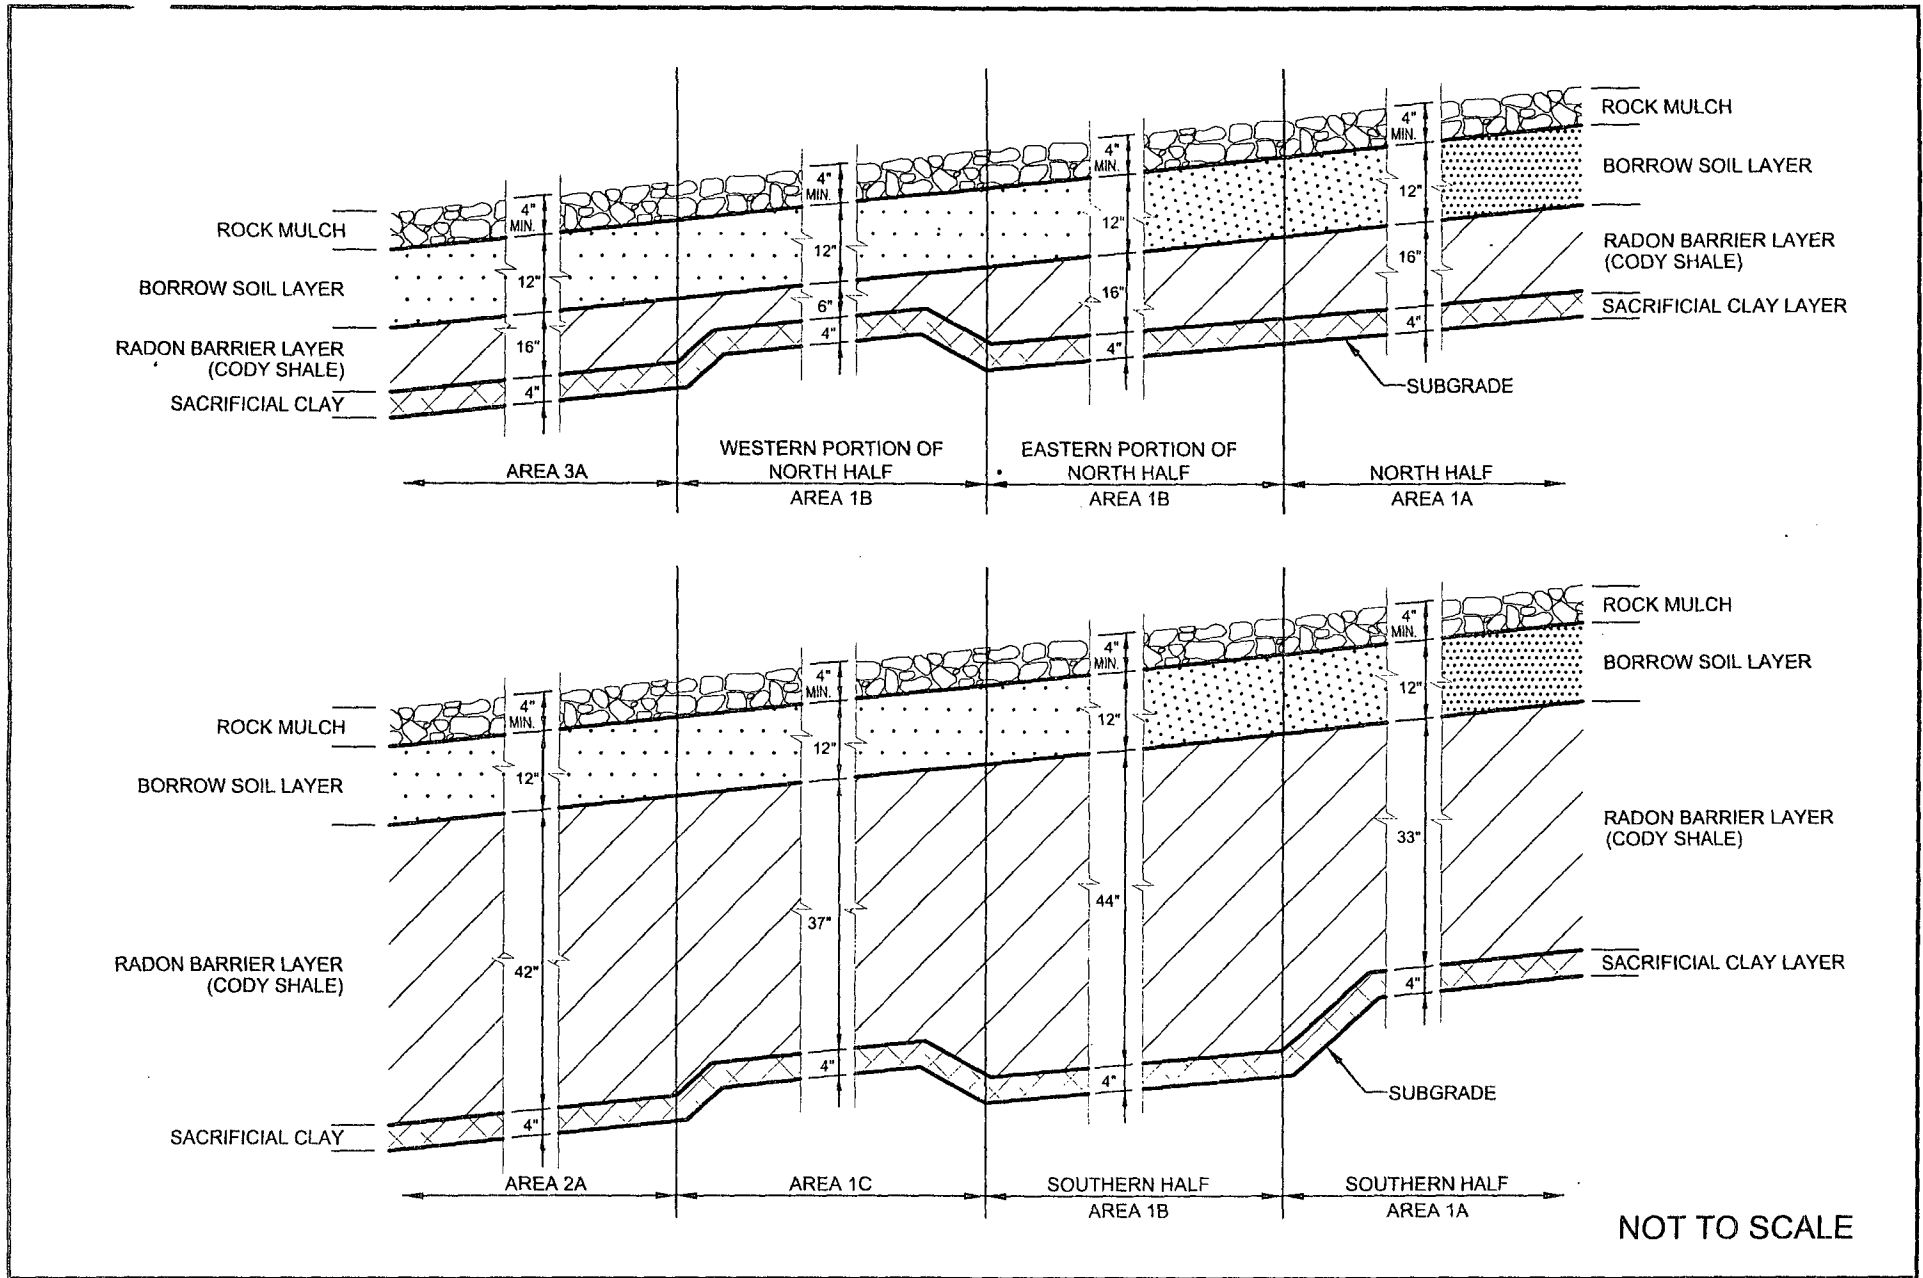
**FIGURE 8
AREA 1A/1B
OVERLAP ZONE**

Construction of the southern halves of Areas 1A, and 1B was initiated in 1996. During an internal field audit performed by WNI on May 22, 1996, it was found that material from Area 1B which had a radon barrier thickness requirement of 44 inches had inadvertently been moved to Area 1A which had a radon barrier thickness requirement of 33 inches. Since this did not conform with the design specifications as Area 1A had a lower radon barrier thickness requirement, a non-conformance was noted. A subsequent survey indicated that a maximum of 2.3 feet of Area 1B tailing had been placed over a limited area in Area 1A. This had then been covered with at least 3 feet of Area 1A tailing. To determine the impact on the radon barrier design, an analysis was performed using the NRC's RADON computer code. This analysis assumed that a 3-foot thick layer of 1A

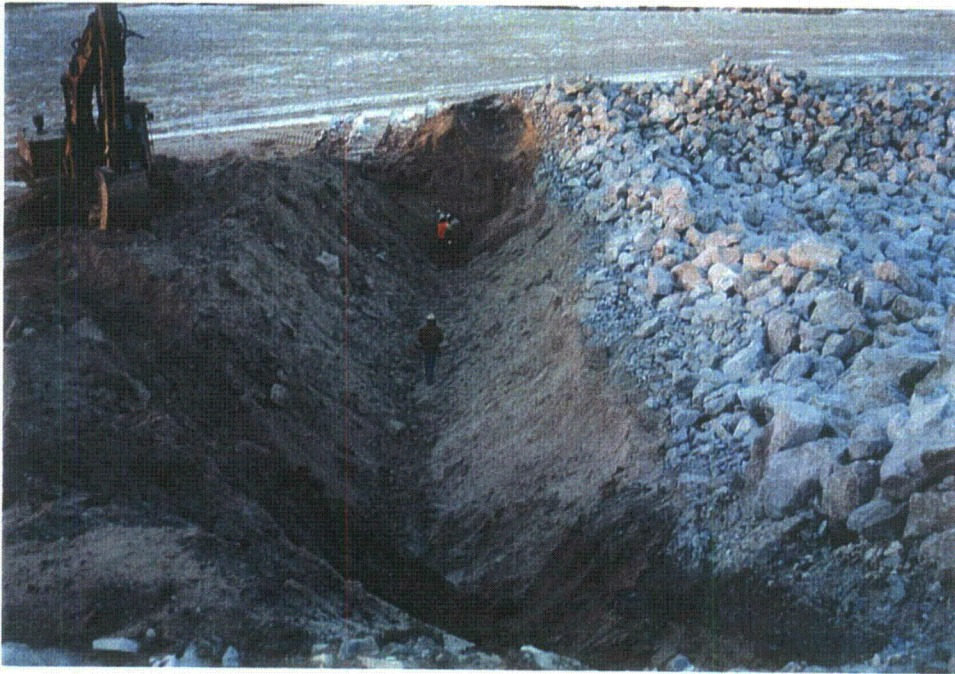
Photo 39 - South Diversion Ditch - measuring scour trench, December, 1997

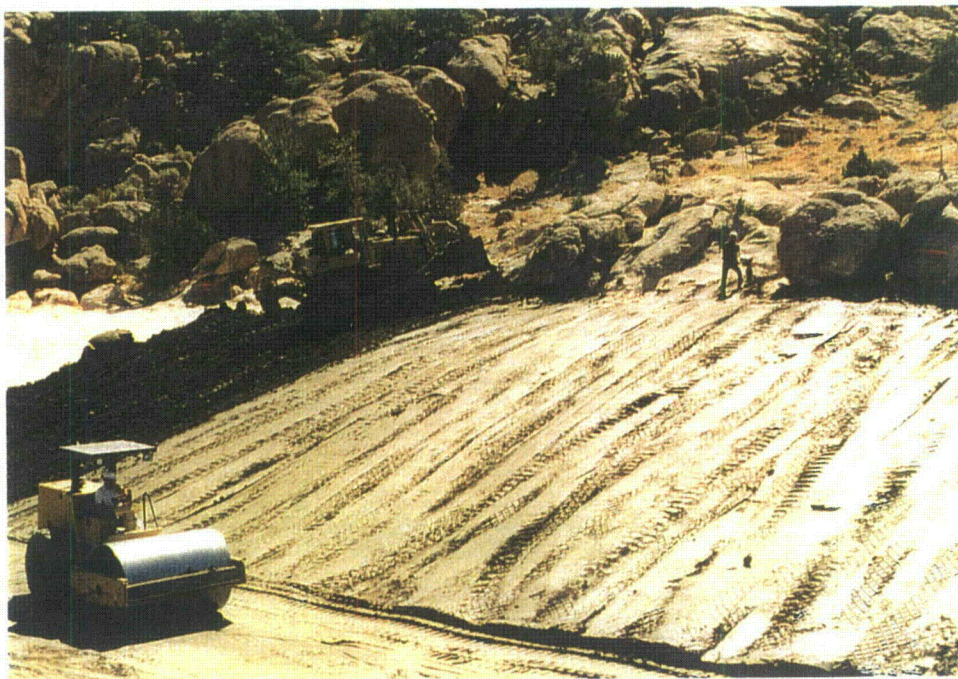
Photo 29 – South Diversion Ditch - Sacrificial clay and first lift - Approximately station 9+00 - Outside slope. Note hand compaction around granite outcrops, August, 1996

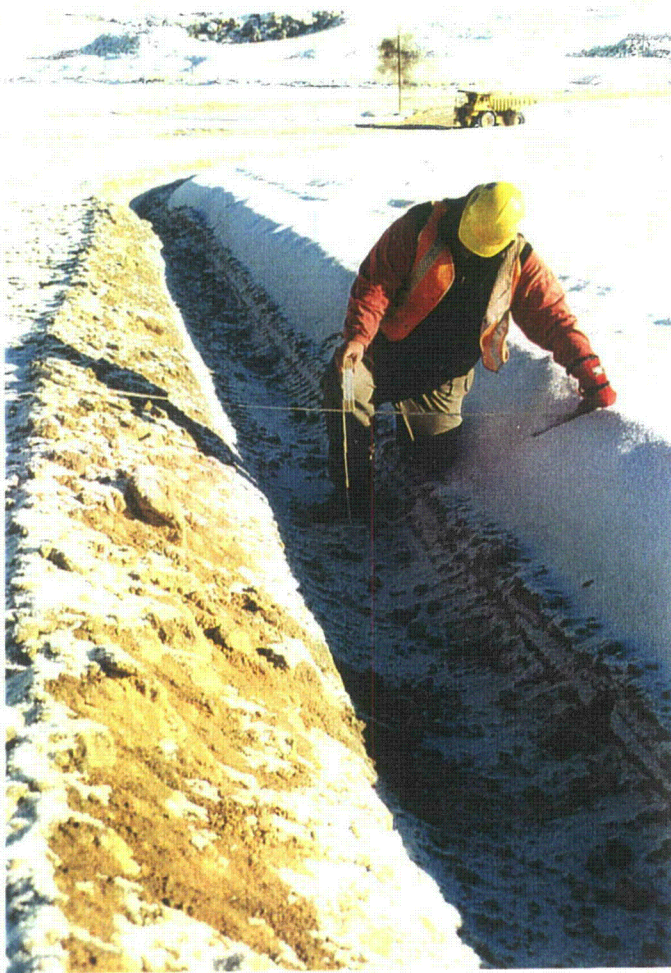
Photo 38 - Key Trench by Area 3A - depth measurement, December, 1997
