Watts Bar Nuclear Plant, Unit 1  
Facility Operating License No. NPF-90  
NRC Docket No. 50-390

Subject: **Licensee Event Report 390/2011-004, Reactor/Turbine Trip due to Loss of Main Generator Excitation**

**4. TITLE**  
Reactor / Turbine Trip due to Loss of Main Generator Excitation

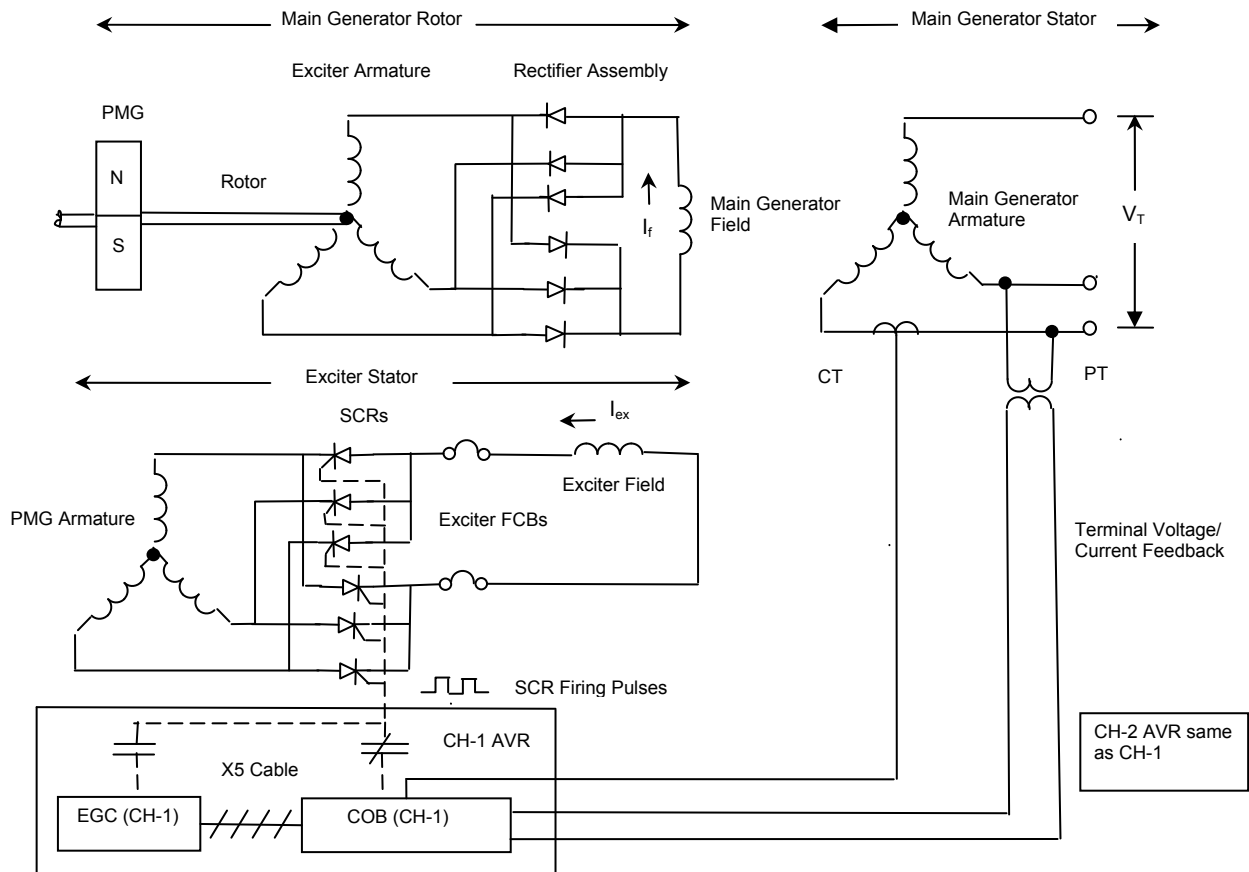
**Figure 1**  
**Simplified Brushless Excitation System Block Diagram**

The major electrical components that make up the main generator excitation system are the AVR, exciter field windings, exciter armature windings, rotating rectifier assembly, and the main generator field windings (see Figure 1). The AVR is a dual-channel digital control system designed by ABB that was installed during U1 Refueling Outage 10, which ended May 21, 2010. Each AVR channel has one Control Board (COB) module and one Extended Gate Controller (EGC).
