PART 21 - EMERGENCY DIESEL GENERATOR FAILED AIR START MOTOR

Report No. 10CFR21-0102

**10CFR21 REPORTING OF DEFECTS
AND NON-COMPLIANCE**

COMPONENT: Air Start Motors with friction-clutch inertia drives

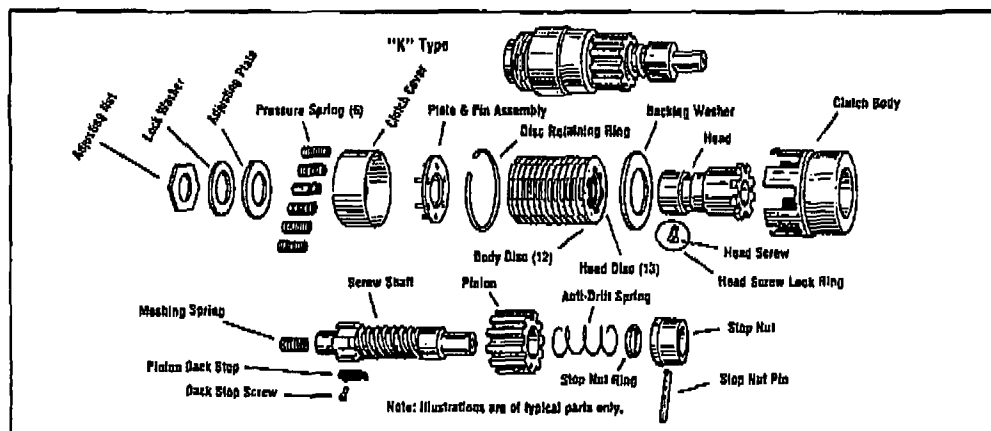
EXPLODED VIEW OF FRICTION-CLUTCH INERTIA DRIVE

The evaluation was concluded on 08/01/11 and determined the air motor failure to be a reportable defect as defined by 10CFR21. The starter drive failure was attributed to excessive torque adjustment of the clutch assembly. This overstressed the clutch disc plates which lead to eventual failure of the friction-clutch inertia drive assembly. Failure of the clutch drive renders the air start motor inoperative. Depending upon the configuration of the engine's starting system, an inoperative air start motor could cause excessive starting times or a start failure. Either scenario has the potential to prevent the emergency diesel generator from performing its safety related function.

The friction-clutch inertia drive is utilized on air starting motors that do not incorporate the pre-engagement feature. In this case, air motor rotation begins before the drive pinion gear meshes with the engine ring gear. The clutch is designed to slip at a prescribed torque setting to absorb the initial torque inrush experienced by the air motor as the pinion and ring gears mesh. This drive assembly was originally manufactured by Facet and was their "K" Type friction clutch. Facet P/N A-3111 was used on clockwise rotation (RH) air starters and P/N A-3236 was used on counterclockwise rotation (LH) air starters. Facet has not supplied starter drives since 2003 and the clutch drives are now supplied by two (2) other manufacturers, ASC (Air Starter Components) and Sun Autoelektrik.

Users should return any of the suspect air start motors in their inventory to ESI for verification of the inertia drive clutch torque setting. These starters can then be used to replace currently installed starters once the torque setting is verified.

At the next available maintenance interval, users should return any installed starters to ESI for verification of the inertia drive clutch torque setting.

ESI will include clutch torque setting verification in the dedication process for all future shipments of air start motors with friction-clutch inertia drives.
