PART 21 - EMERGENCY DIESEL GENERATOR FAILED AIR START MOTOR

Report No. 10CFR21-0102

COMPONENT: Air Start Motors with friction-clutch inertia drives

SYSTEM: Emergency Diesel Generator – starting air system

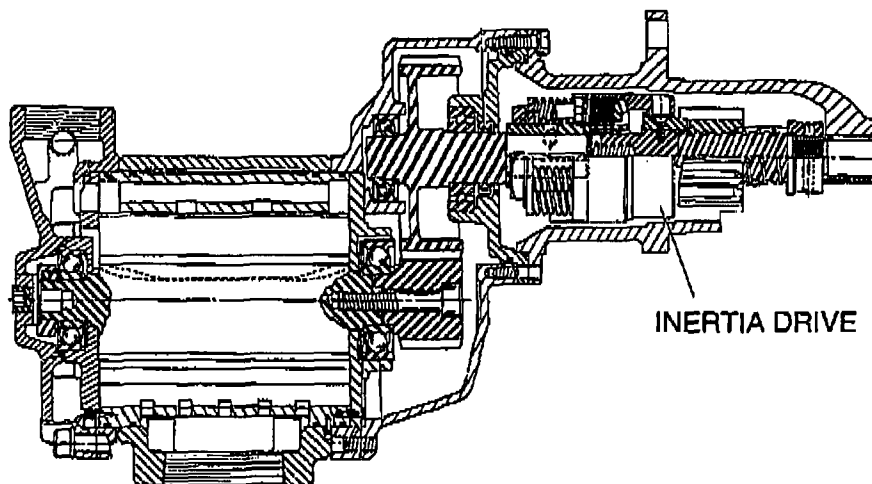
TYPICAL AIR START MOTOR ASSEMBLY

The evaluation was concluded on 08/01/11 and determined the air motor failure to be a reportable defect as defined by 10CFR21. The starter drive failure was attributed to excessive torque adjustment of the clutch assembly. This overstressed the clutch disc plates which lead to eventual failure of the friction-clutch inertia drive assembly. Failure of the clutch drive renders the air start motor inoperative. Depending upon the configuration of the engine's starting system, an inoperative air start motor could cause excessive starting times or a start failure. Either scenario has the potential to prevent the emergency diesel generator from performing its safety related function.

Users should return any of the suspect air start motors in their inventory to ESI for verification of the inertia drive clutch torque setting. These starters can then be used to replace currently installed starters once the torque setting is verified.

At the next available maintenance interval, users should return any installed starters to ESI for verification of the inertia drive clutch torque setting.
