APPENDIX W
FILTER AND RIPRAP LAYER THICKNESSES LOGS -
DIVERSION DITCHES AND TAILING SWALE

WESTERN NUCLEAR, INC. - SPLIT ROCK MILLSITE QUALITY COMPLIANCE REPORT

Diversion Ditch Filter and Riprap Thickness Measurement Log

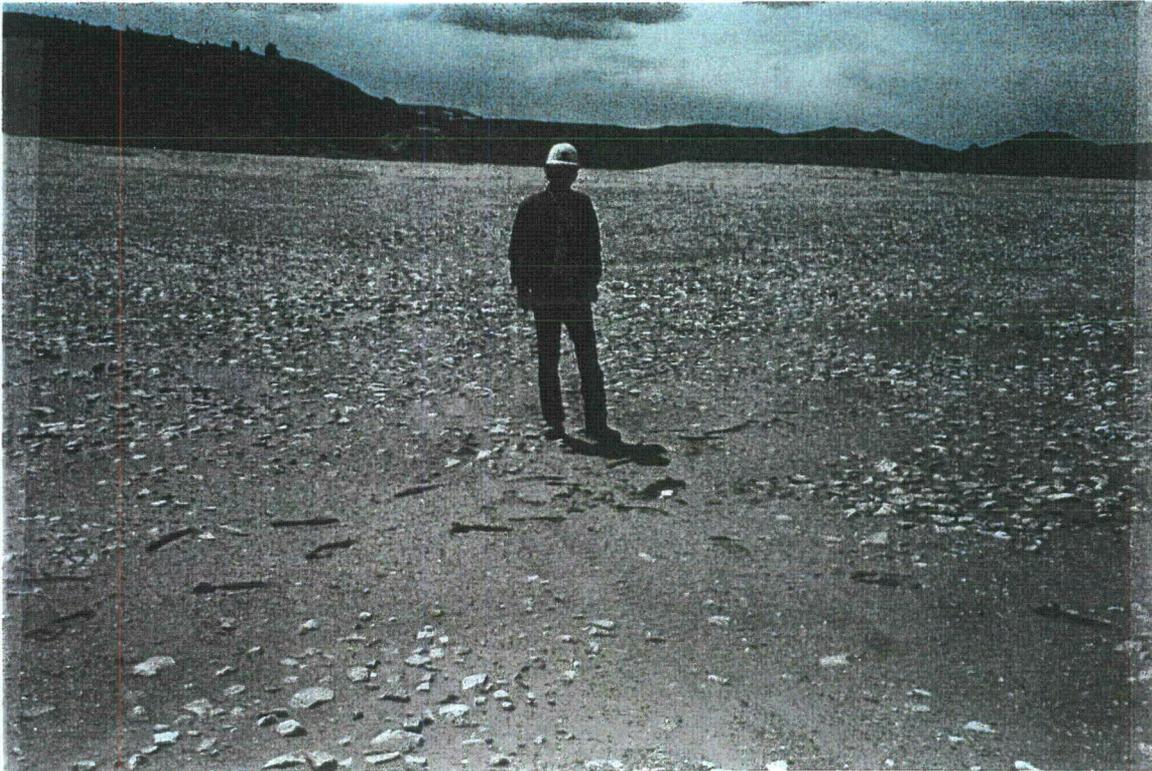
Photograph 11: Western Nuclear employee in Area 3B (minor erosion noted in this area)

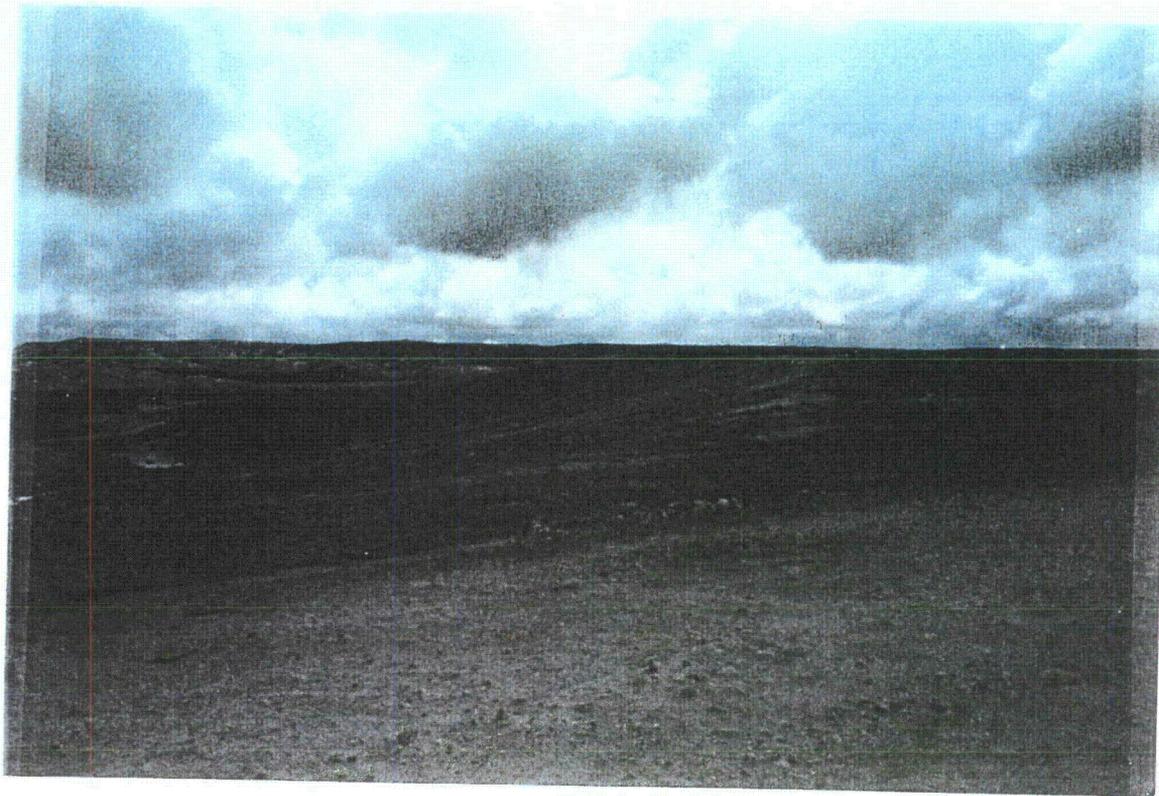
Photograph 19: Day Loma Heap Leach pile; open mine pit on far left side of photograph (a long term erosion control concern)
