7.3.0 Water Hammer At San Onofre

7.3.3 San Onofre Water Hammer Incident

7.3.5 Water Hammer-Induced Damage

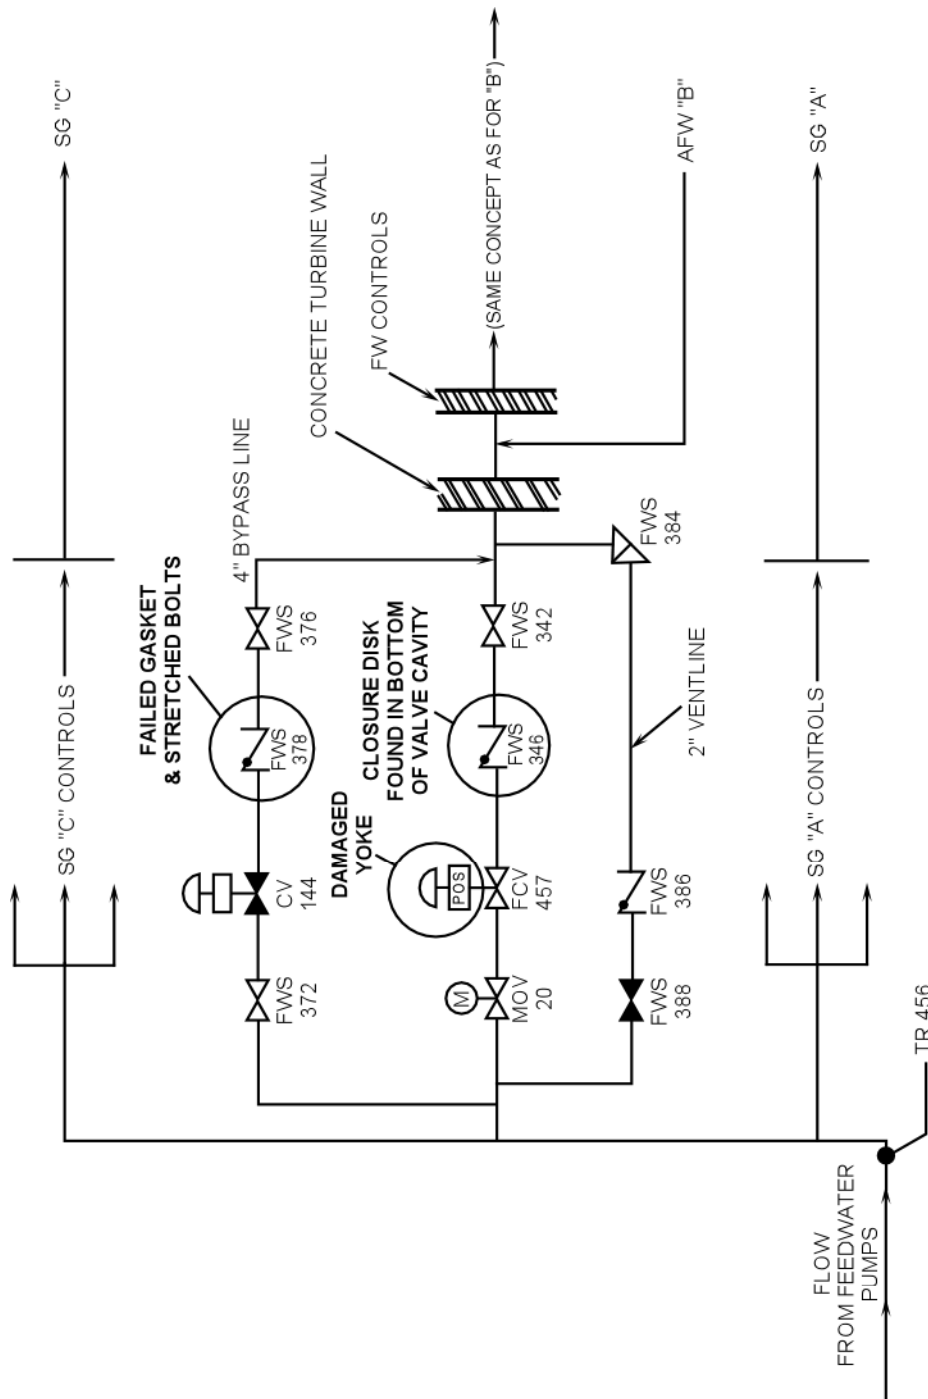
Figure 7.3-7 SONGS-1 Loop B Steam Generator Flow Control Station

Because check valve FWS-378 was intact and operational, it was subjected to water hammer loads and absorbed much of the water hammer energy, whereupon the bonnet studs yielded and the gasket was forced outward against the studs. The failure of the gasket relieved much of the internal pressure, thereby minimizing damage to other equipment and valves at this station. Valve FCV-457 did incur damage to the flow actuator yoke and a bent valve stem.

Failure of the yoke of FCV-457, the loop B feedwater regulating valve, was probably due to lack of sufficient support or bracing of the valve operator during the pipe movement caused by water hammer loading.

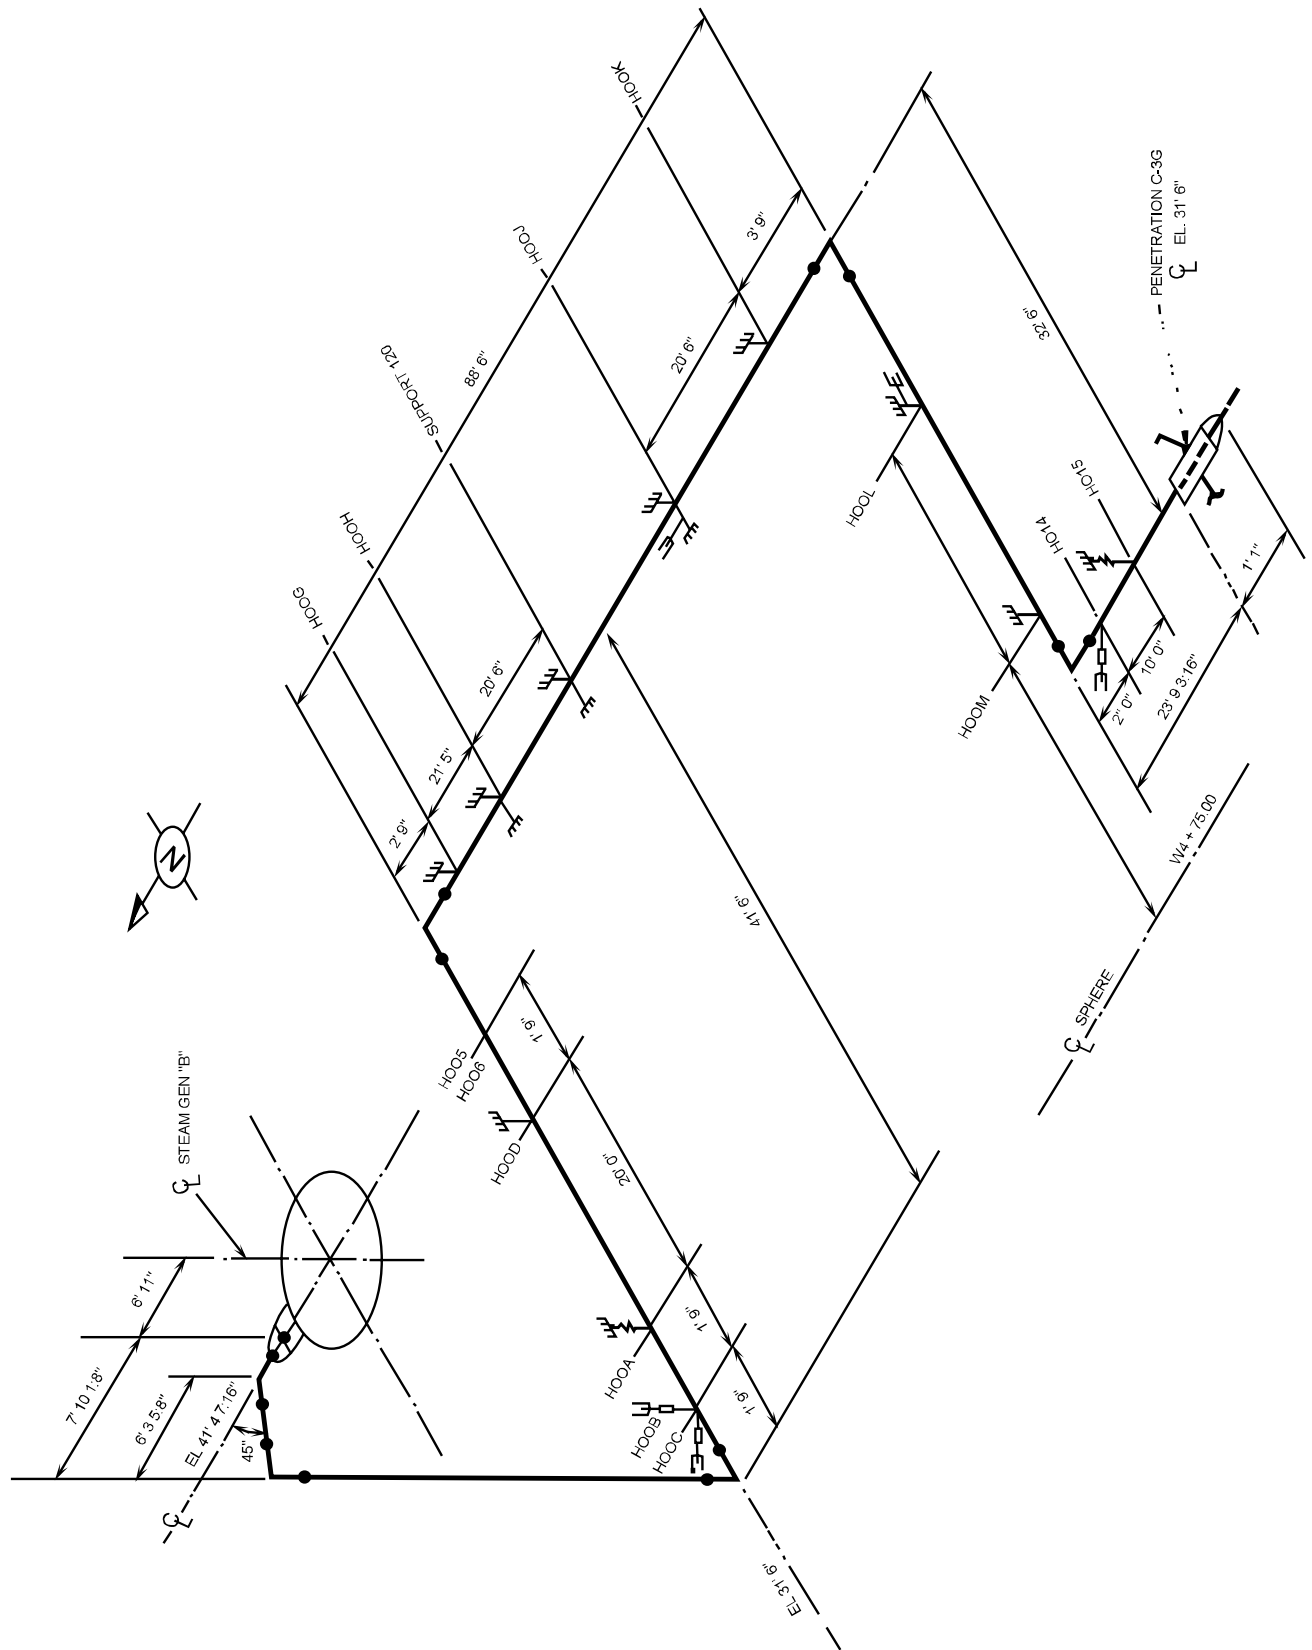
Figure 7.3-9 FW Loop B Piping and Support Layout

Figure 7.3-9 shows the loop B FW piping layout and identifies the piping support stations where damage occurred. This figure also provides directional orientation and indicates piping dimensions. Figure 7.3-10 shows principal areas of damage and indicates how the pipe moved.

The water hammer forces were sufficiently large to damage pipe supports and piping and to transmit loads through the containment building penetration structure outward to the loop B feedwater regulating station. No damage was evident to the steam generator B feeding or nozzle region that can be attributed to water hammer, nor was there evident damage to or movement of the piping between support HOOC and the steam generator B feedwater nozzle. Table 7.3-1 and Figures 7.3-9 and 7.3-10 illustrate the piping and support damage.

HOOL	Lateral movement (westward) of pipe which resulted in sheared vertical support structure. Concrete and support plate damaged by water hammer, nuts were loosened and bolts were missing in wall plates.
HOOM	Piping and support damage just downstream of where FW B line takes a 90-degree bend to exit the containment building.

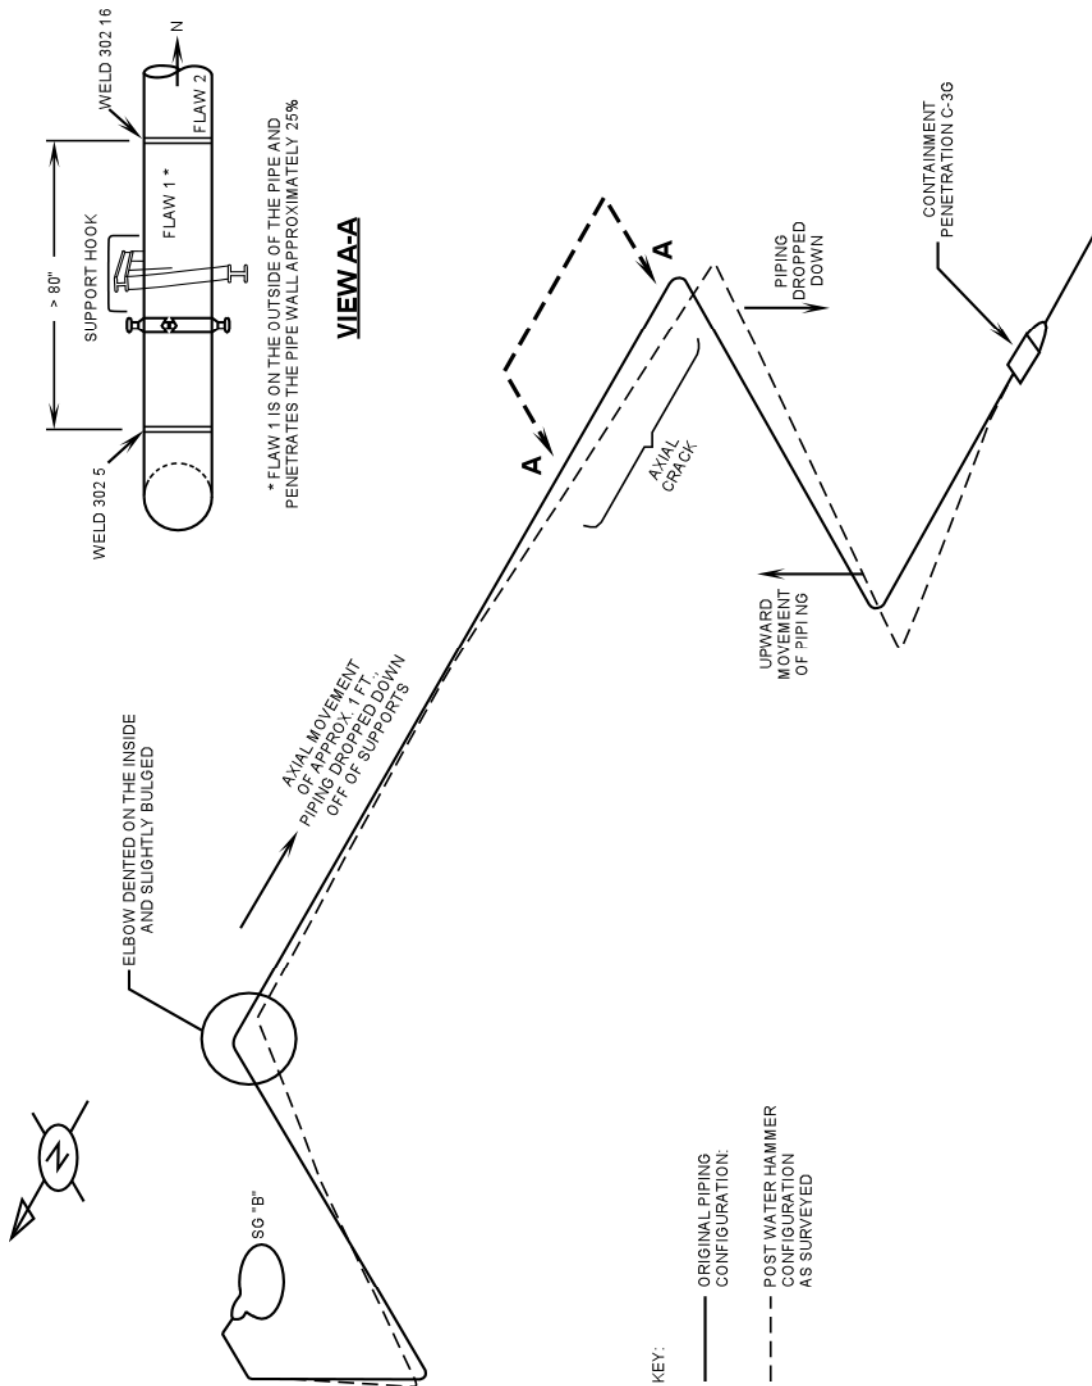
Figure 7.3-10 Overview of Feedwater Piping and Support Damage Due to Water Hammer

Damage to the loop B FW piping was confined to plastic yielding of the northeast elbow and to a visible crack on the outside of the pipe, extending approximately 80 inches axially. The crack penetrated approximately 30 percent of the pipe wall at its deepest point from the outside and approximately 25 percent on average. Damage to supports was severe in some instances. This section provides a description of the damage visible after the FW piping insulation was removed.

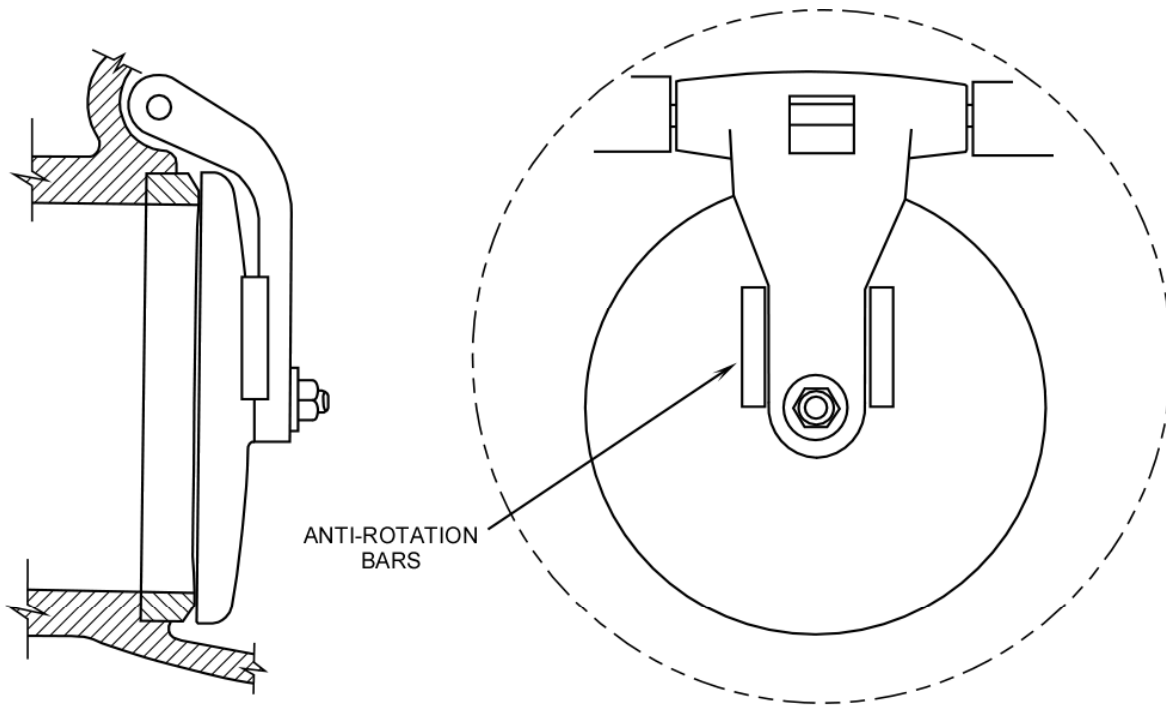
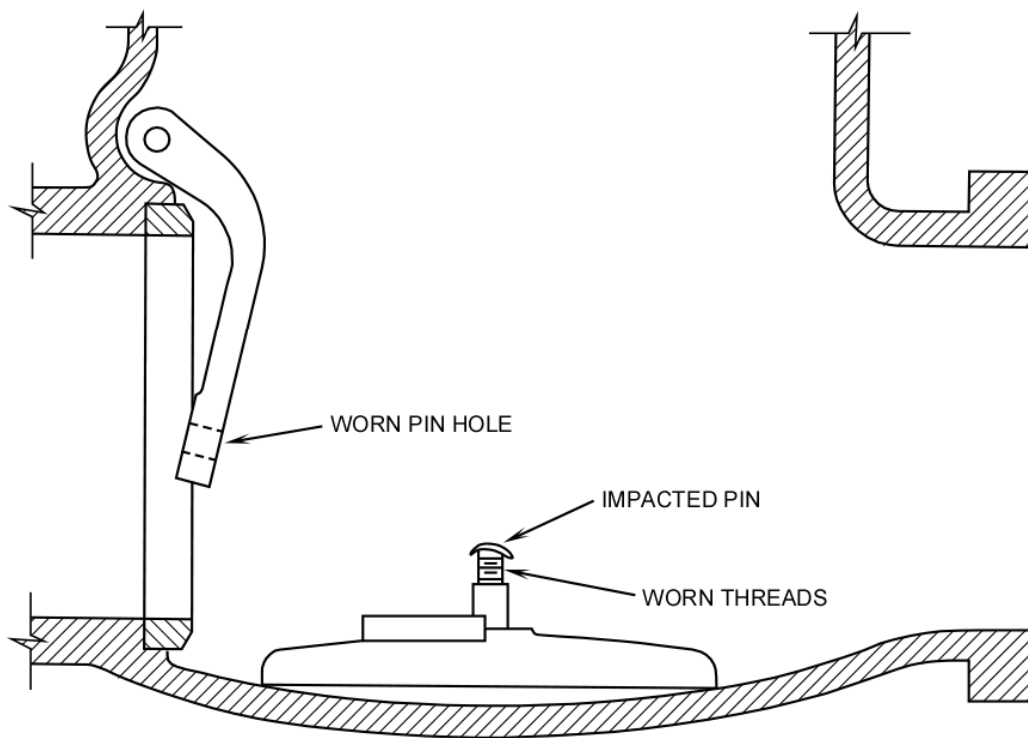
Figure 7.3-12 Check Valve FWS-346

The failure of FWS-346, the B feedwater header check valve, may have been caused by the inadequate hardness of the disc-attaching stud, which allowed the threads to strip and the end to mushroom over, conditions contributing to the ultimate valve failure. However, the service conditions (i.e., flow-induced vibration) experienced by this valve may also have been a major contributor to failure. The failures of FWS-345 and FWS-398, the A and C feedwater header check valves, may have been due to similar service conditions.

<u>Valve</u>	<u>Description</u>	<u>As Found</u>
FWS-345 SG A	MFW Reg Check	Disc separated from hinge arm, disc stud broken (threaded portion).
FWS-346 SG B	MFW Reg Check	Disc separated from hinge arm, disc stud deformed.
FWS-398 SG C	FW Reg Check	Disc nut loose. Disc partially open. Disc caught inside of seat ring.
FWS-438	FWP Discharge Check	Disc nut loose. Disc partially open. Disc caught inside of seat ring. (Figure 7.3-13)
FWS-439	FWP Discharge Check	Disc nut loose. Disc partially open. Anti-rotation lug lodged under hinge arm.

VALVE FWS-346 AS FOUND

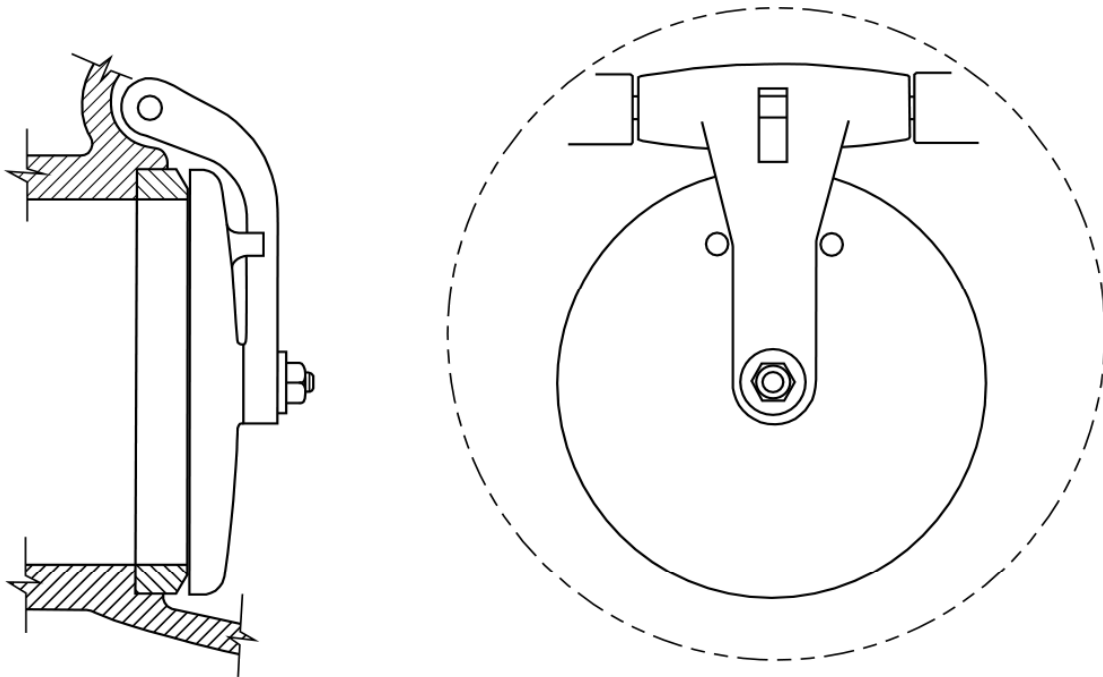
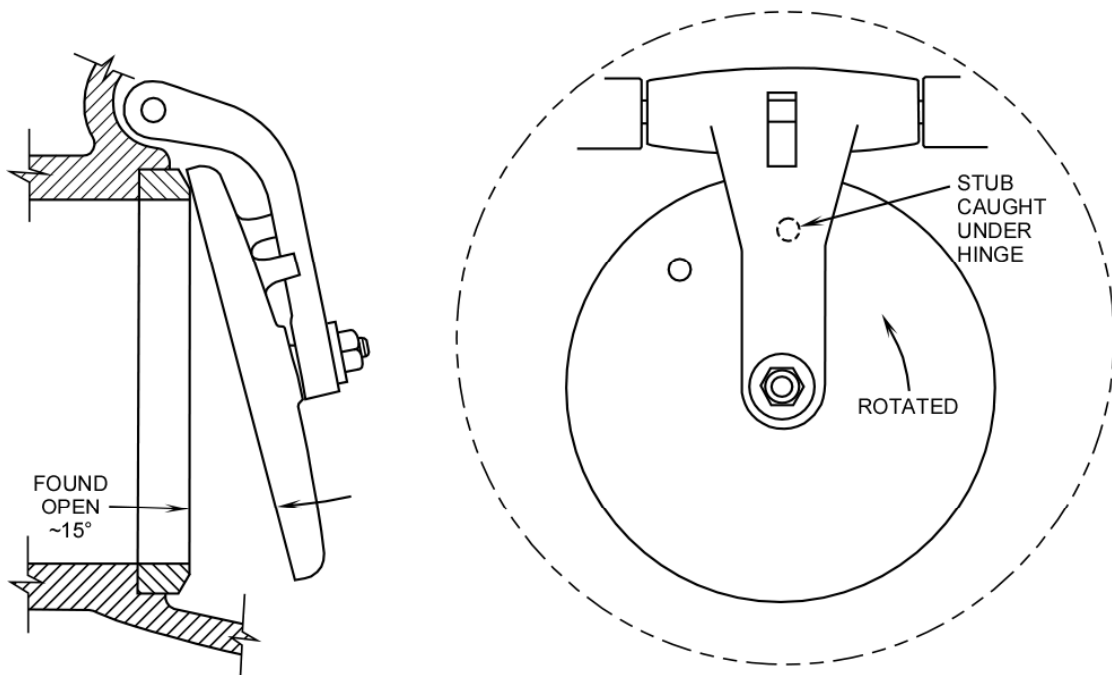
Figure 7.3-13 Check Valve FWS-348

Failures of FWS-438 and FWS-439, the main feed pump discharge check valves, may have been due to inadequate valve design, since the disc-retaining nut of each valve was not provided with a positive locking device that should have reduced the probability of the disc working loose, wedging into the valve seat, and failing open. Additionally,

excessive clearances between the hinge and disc assemblies allowed the discs to rotate past the anti-rotation devices.

When bus 2C was de-energized and the east main feed pump tripped, failed discharge check valve FWS-438 allowed the west main feedwater pump to pressurize the east condensate header.

VALVE FWS-438 AS FOUND
