SUBJECT: SUBMITTAL OF REFERENCE DOCUMENTS RELATED TO EA-11-018 FOR BROWNS FERRY NUCLEAR PLANT UNIT 1, DOCKET 50-259

Browns Ferry Unit 1 FCV-074-066
RHR Outboard Injection Valve Failure
NRC Questions (#2)

BFN 1-FCV-74-66 Valve Failure
NRC Follow-up Questions - April 18, 2011

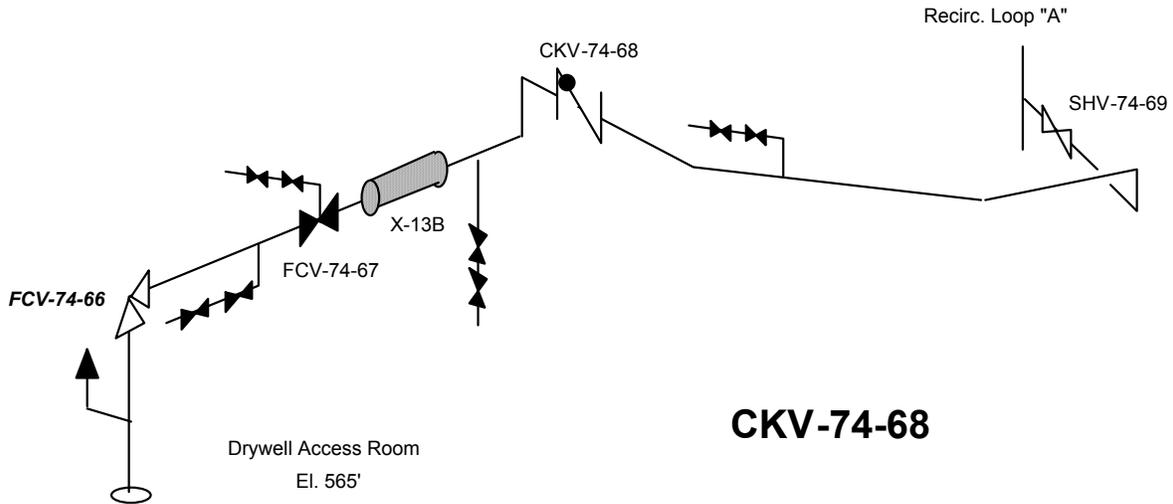
The configuration for RHR Loop II shown in Figure 1 above illustrates the location of FCV-74-66 in relation to other IST Program valves (FCV-74-67 and CKV-74-68). RHR Loop I containing FCV-74-52 is similarly configured as shown in Figure 2 below.

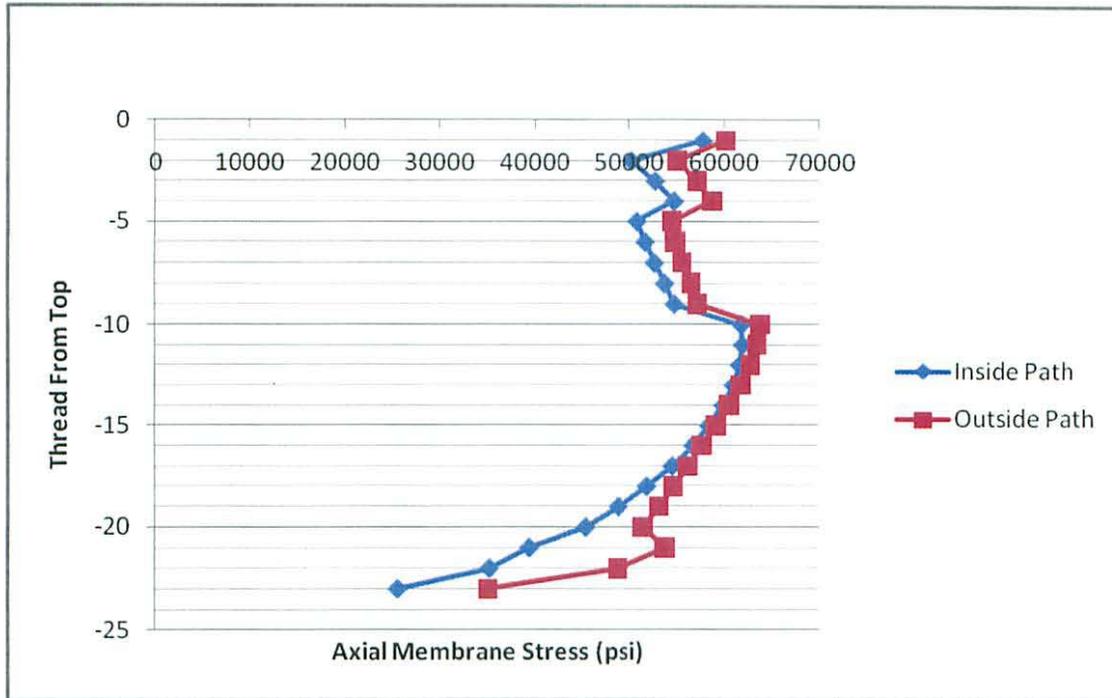
"We disagree with observations (bullets) #2 and #3 above. Figures 2 and 3 below, taken from the Westinghouse Failure Analysis Report, indicate that a significant number of the threads exhibited plastic deformation, and that the most significant deformation was at the top of the threaded joint (bottom of the figures since they are upside down). This is consistent with the loading distribution predicted in Figure 1 below.

Figure 1 – Finite Element Thread Stress Results at 314 kip Axial Load

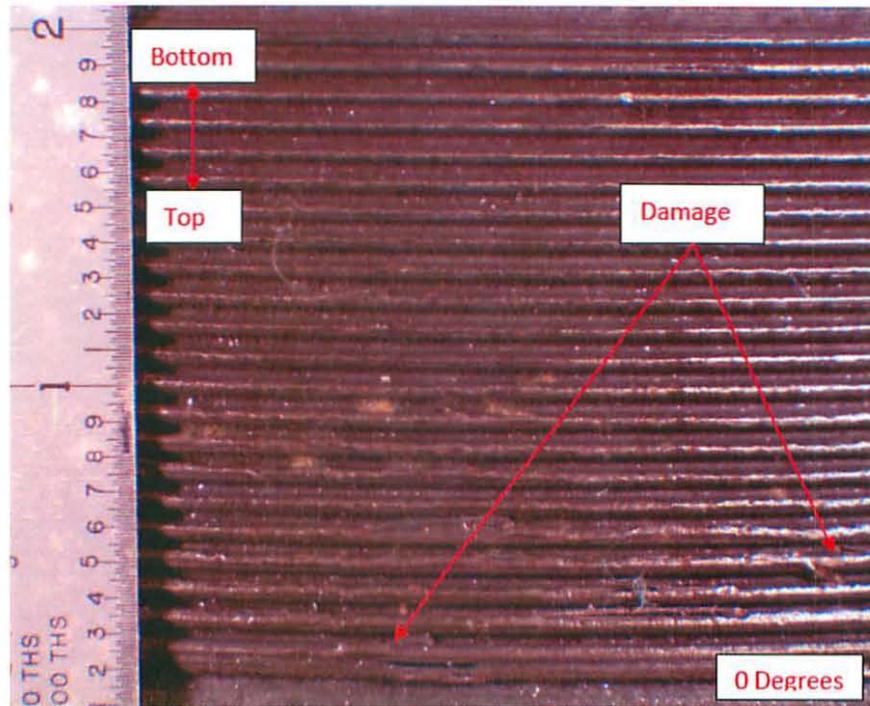
Figure 2 Close-up Macrograph of Skirt Threads, Showing Thread Damage (Fig. 3.3 from Ref. 1)

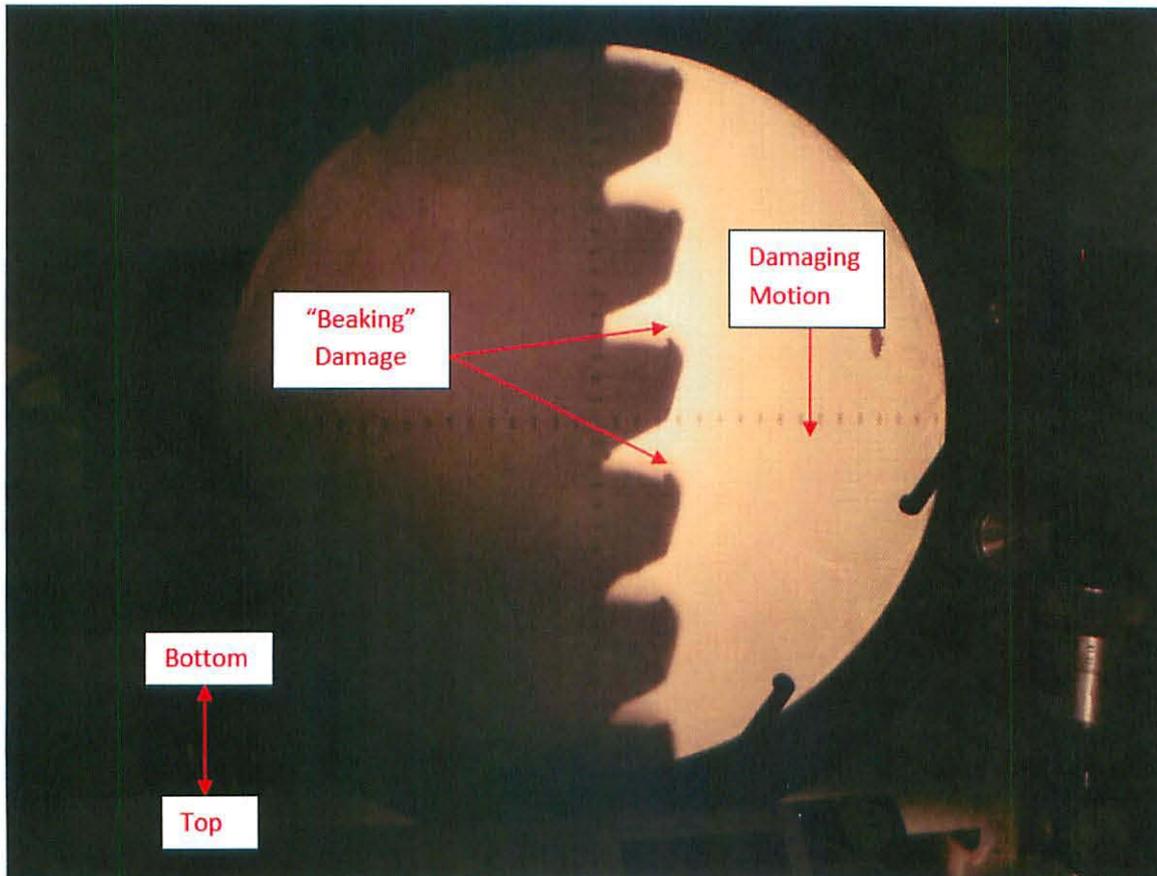
Figure 3 - Optical Comparator Image of Damaged Threads (Fig. 3-10 from Ref. 1)

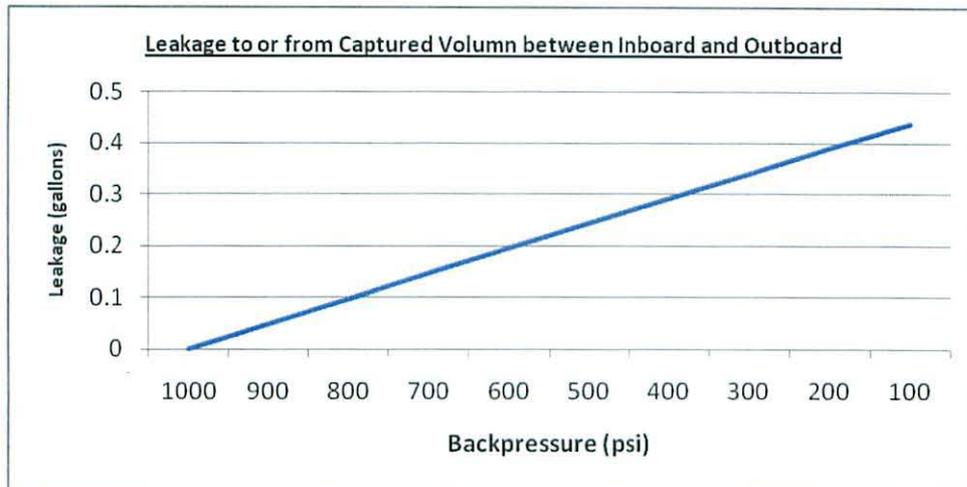
The backpressure force can vary based on the leak tightness of the FCV-74-66 and 52 flow control valves (FCVs). The figure below demonstrates the effect of leakage either into the volume above the disc (i.e., between the inboard and outboard valves) (raising the pressure) or out of the volume (reducing the pressure). This figure charts the change in specific volume as the pressure in a controlled volume is changed converting the change in mass to gallons. All the outboard valves are the same 24" angled globe valve manufactured by Walworth.

The applied backpressure could be significantly different depending on the relative leak tightness of the three in-line valves (injection check, inboard, and FCV). If the FCV is relatively leak tight, pressure would build-up during the cycling of the inboard valve. All the Units 2 and 3 available as-found leak rate results from 1993 until current for the injection check valve (36 tests) and the inboard injection gate valve (38 tests) were collected to determine the mean leakage (1.15 and 0.29, SCFH respectively) and standard deviation (1.36 and 1.08, respectively). The as-found October 28, 2008, leak rate results for the Unit 1 RHR Loop II injection check valve and the inboard injection gate valve were 13.5 (9 standard deviations above the mean) and 12.46 (11 standard deviations above the mean) SCFH respectively. The leakage rate past the check valve is more than enough to pressurize the volume of 21.2 ft³ (Δ of ~0.06 ft³) needed to pressurize to reactor pressure) during stroking of the inboard injection valve as long as leakage past the FCV (74-66) is relatively lower. This backpressure will not decrease if leakage past the inboard valve is higher than the FCV after the inboard valve is closed and the FCV (74-66) is given a signal to open as is done during logic surveillance testing. The leak tightness of the Unit 1 FCV-74-66 valve was demonstrated while troubleshooting the October 23, 2010 separated disc. A pressure gage was placed between the closed inboard injection valve and closed FCV. The FCV was given an open signal and while the stem moved open the pressure decreased well below atmospheric pressure indicating leak tightness. Therefore the backpressure on the Unit 1 74-66 valve had the potential to be significantly higher than that experienced the comparable Unit 2 and 3 valves. The Unit 1 RHR Loop I injection check valve and inboard injection gate valve also exhibited high leakage similar to RHR Loop II. However, based on the results of inspection of the 1-FCV-74-52 valve (i.e., disc and skirt not separated and welds intact), it is concluded that either relative leakage past the outboard valve (1-FCV-74-

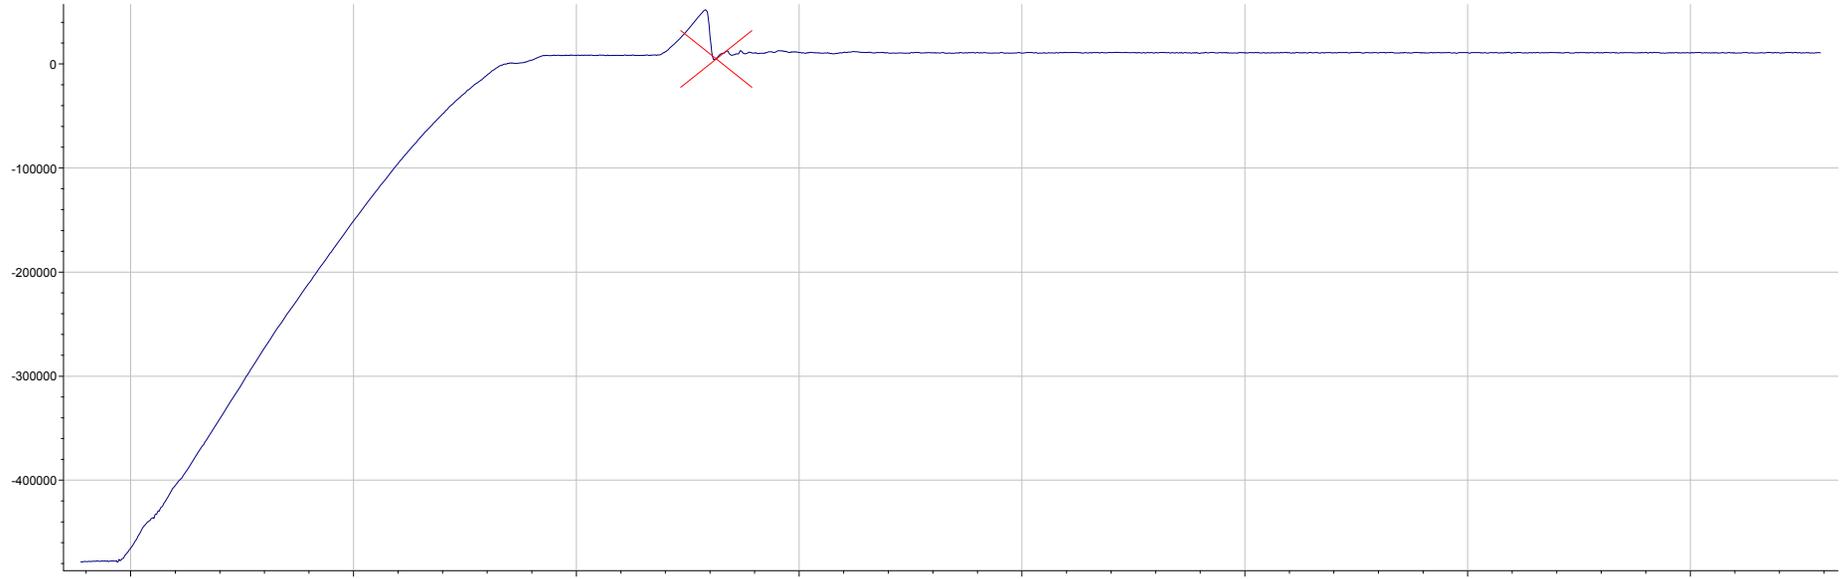
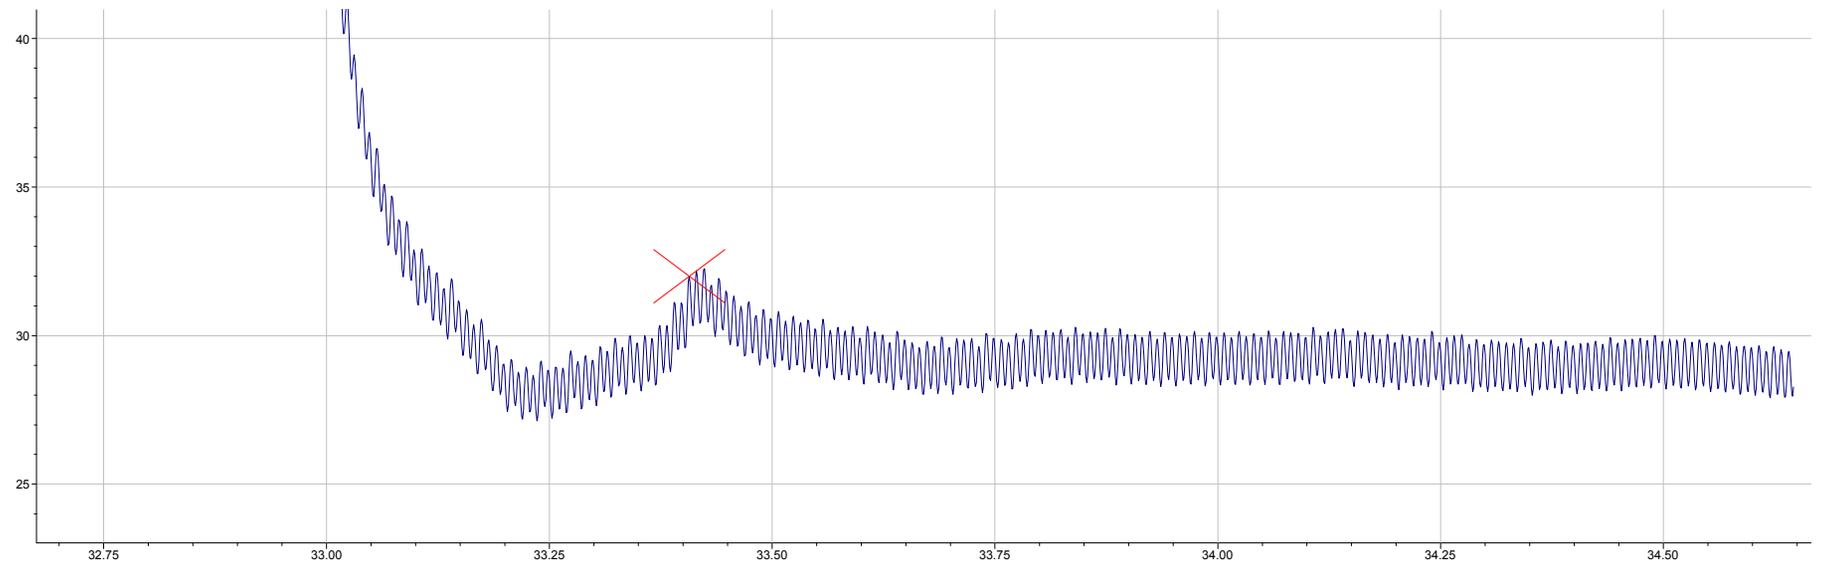
Valve ID 1FCV7466
Test Desc. ALFS/TSS1.0625
1-FCV-74-66 UNSEATING EVENT 2010

It is true that we observed unseating in the MOVATS trace of November 12, 2010. The reason we did not observe the unseating in the past (2006) is that the stellite surface was relatively new and the COF is lower. With the additional time, the stellite surface has aged and the COF is high enough to observe the unseating. It would be anticipated that the unseating forces would be observed in 2008 however, the stem and disc were already separated. The seats were not machined in 2010 when the valve was repaired and therefore the aging stellite surfaces were not disturbed.

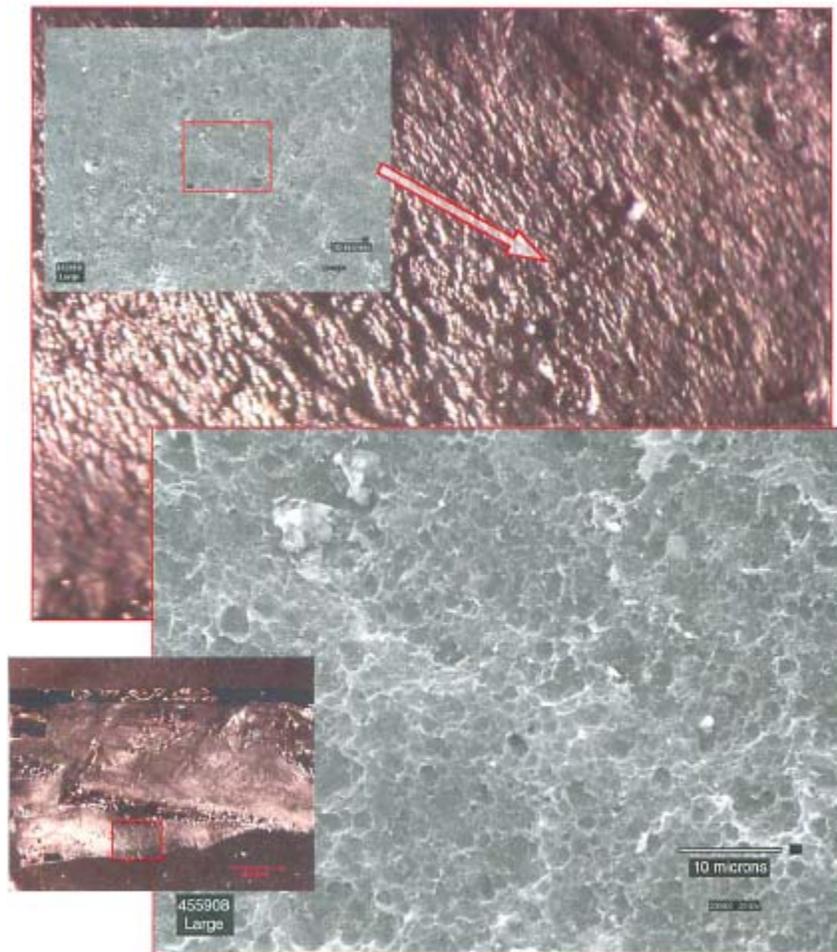
Figure 29. SEM replica image (2000X) showing dimples found on the fracture surface near the left side of the fractured weld.

Dimples shown in Figure 29 are a strong indication that the failure caused in this area was caused by overload.

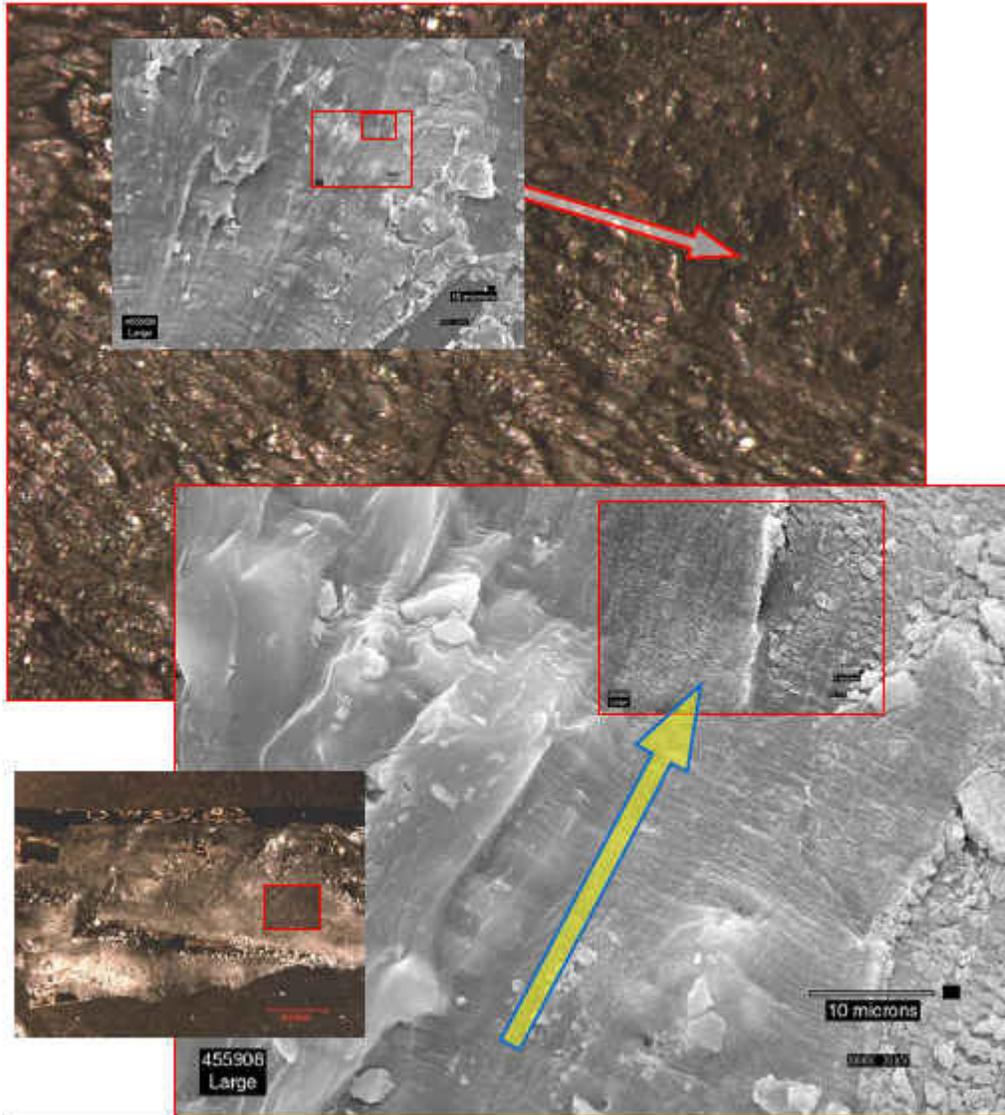
Figure 30. SEM replica image (2000X) showing possible fatigue striations found on the fracture surface near the left side of the fractured weld. (Spacing ~ 0.3 microns)

Figure 30 clearly indicates fatigue striation. The clearly establishes cyclic loading and fracture progression across the fracture surface consistent with loading in the axial direction.

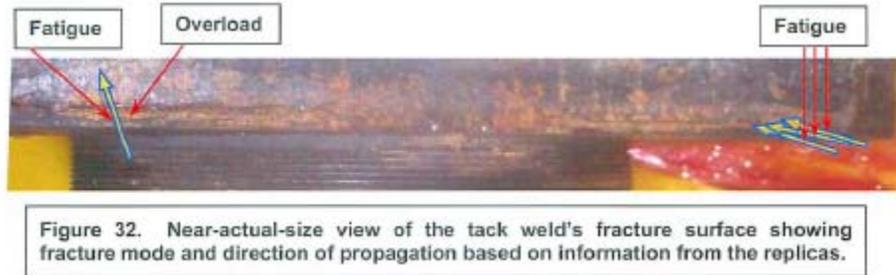
Figure 32 shows the locations where failure modes were identified in the replicas. In the areas where axial fatigue modes were identified as the failure mode, an arrow with a blue outline and a light-yellow fill is shown on the fracture surface. These arrows also show the propagation directions which are consistent with Crane Nuclear statement that the axial failure would start at the weld endpoint and propagate along the weld cross section. Where axial overload was the failure mode, a labeled arrow points to the location on the fracture surface.

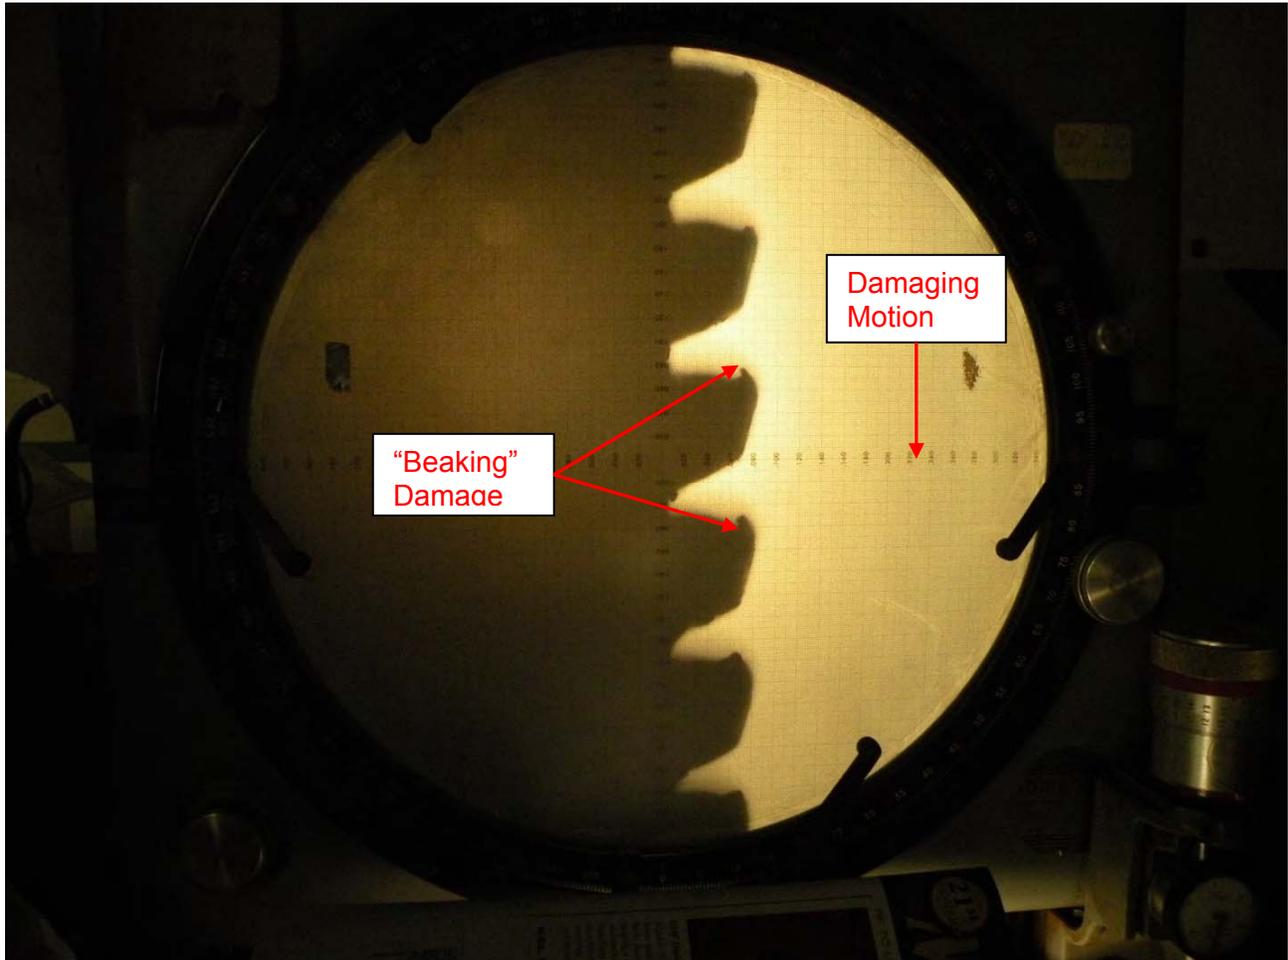
Figure 3.10 Optical Comparator Image of Damaged Threads (Location Not Specified)

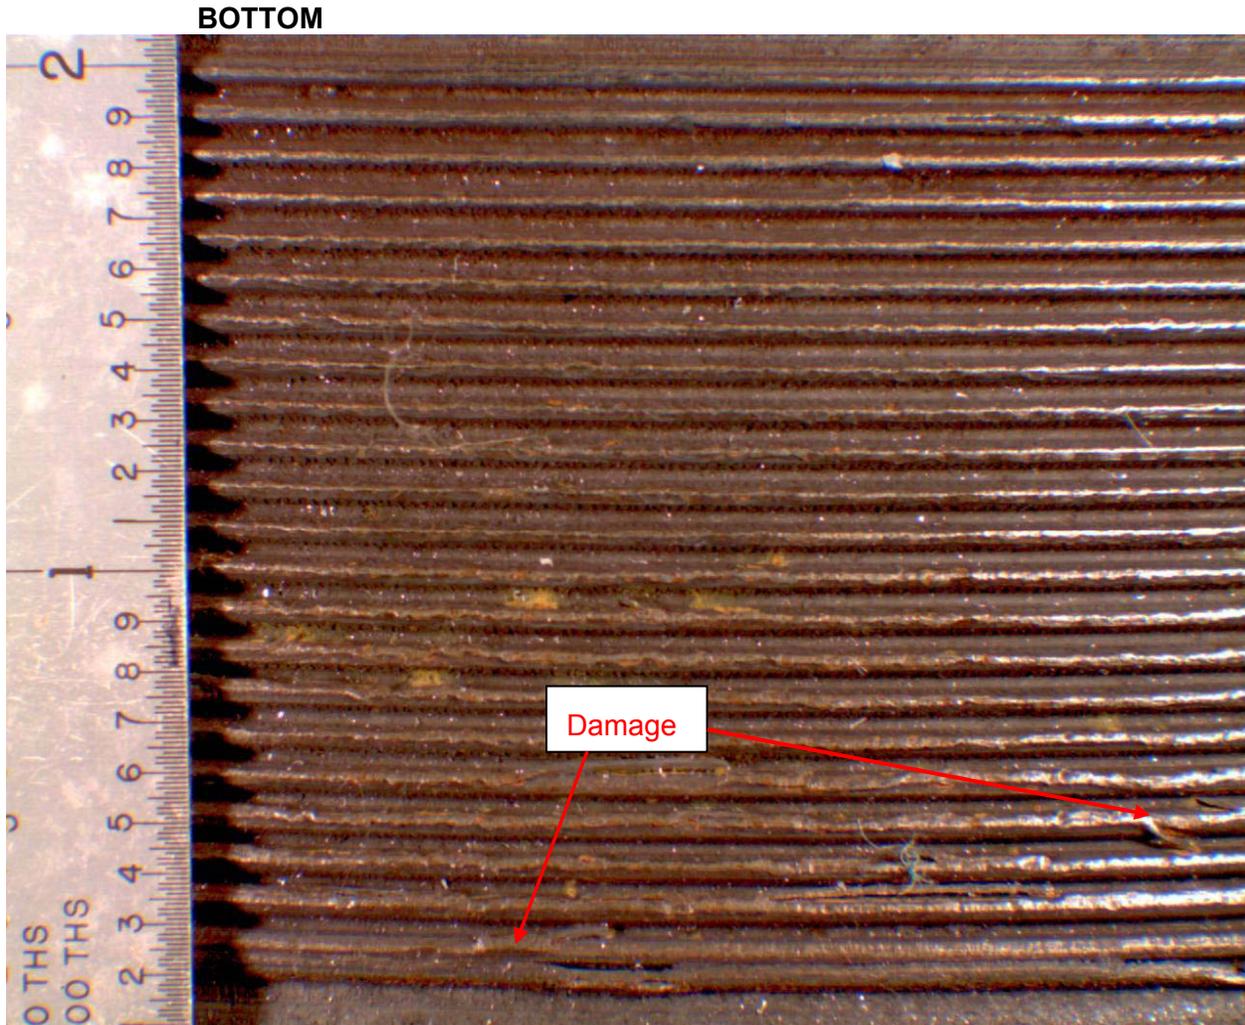
TOP
**Close-up Macrograph of Skirt Threads, Showing Thread Damage,
12 Threads per Inch Spacing (0 Degree View)**

Although the tack welds are not designed as a load bearing feature, more weld metal would improve the axial load carrying capability of the disc skirt connection. The Structural Integrity report (Reference 4) did not reduce the capability of the 0.2" weld based on the porosity and de-lamination discussed in the Westinghouse report. The Structural Integrity report only considered the load that a 0.2" weld would be able to support in the event of the undersized threads. The threads are the axial load bearing component. As such, Structural Integrity did not consider the porosity and de-lamination of the welds. The Burns and Role independent metallurgist also evaluated the porosity and de-lamination of the welds and considered them to not be contributors to weld failure (Reference 3). The Structural Integrity report (Reference 4) stated that even a perfect 0.5" fillet weld would not be capable of withstanding the design backpressure when thread contact is reduced by undersized threads or plastically deformed threads (as it was in the case of the 1-FCV-74-66 failure). From a structural design standpoint, a fillet weld has an inherent flaw at the root of the weld

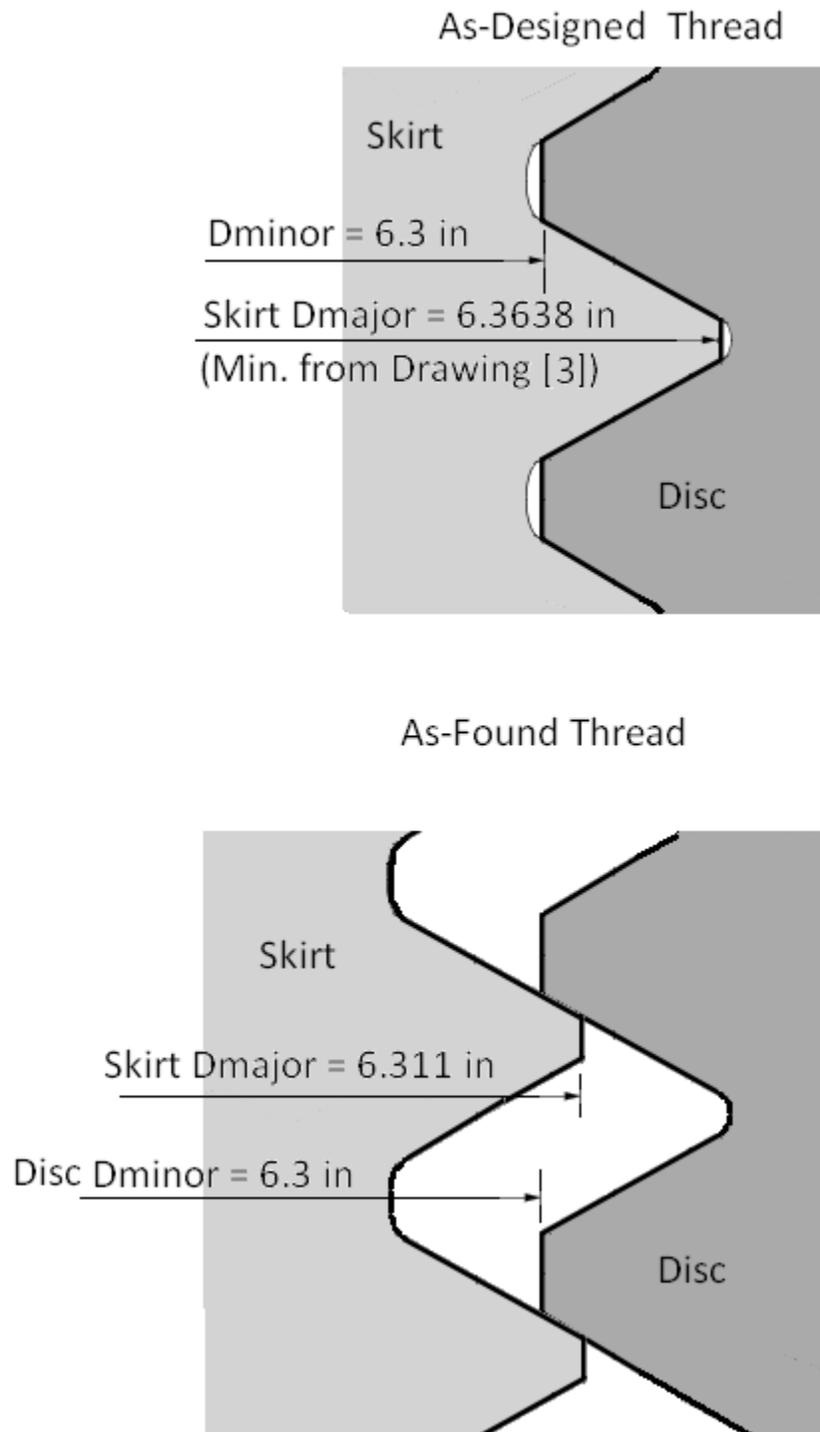
Figure 1 – Illustration of Thread Undersize Condition with Minimum Measured Skirt Diameter

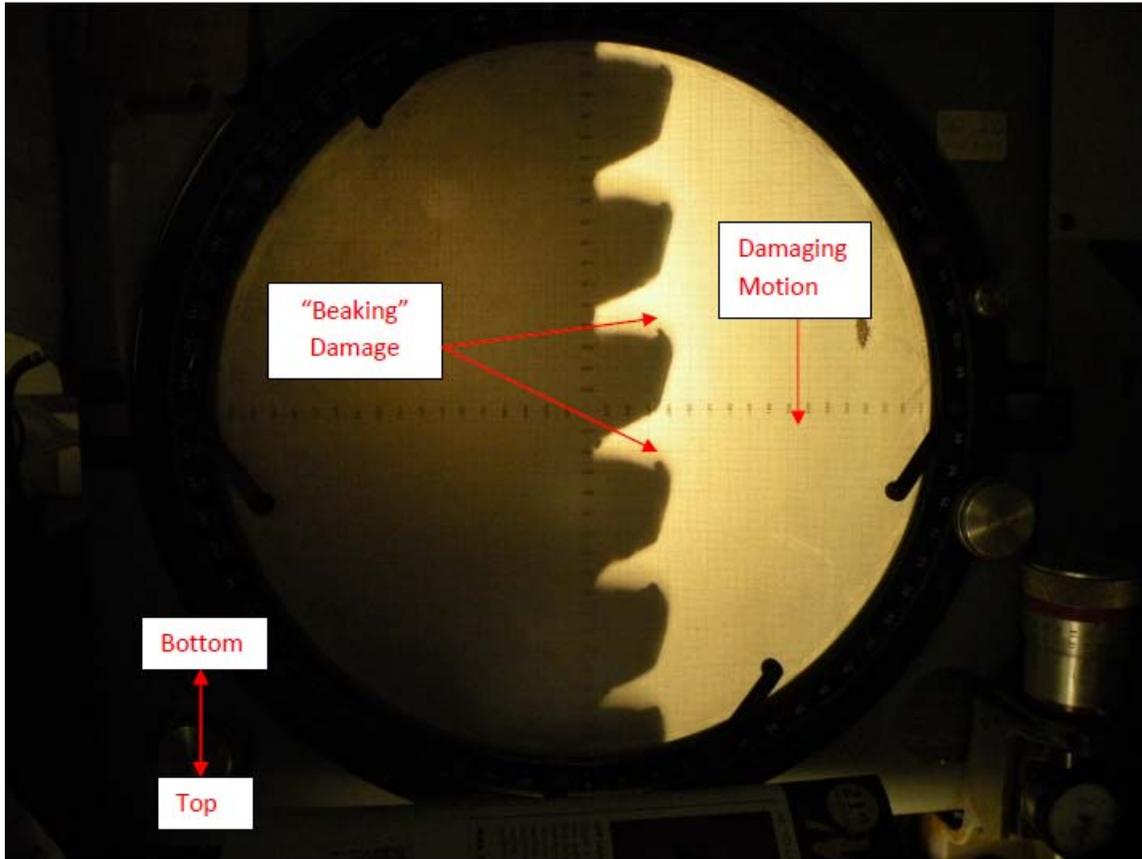
Figure 2 - Optical Comparator Image of Damaged Threads (Fig. 3-10 from [4])

“Beaking” damage consisted of deformation in which part of the threads were extruded towards the bottom of the skirt, which is consistent with the skirt being pulled out of the disc by an overload in the upward direction. A second form of damage was manifested as flat thread peaks, which is consistent with very small thread contact such that the skirt could pull through the disc threads without major (beaking) deformation. Also observed in [4]: “Some threads had no apparent damage. The mixed damage forms suggest that the threads were probably not unscrewed but rather were removed by an asymmetrical force or were the result of an inconsistent mating surface in the base.”

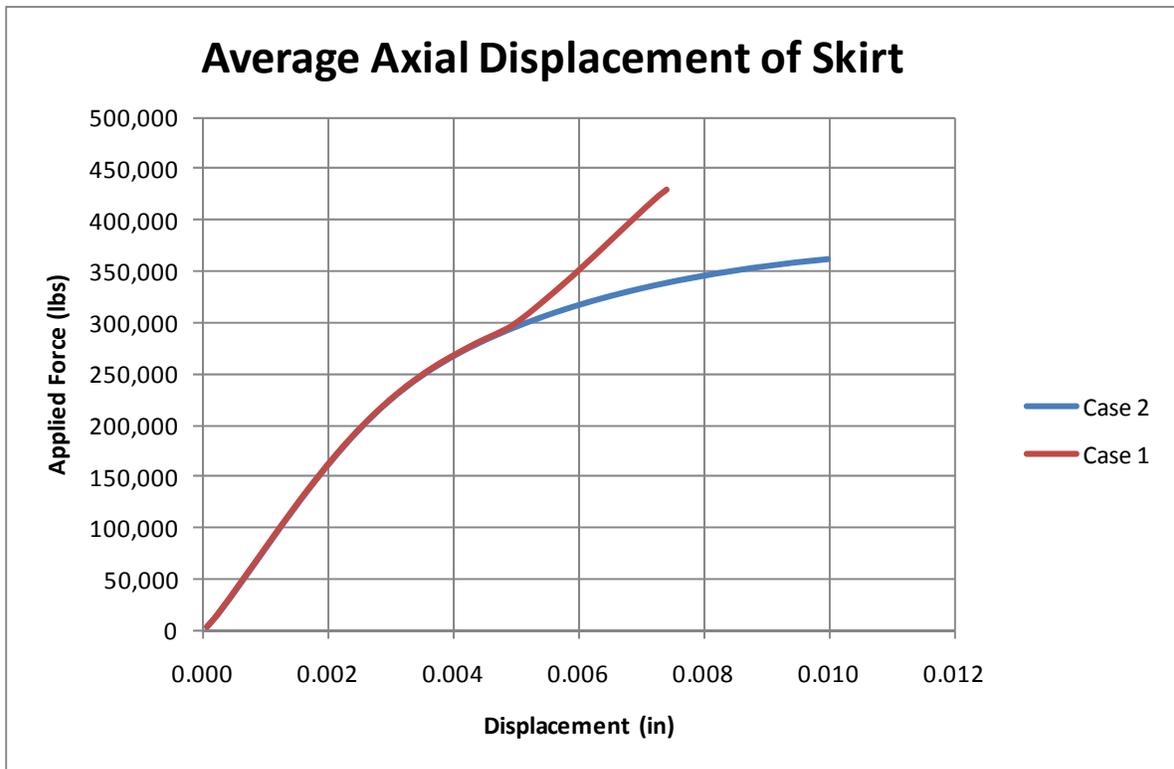
Figure 4 – Results of Elastic-Plastic Analysis

It is seen from this figure that the two cases track identically up to a load of ~300 kips, at which point, the threads have undergone ~0.005 inches displacement. At that point, in Case 1, the remaining bottom threads engage, and the joint is able to sustain additional load up to the max load applied to the model, 430 kips. In Case 2, on the other hand, the bottom threads don't engage, and the curve flattens out at a maximum load of ~360 kips (the analyses failed to converge beyond that point, indicative of a limit load failure or pullout). In summary, the elastic-plastic analysis [7] yielded similar results to the previously discussed thread pullout calculation. Depending on the thread diameters and engagement length assumed, pullout failure of the joint is predicted at loads on the order of 350 to 500 kips, well short of the load capacity of the as-designed joint (884 kips). The analysis also showed that the threads are subject to significant plastic deformation under these loads, consistent with the observations of severe damage (beaking) in some threads in the metallurgical report [4]. Also note, from Table 2, that the beaking is more prevalent in the top threads, and at certain azimuths (especially 290 degrees). This is consistent with the above assumption of upper thread only engagement in Case 2, and also indicative that the thread engagement was not perfectly concentric.

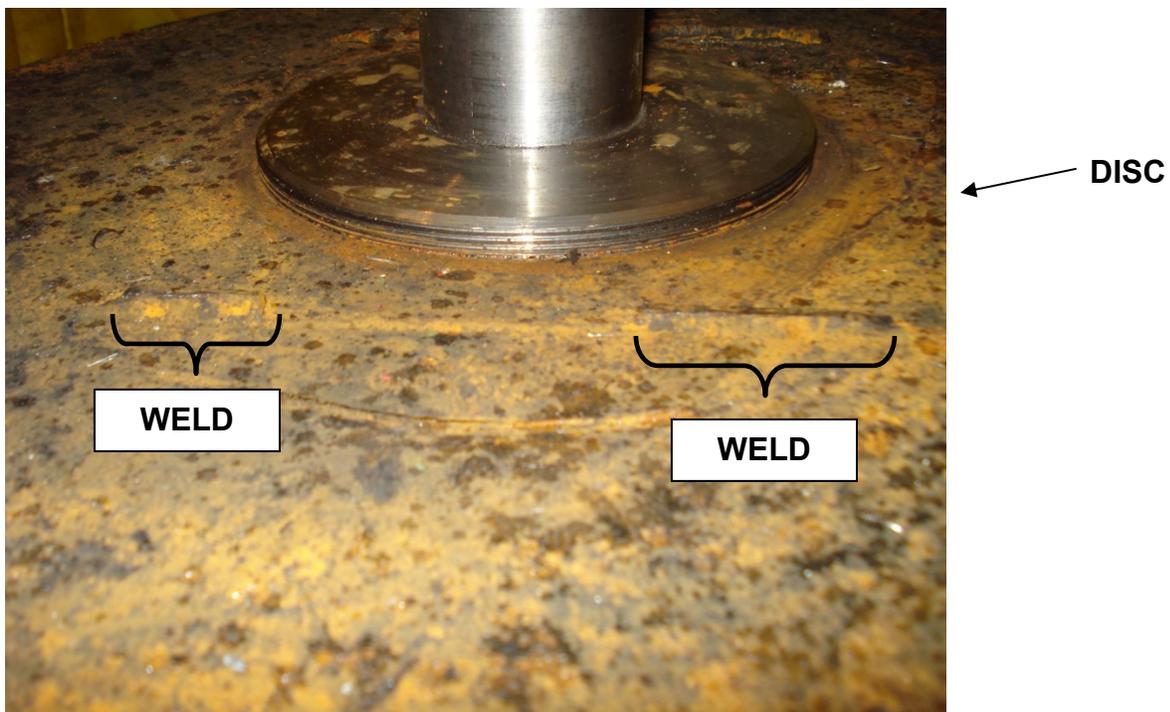
1-FCV-74-66 failure occurred due to an axial “pull out” instead of a torsional failure. This is identified by the weld segments left on the disc and disc skirt. The remaining weld segments condition at the time of discovery are not consistent with a rotational event, because any significant rotation would have knocked them off. Typically the valve disk and disc skirt are snug tight prior to welding as discussed in the General Electric Field Deviation Instruction (see the attachment). The thread dimensions according to drawing C-12337-7-3A are 6 3/8 -12 NS-3, which is a pitch of 12 threads per inch which is what was observed, which means in one rotation the linear movement of the skirt away from the disc is 1/12 inch, or 0.08333. Based on the height and orientation of the protruding portions of weld left on the skirt and disc (greater than 1/12”), the protruding weld segments would act as a stop to the rotational motion of the skirt versus the disc. The locations of these protruding weld segments would prevent even one full rotation of the skirt away from the disc. See the pictures below. Therefore, the valve disc could not have rotated relative to the skirt based on the condition of the tack weld at the time of discovery.

View from top of 1-FCV-74-66 with extraction device installed

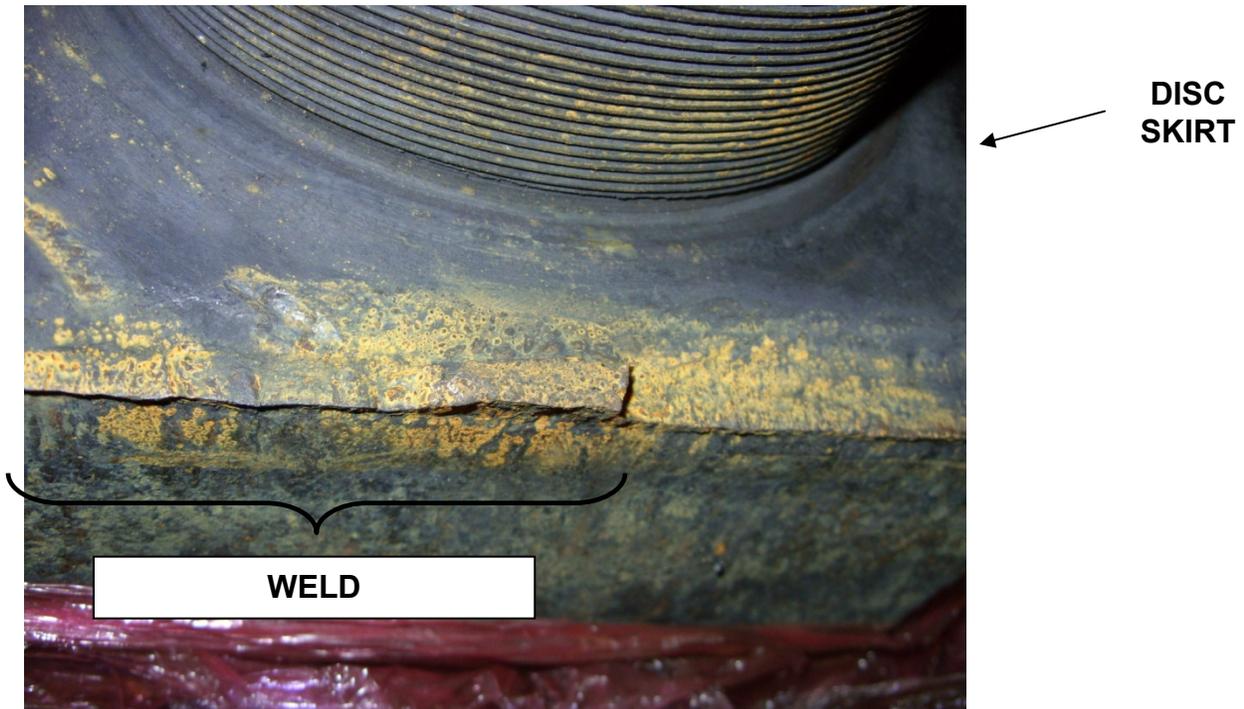
Thread side of skirt with protruding weld

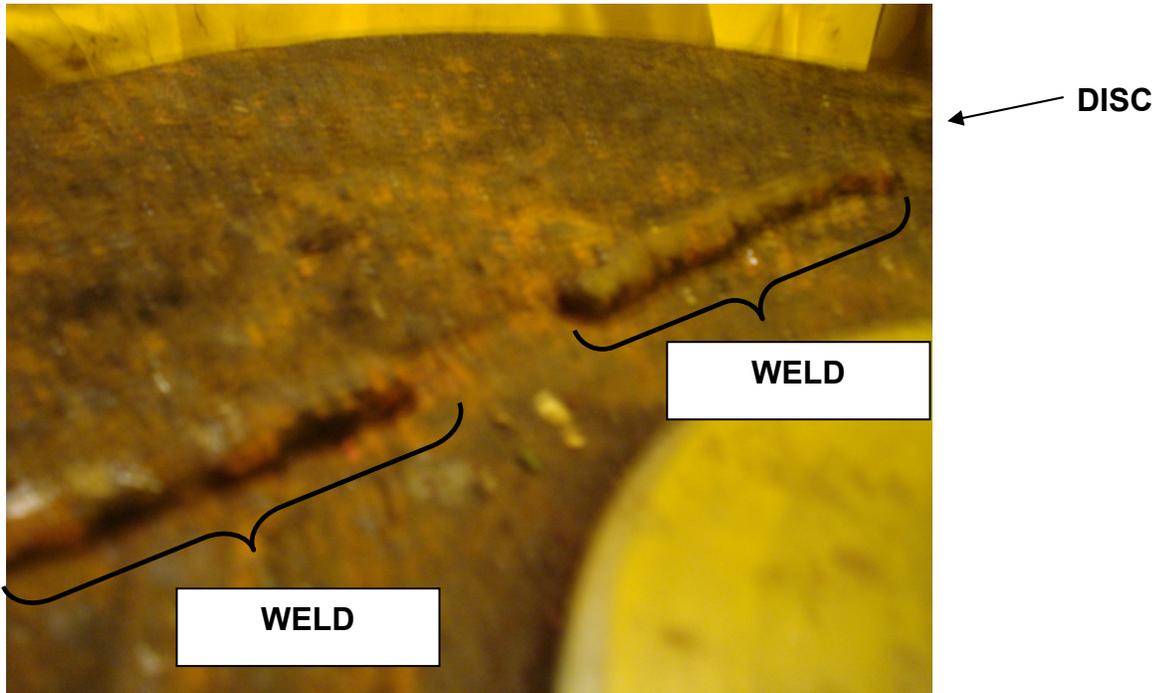
Top of disc

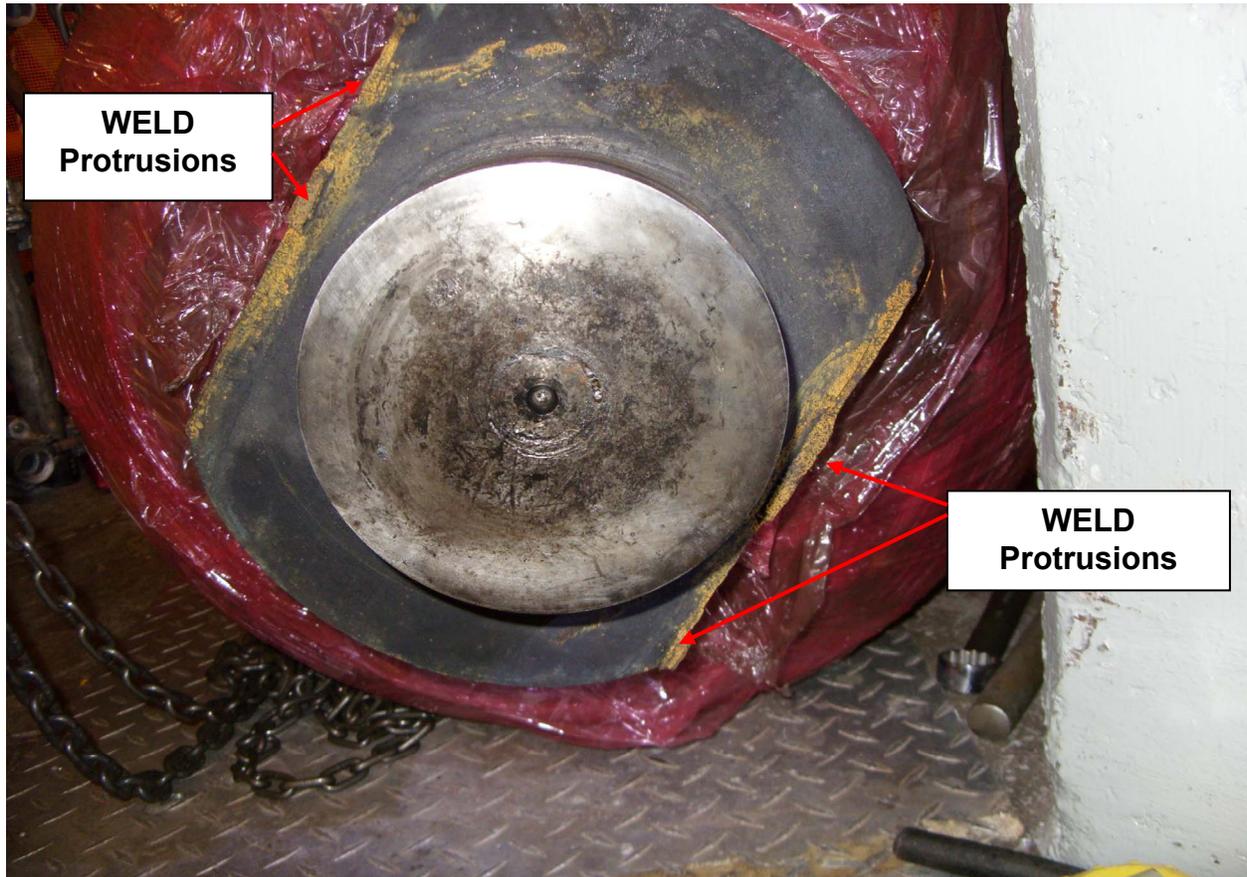
Bottom of skirt with stem installed

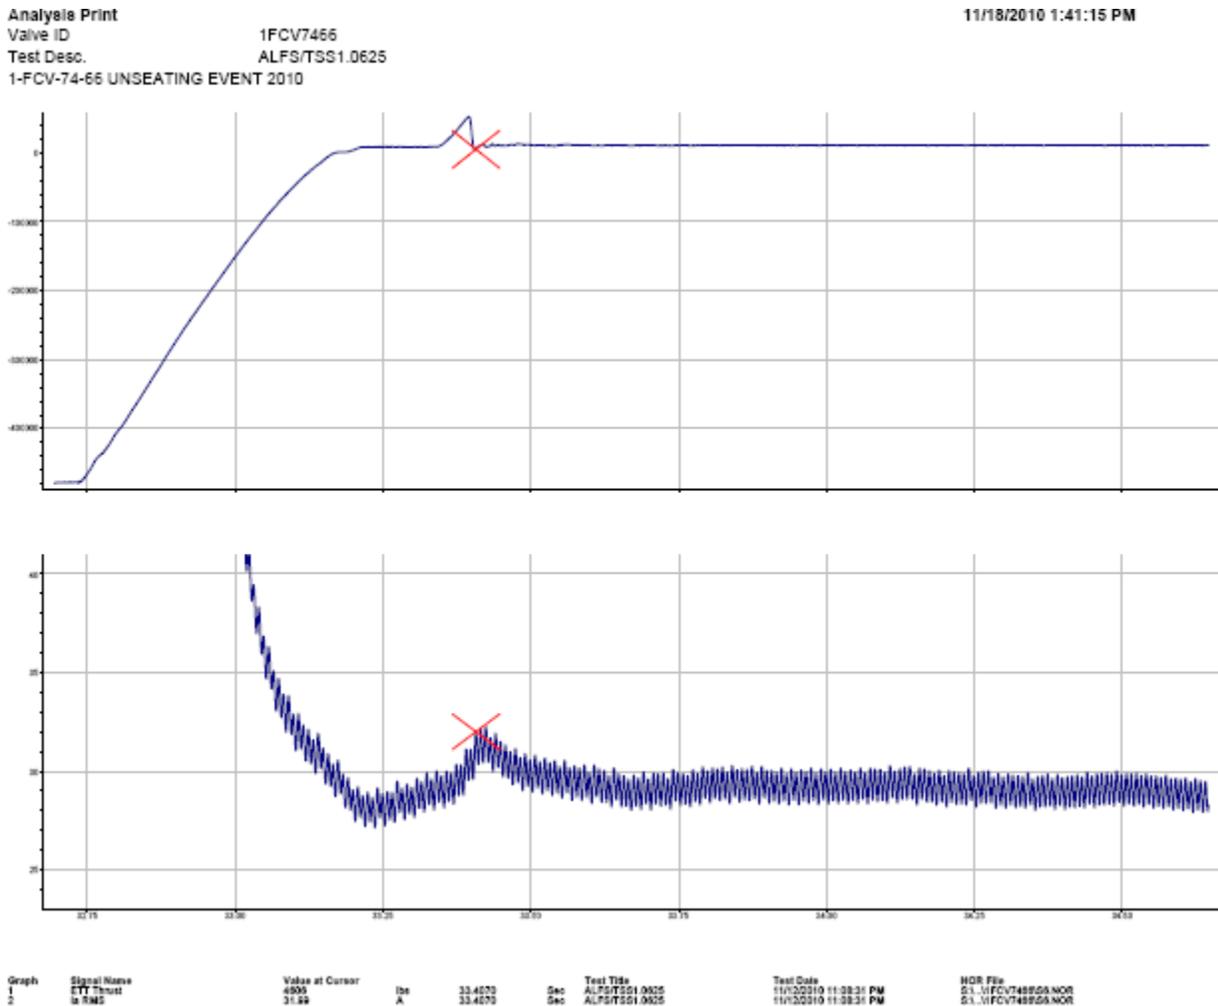
The 2010 MOVATS data taken for 1-FCV-74-66 after the repair are provided below and are also attached in the Root Cause Analysis.

NOTE: The X denotes the unseating of the valve disc.

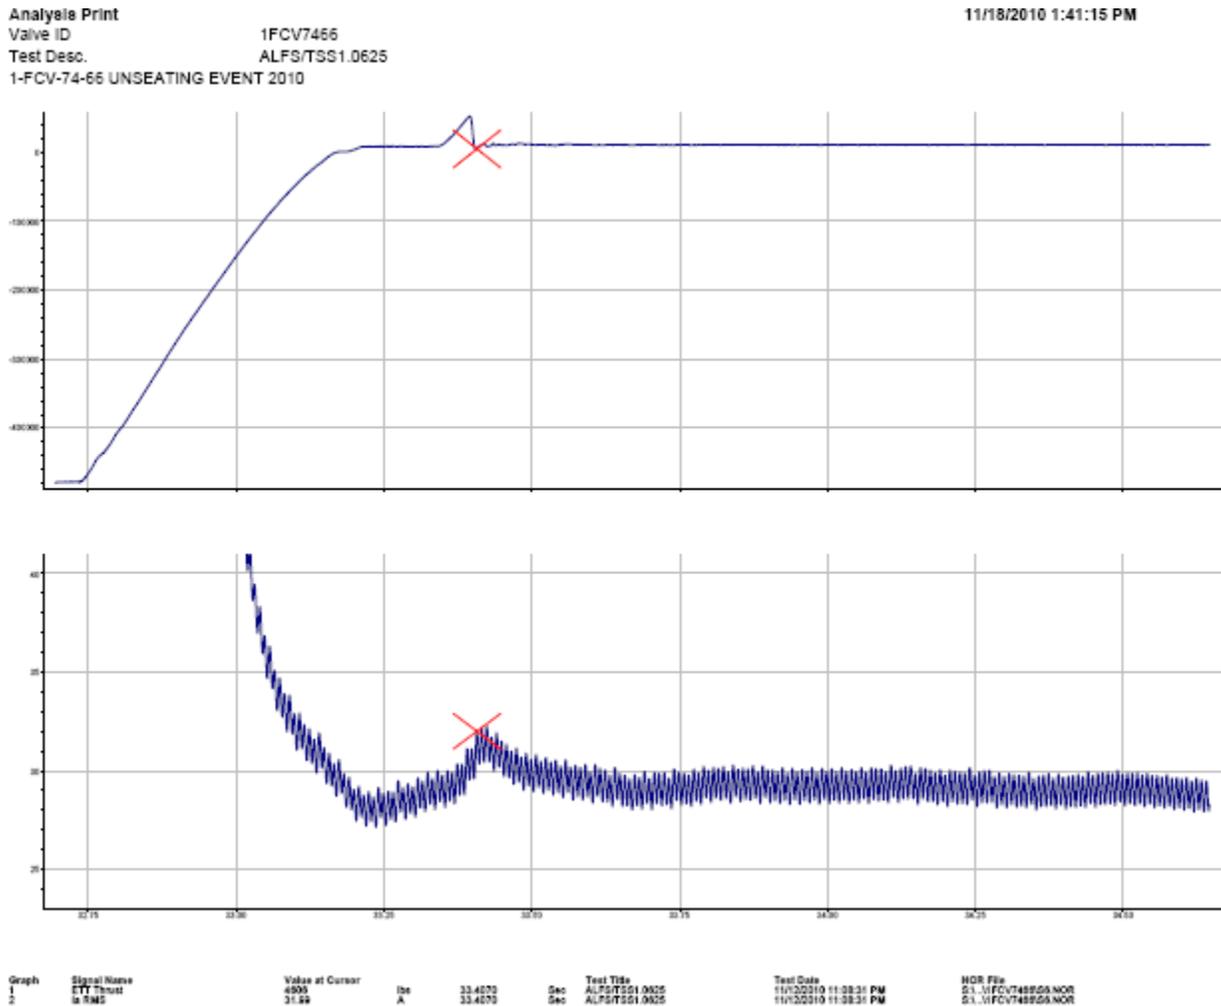
The 2010 MOVATS data taken for 1-FCV-74-66 after the repair are provided below and are also attached in the Root Cause Analysis.

NOTE: The X denotes the unseating of the valve disc.
