Enclosure: IE Circular
No. 77-06, "Effects of
Hydraulic Fluid on
Electrical Cables"

EFFECTS OF HYDRAULIC FLUID ON ELECTRICAL CABLES

Reference: Quad-Cities Nuclear Power Station
Docket No. 50-265, DPR-30, Unit 2

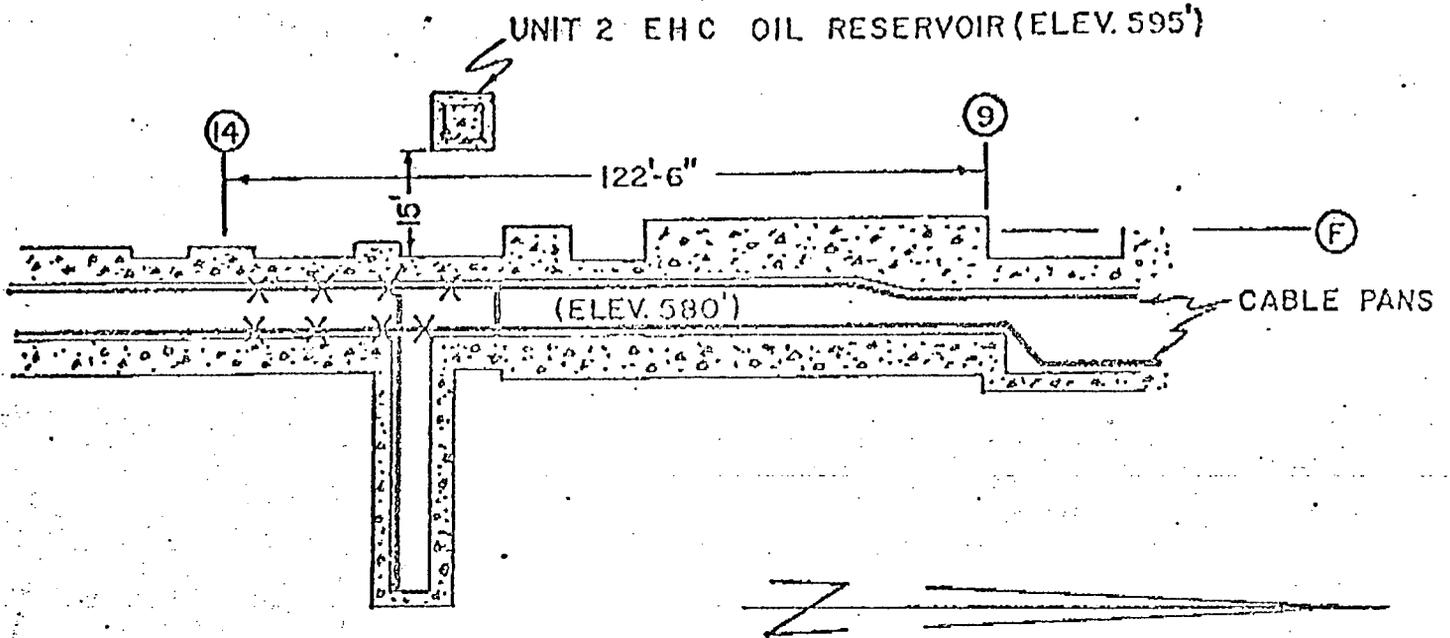
FIGURE. 1

Figure 1 shows the approximate locations where EHC fluid accumulated. Figure 2 illustrates the postulated path of EHC fluid migration from the EHC fluid reservoir to the Unit 2 cable tunnel area. The accumulation of EHC fluid around the EHC fluid reservoir foundation, and subsequent migration between the finish floor and rough slab, via small cracks in the concrete, is the postulated cause of the EHC fluid problem.

X- DENOTES AREAS WHERE THE EHC OIL HAD ACCUMULATED
REFERENCE DRAWING - SARGENT & LUNDY M-5

At the present time, all the cables in the affected area of the Unit 2 cable tunnel are being protected from the continuing EHC fluid leakage. The leakage has subsided and once it has stopped the ceiling area will be cleaned and a protective sealer will be applied to prevent any possible leakages.

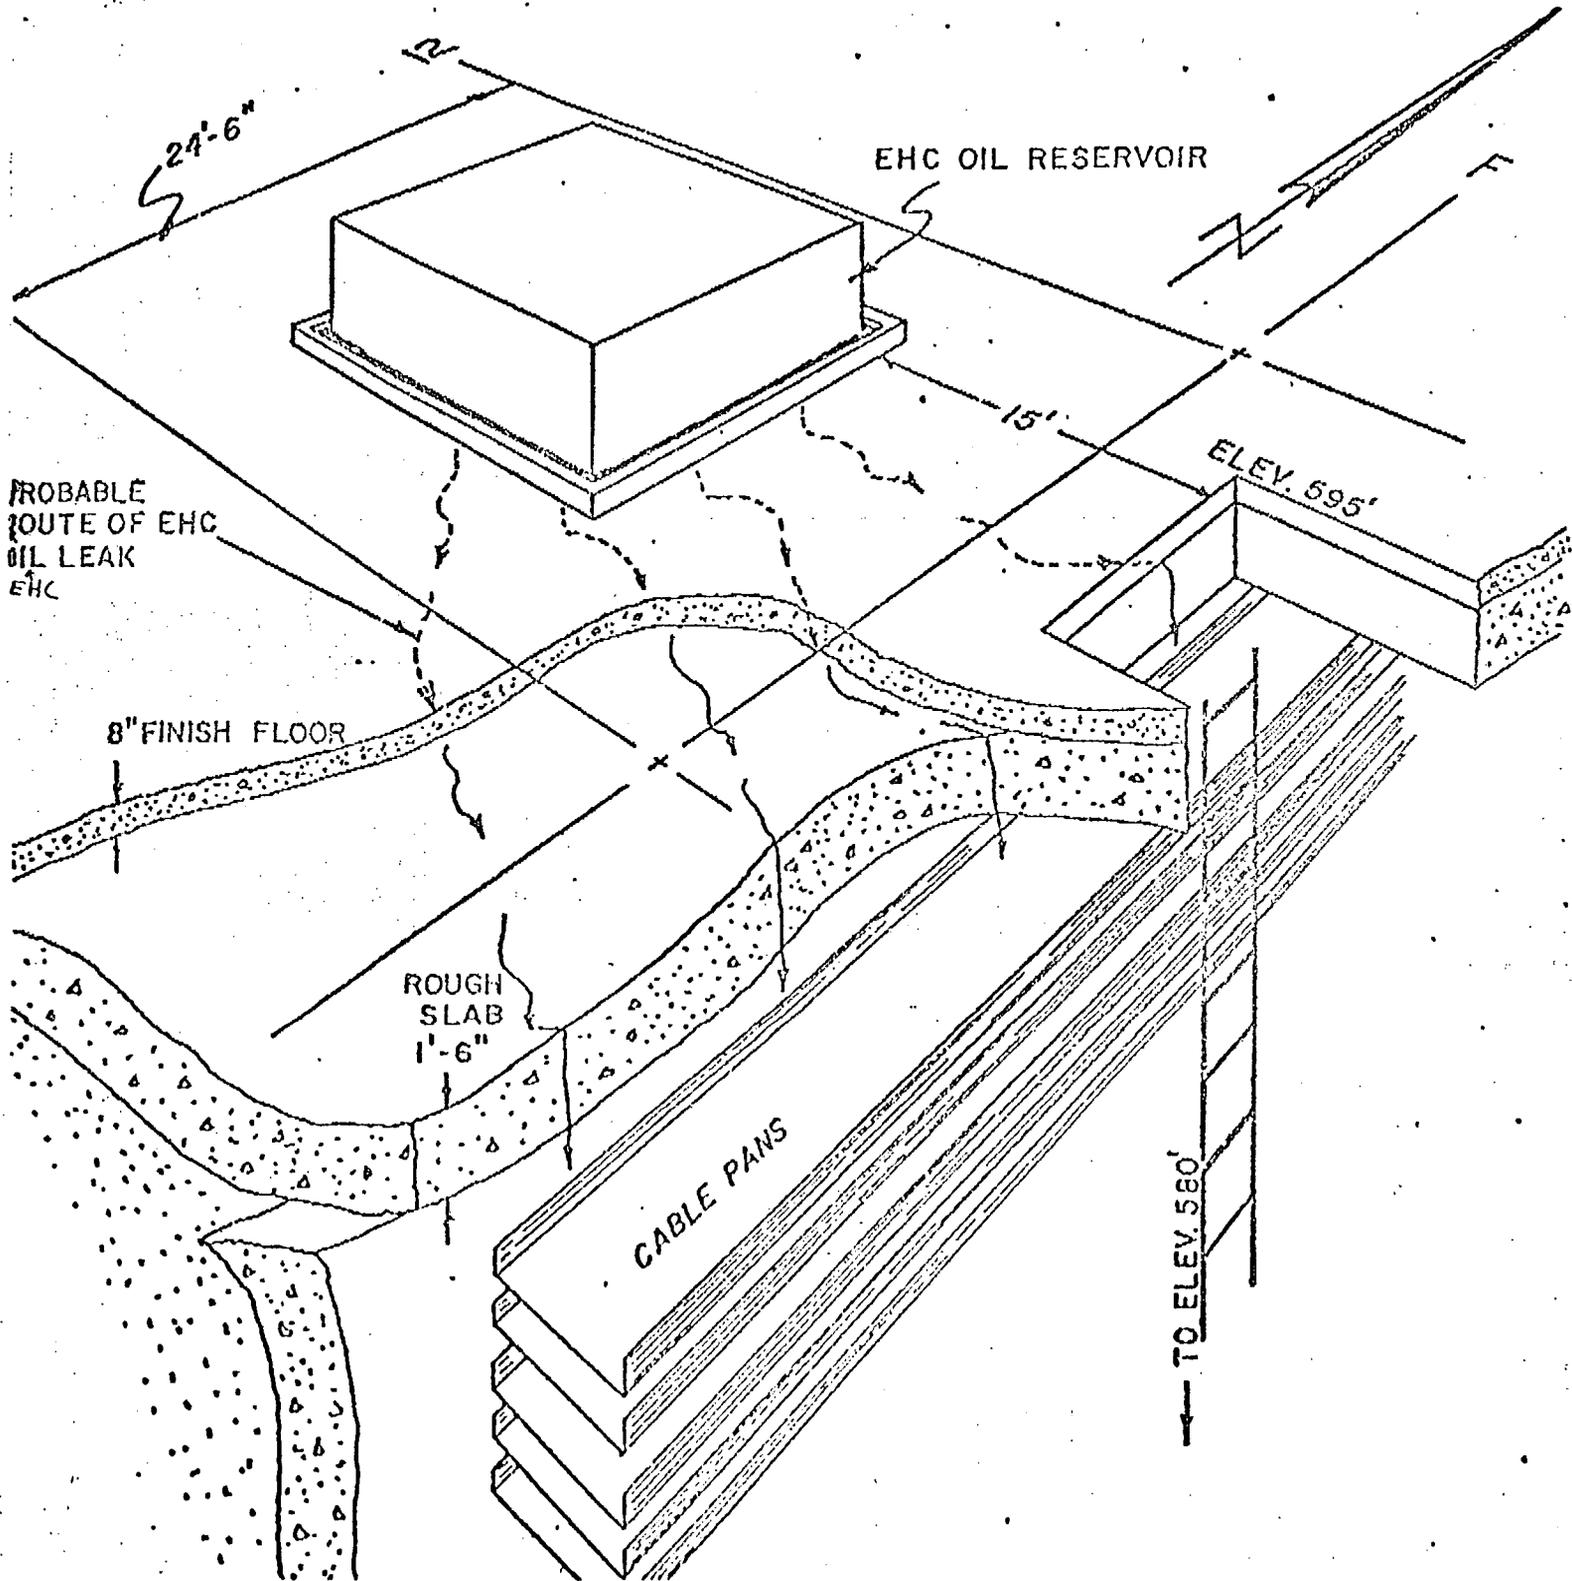
FIGURE. 2

The rough slab serves as the ceiling in the Unit 2 cable tunnel and minor small cracks in the ceiling served as a leak path out of the concrete and onto the cable trays and floor. Portions of cables within these trays thus became saturated with the EHC fluid.

The upper cable trays did not contain all of the EHC fluid, even though the pans in the cable tunnel were of solid bottom construction. This was because the EHC fluid had leaked through the cable pan connecting joints and thus all the cable pans below were subjected to the EHC fluid. The cables closest to the bottom of the cable pans were most affected by the EHC fluid because these cables were in constant saturation with EHC fluid.

The EHC fluid reservoir foundation must also be sealed with the same protective sealer once leakages have been resolved. The sealer has been ordered from the Carbolite Company, type 187 HFP, which is a recommended EHC fluid sealant.
