U.S. NUCLEAR REGULATORY COMMISSION  
OFFICE OF INSPECTION AND ENFORCEMENT

IE Bulletin No. 78-05

**MALFUNCTIONING OF CIRCUIT BREAKER AUXILIARY CONTACT MECHANISM -  
GENERAL ELECTRIC MODEL CR105X**

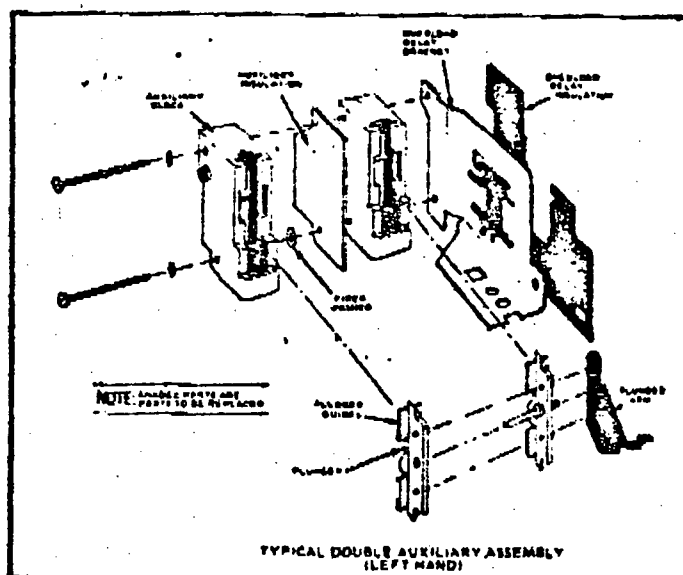
FIGURE 2

The Sacramento Municipal Utility District recently reported a problem encountered with the operation of the GE Model CR105X auxiliary contact mechanism installed in a 480 volt circuit breaker. Investigation into the cause for the inability to shutdown a booster supply fan (SF-A-7) in the control room emergency air conditioning system revealed that an auxiliary contact (GE Model CR105X) had failed in the closed position, preventing the fan's power supply circuit breaker from opening. The specific cause for failure was binding of the plunger arm due to burrs and nicks on its surface.

#### CHANGING PLUNGER ARM & INSULATION (SEE FIG. 2)

1. Slide plunger assembly out of auxiliary contact block, by lifting up and out.
2. Select the new plunger arm that is bent the same way as the one installed.

3. Loosen screw on plunger to release metal arm but DO NOT REMOVE SCREW FROM PHENOLIC PLUNGER (OR PLUNGERS).
4. Mount new plunger arm on plunger. Fasten arm to plunger with screw (or plunger post if installing double aux. blocks).

5. Apply thin coat of aeroshell grease along plunger guides.
6. Reinstall plunger assembly in contact block.
7. Reassemble overload to mounting bracket. Remove overload insulation and install new. (NOTE: Overload insulation must be removed and replaced with new insulation supplied with kit.)

8. Remount complete assembly on contactor base.
9. Reconnect any wires previously removed.
10. Reassemble magnet assembly to contact base (on reversers or multispeeds be sure to interlock this assembly with mechanical interlock arm. Check for free movement of armature assemblies and mechanical interlocks).

11. Observe that auxiliary contact plunger assemblies are operating properly.
