Screen No. 11-010

Facility Name: TMI-2 ISFSI

Change No.: EDF-9897

Activity Description: EDF-9897 is developed to document the 2010 HSM and base mat concrete field inspection and evaluation performed August and September 2010. This EDF documents with photographs and description the concrete condition in 2010. The annual field inspection is a recommendation in EDF-8903 and EDF-9516 to assure noted cracking has not developed to a point that it might affect the structural capacity, radiation shielding capacity, or thermal capacity HSM safety functions. These photographs are used to compare any change that may have occurred since the 2008 concrete evaluation documented in EDF-8903 and the WJE inspection documented in EDF-9516. During this inspection notable active cracking and efflorescence growth was observed in new and exiting locations indicating cracking is active. The polyurethane foam recommended in EDF-9516 has been installed. Since the structural capacity has not been reduced and no concrete thickness has been lost, neither the structural capacity, radiation shielding capacity or thermal capacity of the HSM affecting the safety functions of the HSM has been changed.

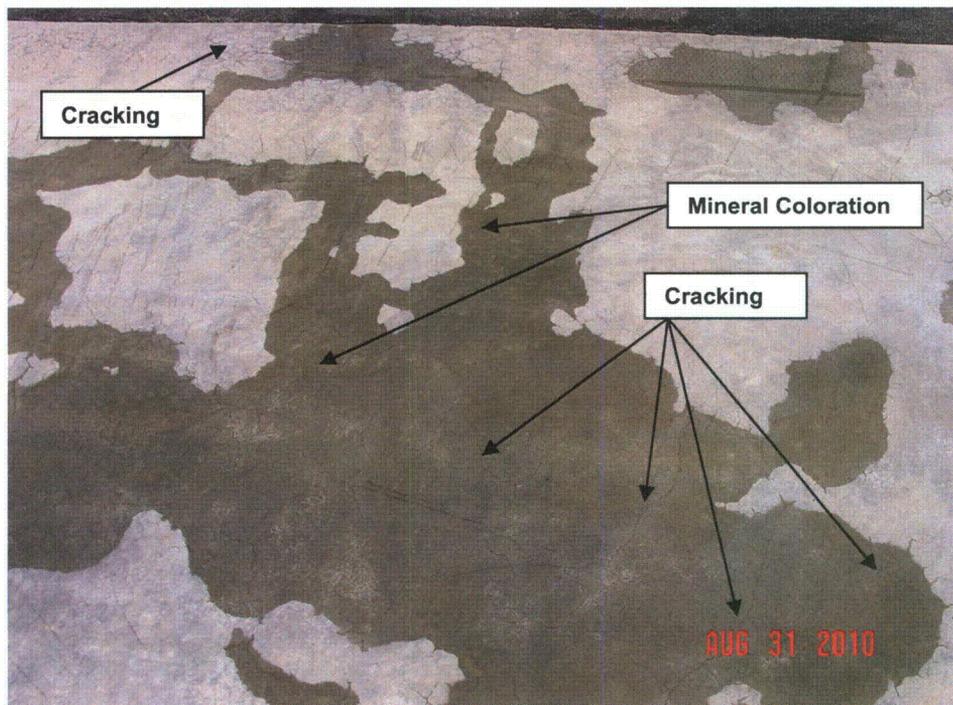
North West Corner Base Mat – Photo 1 of 3

Crack growth continues through out the base mat. This is an indication that cracking is active, water is being frozen in the existing cracks continuing to force crack growth. Crack severity ranges from 1 very slight to 3 moderate. (Appendix B)
