U.S. NUCLEAR REGULATORY COMMISSION  
OFFICE OF INSPECTION AND ENFORCEMENT  
REGION III

IE Circular No. 78-18  
November 6, 1978

UL FIRE TEST

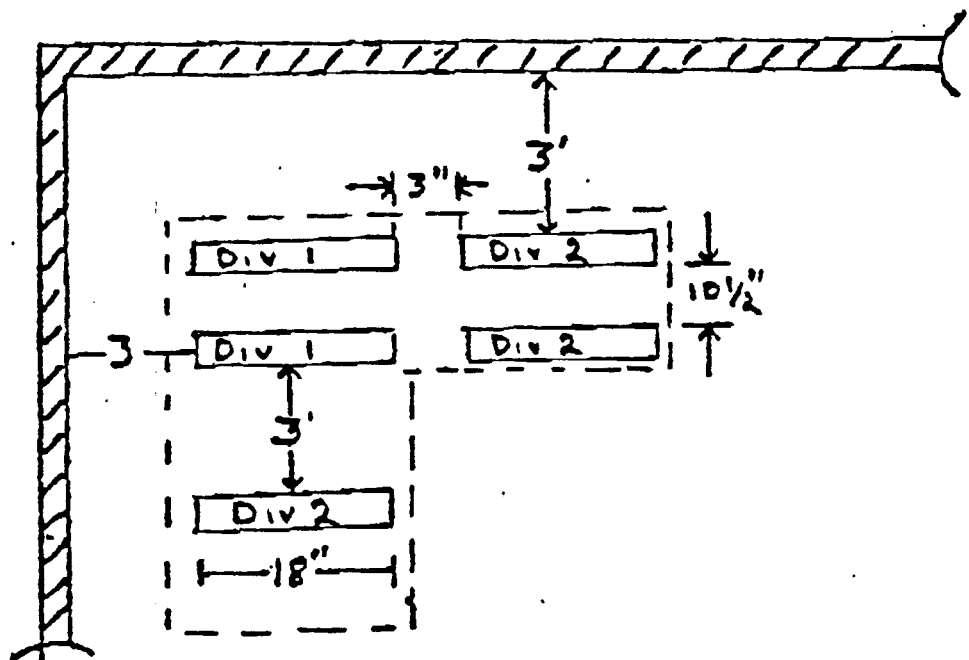
Figure 1

Preliminary information indicates that the flammable liquid or flames penetrated the protective barriers at the bottom of the vertical trays and caused fire damage to the polyvinyl chloride insulation on cables in four of the five trays.

The most probable cause of the fire damage in certain cable trays appears to be related to the absorption or seepage of heptane under the ceramic fiber blanket at the juncture with the floor. Once the heptane entered the interior regions of the cable tray, then ignition apparently occurred via the small opening at the floor or through a vapor/air path within the joints. There is some indication that some cable damage was caused by absorption of heptane on the inside of the barrier (wicking effect) and its ignition which heated a cable tray ladder rung, causing damage to a cable in contact with the rung. The ingress of the heptane into the ceramic fiber needs to be further evaluated since this appears to be the most significant failure mode.

Vertical Tray Corner Test

1. To protect against spills of flammable liquids, barriers or curbs may be needed to prevent entry of the flammable liquid behind fire barriers. A wick effect may also need to be considered in the design of fire barriers.
2. Some small fires may not actuate sprinkler heads. To reduce this possibility in sprinkler systems to be installed, fast response sprinkler heads should be considered (less than approximately 3 minutes in the UL Standard 199 "Automatic Sprinklers for Fire Protection Service").
3. The location of the fire detection devices and the sprinkler heads relative to the fire and components being protected is of great importance. The path of the air movement in the area influences the actuation of such devices and should be considered in the system layout.
