SUBJECT: Forwards response to notice of violation noted in Insp Rept
 50-331/89-19. Corrective actions: comprehensive reinspection.

Subject: Duane Arnold Energy Center
Docket No.: 50-331
Op. License No: DPR-49
Environmental Qualification Issues
Reference: Letter from D. Mineck (Iowa Electric)
to A. Davis (NRC), dated October 20, 1989
(NG-89-3121)
File: A-103, A-64

Iowa Electric Light and Power Company
Response to Notice of Violation
Transmitted with Inspection Report 89-019

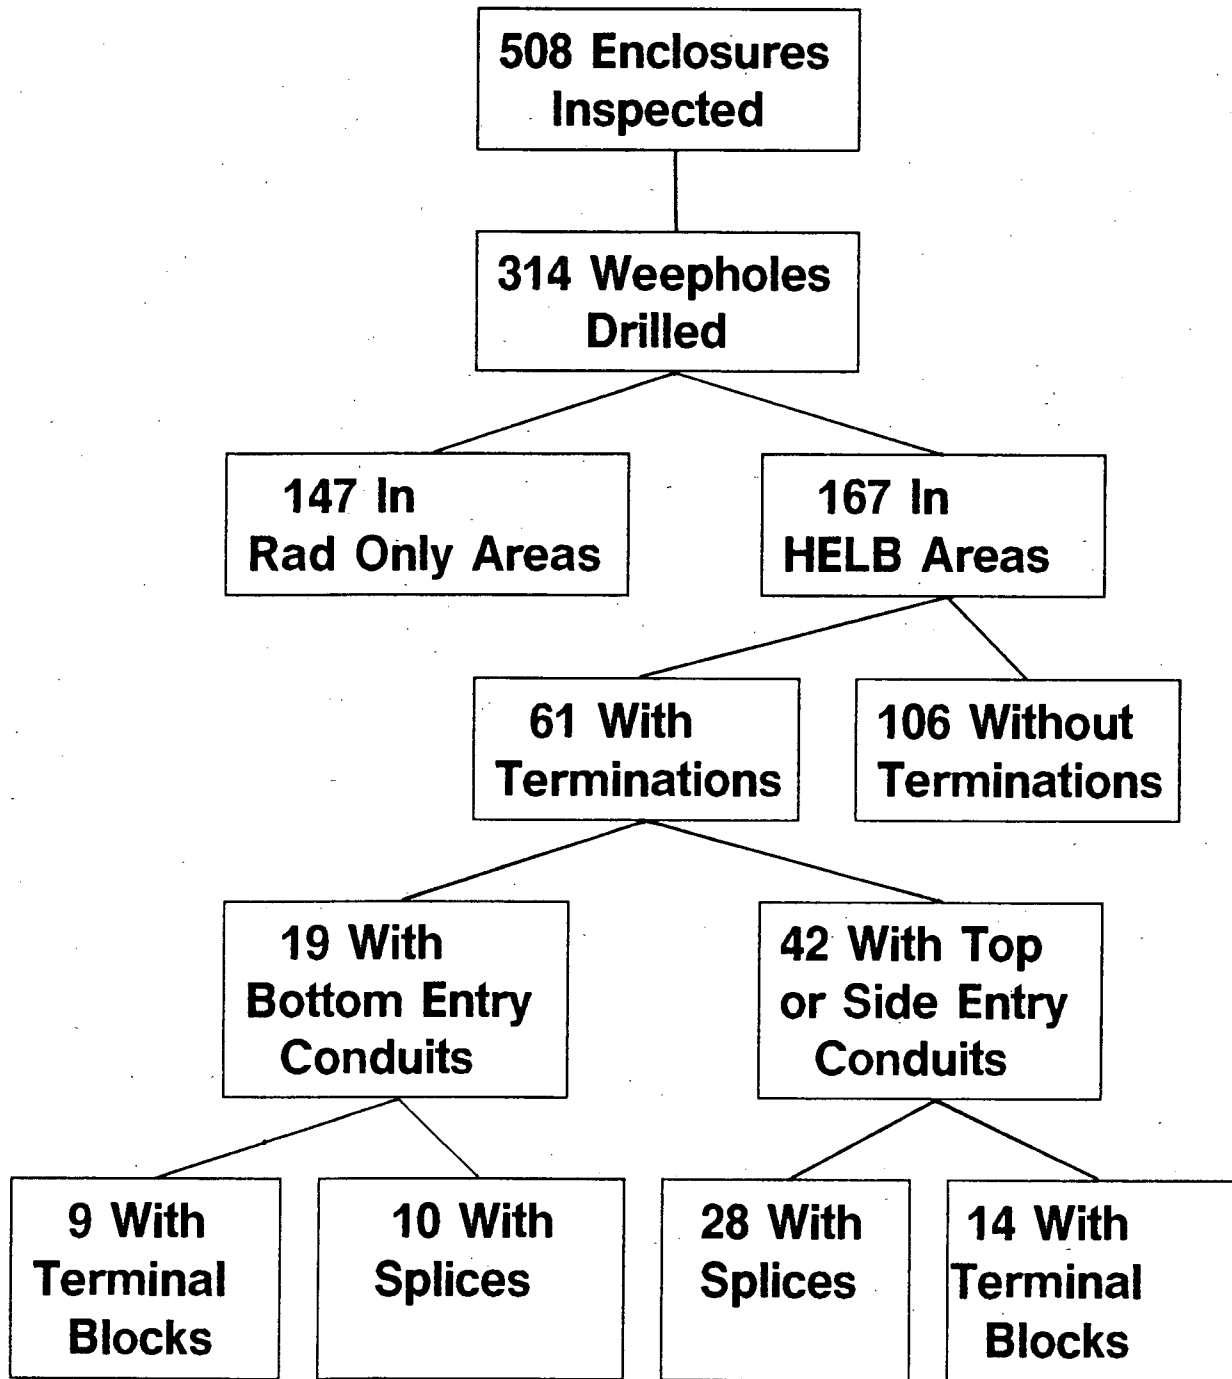
Figure 1

In the most-recent inspection program, previously described, the teams to were instructed ensure that electrical enclosures (junction boxes, field option boxes, pull boxes, and condulets) located in EQ harsh areas had proper drainage paths. The engineering members of the inspection teams evaluated the installation geometry and determined whether the enclosure would allow moisture accumulation, i.e., some configurations had a natural drainage path, such as condulets with bottom exit points. If the enclosure was susceptible to internal flooding and had no drainage point (weep hole), the team provided one. In addition, weep holes were added to enclosures in areas designated EQ harsh for radiation only. We decided to add weep holes to enclosures in both HELB and radiation-only areas even though, in many cases, an engineering evaluation of the installed geometry could have demonstrated that submergence of the components within the enclosure was not possible and, therefore, a weep hole would not be needed.

Summary of Weepholes Drilled
