Pressurized Water Reactor
B&W Technology
Crosstraining Course Manual

Chapter 11.0

ANO-1 Partial Loss of Flow

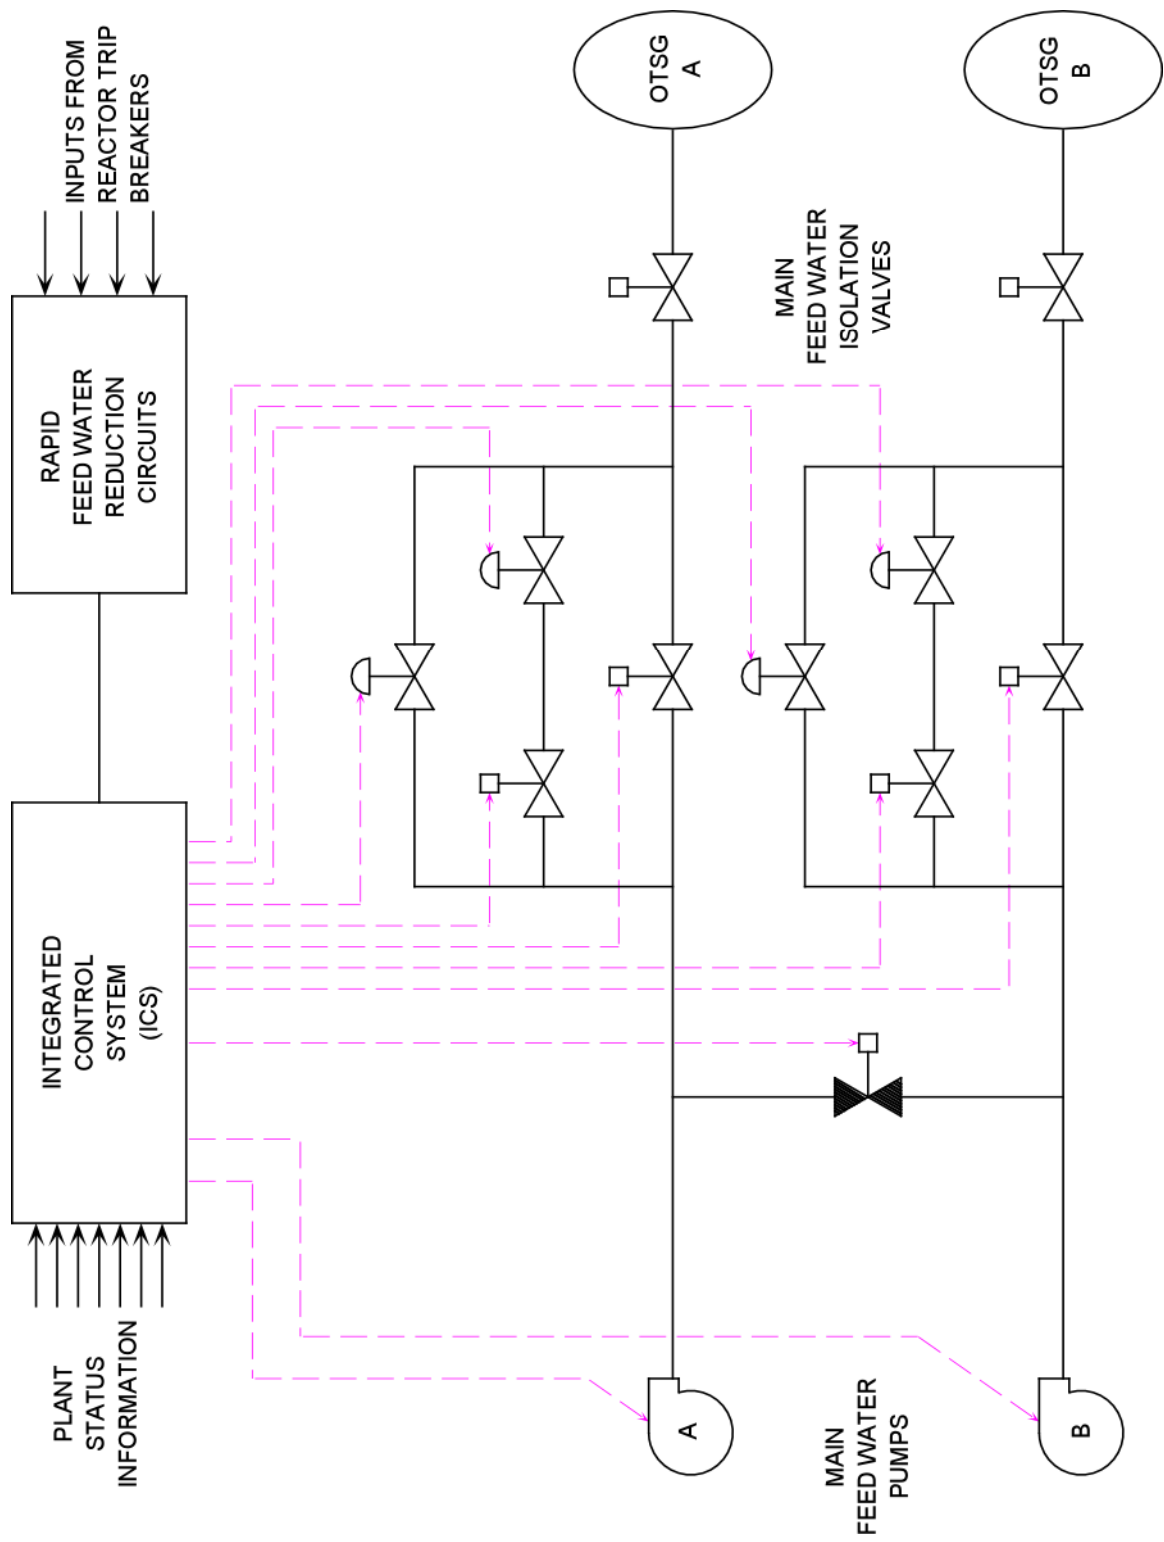
Figure 11-1 Rapid Feedwater Reduction Circuits Interface With ICS and Main Feedwater System

During normal operations, feedwater flow is controlled by the integrated control system (ICS) using startup control valves (SUCVs) from 0% to 15% power, low load control valves (LLCVs) from 15% to 50% power, and feed pump speed control from 50% to 100% power. Following a reactor trip, the rapid feedwater reduction (RFR) circuits provide signals to the integrated control system (ICS) to close SUCVs and LLCVs and runback the speed of the main feedwater pumps. Figure 11-1 shows the relationships between the RFR circuits, the ICS, and the feedwater pumps and valves.

In the ANO-1 event, the SUCVs and the LLCVs remained open and one of the feedwater pumps did not run back. In addition, the main feedwater block valve associated with the failed pump did not close. These failures all contributed to the overfeeding of an OTSG which caused an overcooling of the reactor coolant system. The failure of the SUCVs and LLCVs was due to a wiring error during installation of the RFR circuits. The ICS operated as designed. The output signals from the ICS and RFR circuits to decrease feedwater pump speed and close the main feedwater block valve were correct. The feedwater pump problem may have been a failure in the pump controller or the turbine steam supply. The main feedwater block valve started to close as designed, but stopped

on mechanical overload. A change in the torque switch setting may solve the problem in the future.

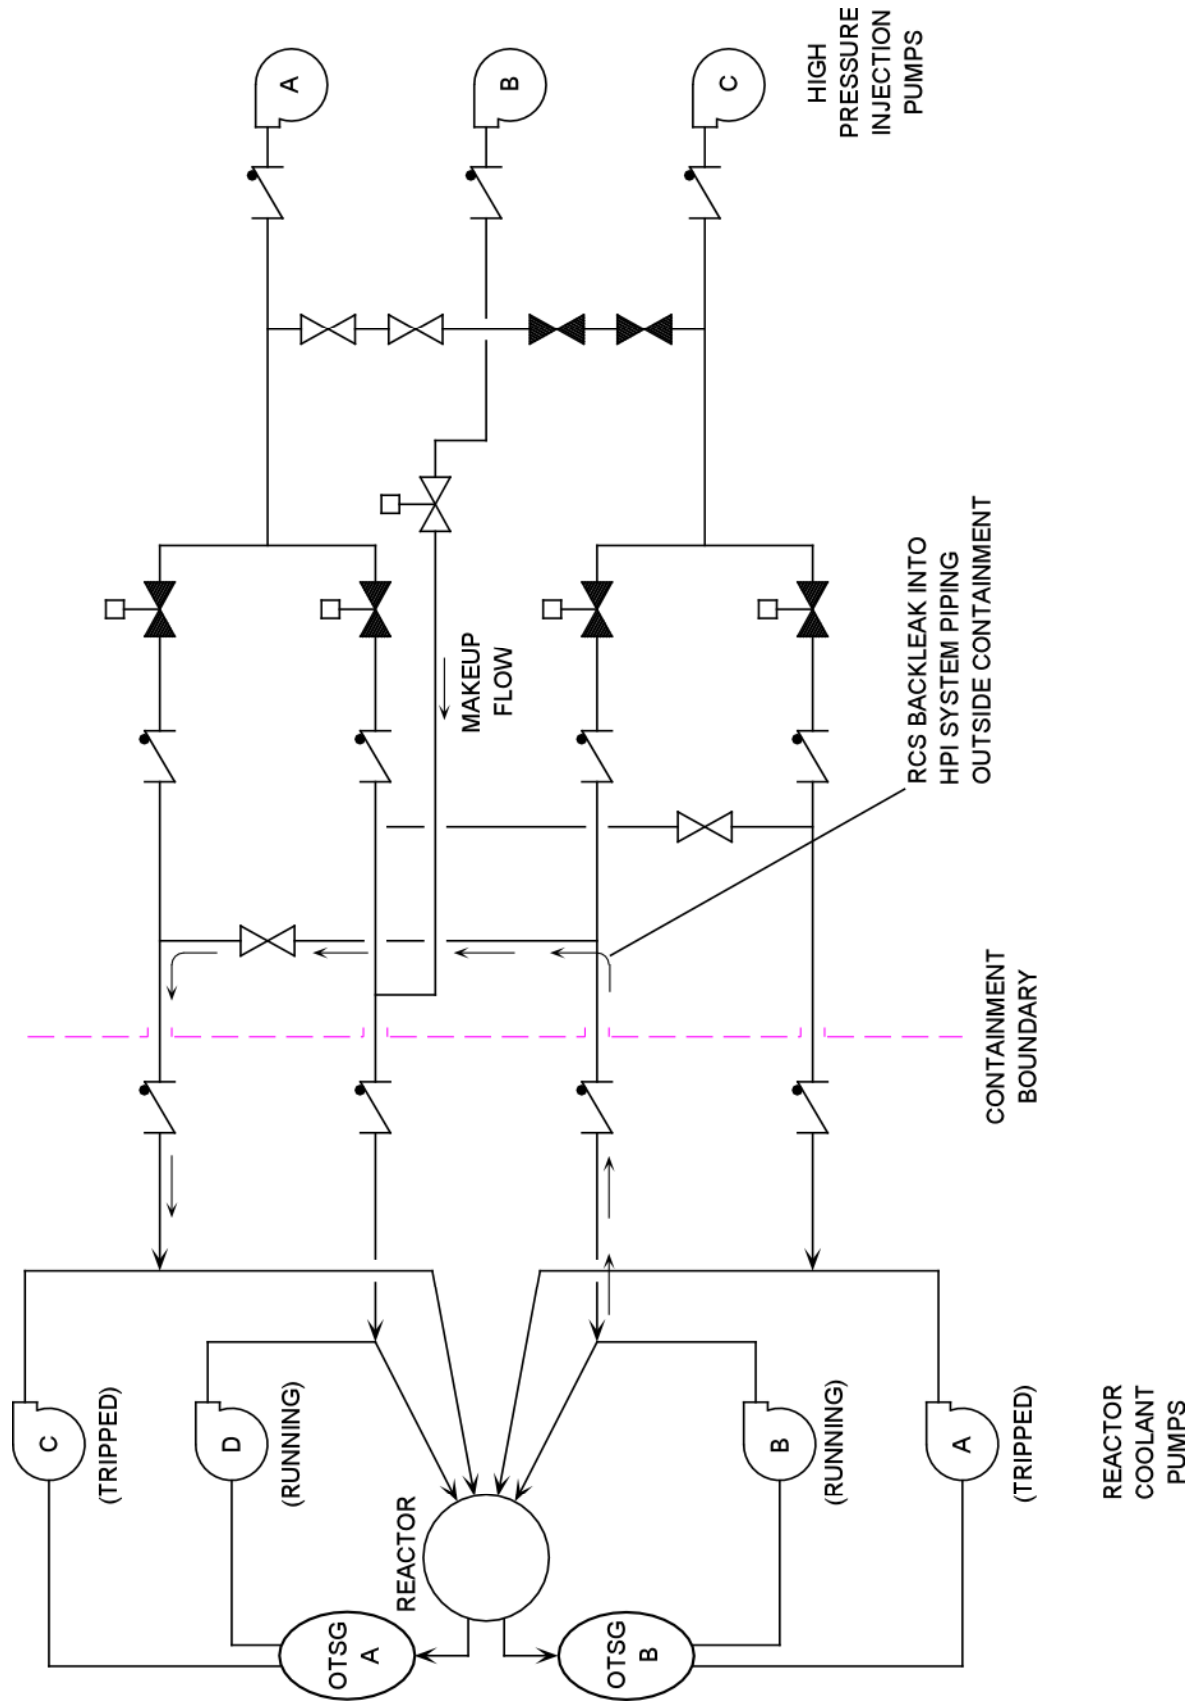
Figure 11-2 High Pressure Injection System

The overcooling caused by the feedwater system malfunctions made the pressurizer level decrease, and the operators manually started high pressure injection. After two minutes, high pressure injection was secured, but the check valve in the “B” injection line did not reseal. Due to the fact that two reactor coolant pumps were tripped and two were running, a differential pressure was created across high pressure injection lines. The “B” and “C” lines are cross connected, and with the “B” reactor coolant pump running and the “C” pump stopped, the check valve in the “B” injection line was needed to stop flow in the cross connect line. The failure of the check valve allowed hot reactor coolant to flow in a high pressure injection cross connect line and back into the reactor coolant system as shown in Figure 11-2. The discovery was made when a fire alarm activated in a penetration area. The “B” and “C” injection lines were found to be hot. This is of concern because the piping in the injection system is rated for reactor coolant system pressure, but it is not rated for reactor coolant system temperature. Analysis has shown that stress limits were exceeded in certain locations in the cross connect line during the event.
