ANO-1 Partial Loss of Flow

Chapter 11.0
B&W Cross-Training Course
R-326C

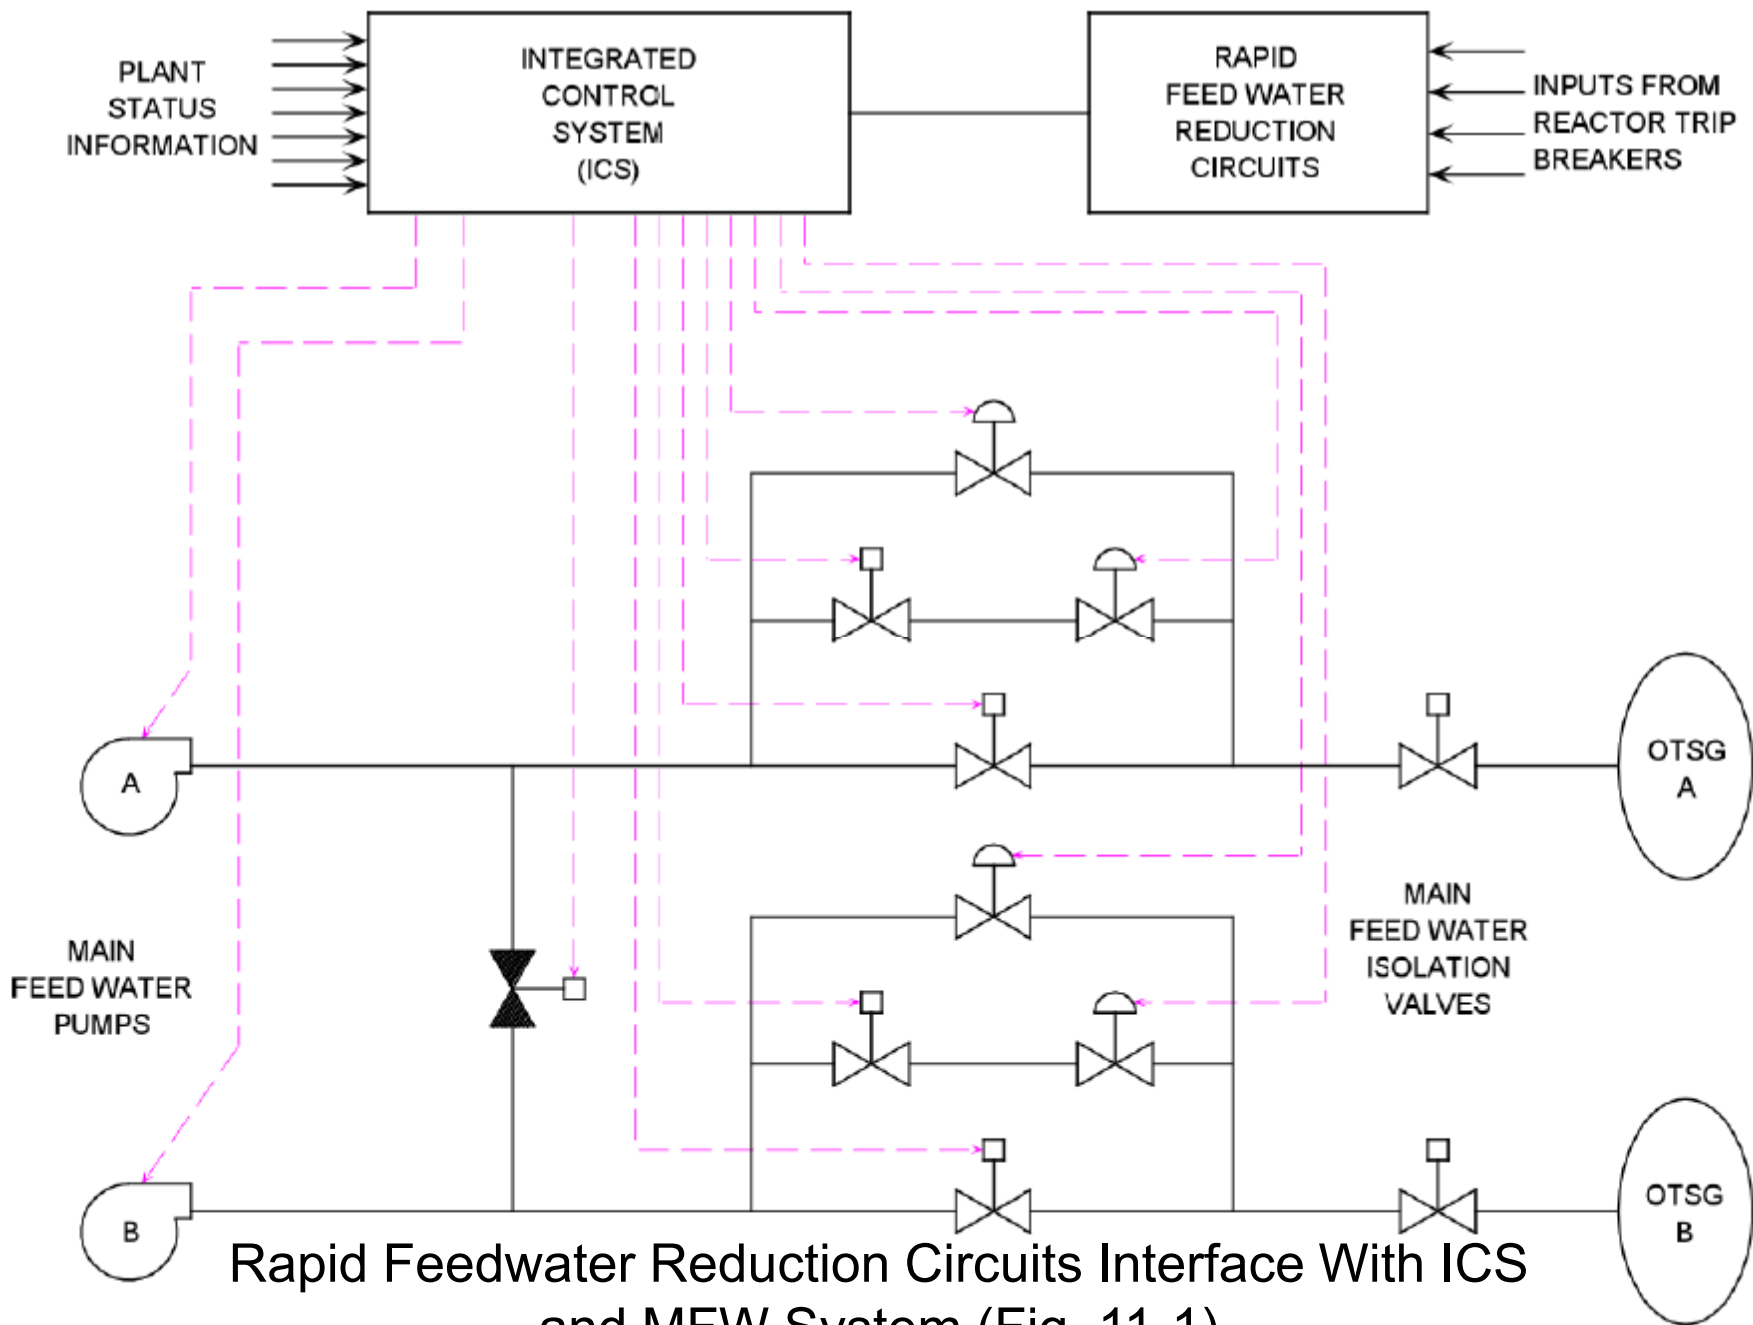
Rapid Feedwater Reduction Circuits Interface With ICS and MFW System (Fig. 11-1)

The main feedwater (MFW) system startup flow control valves (SUCVs CV-2623 and CV-2673) and low load flow control valves (LLCVs CV-2622 and CV-2672) fail to close as designed following the reactor trip, allowing continued MFW flow paths to each OTSG.

The “B” MFW pump (P1B) fails to runback to minimum speed as designed following the reactor trip.

The “B” MFW block valve (CV-2675) fails to close as designed following the reactor trip. The valve starts to close, but stops when the valve torque switch actuates before the valve closes.

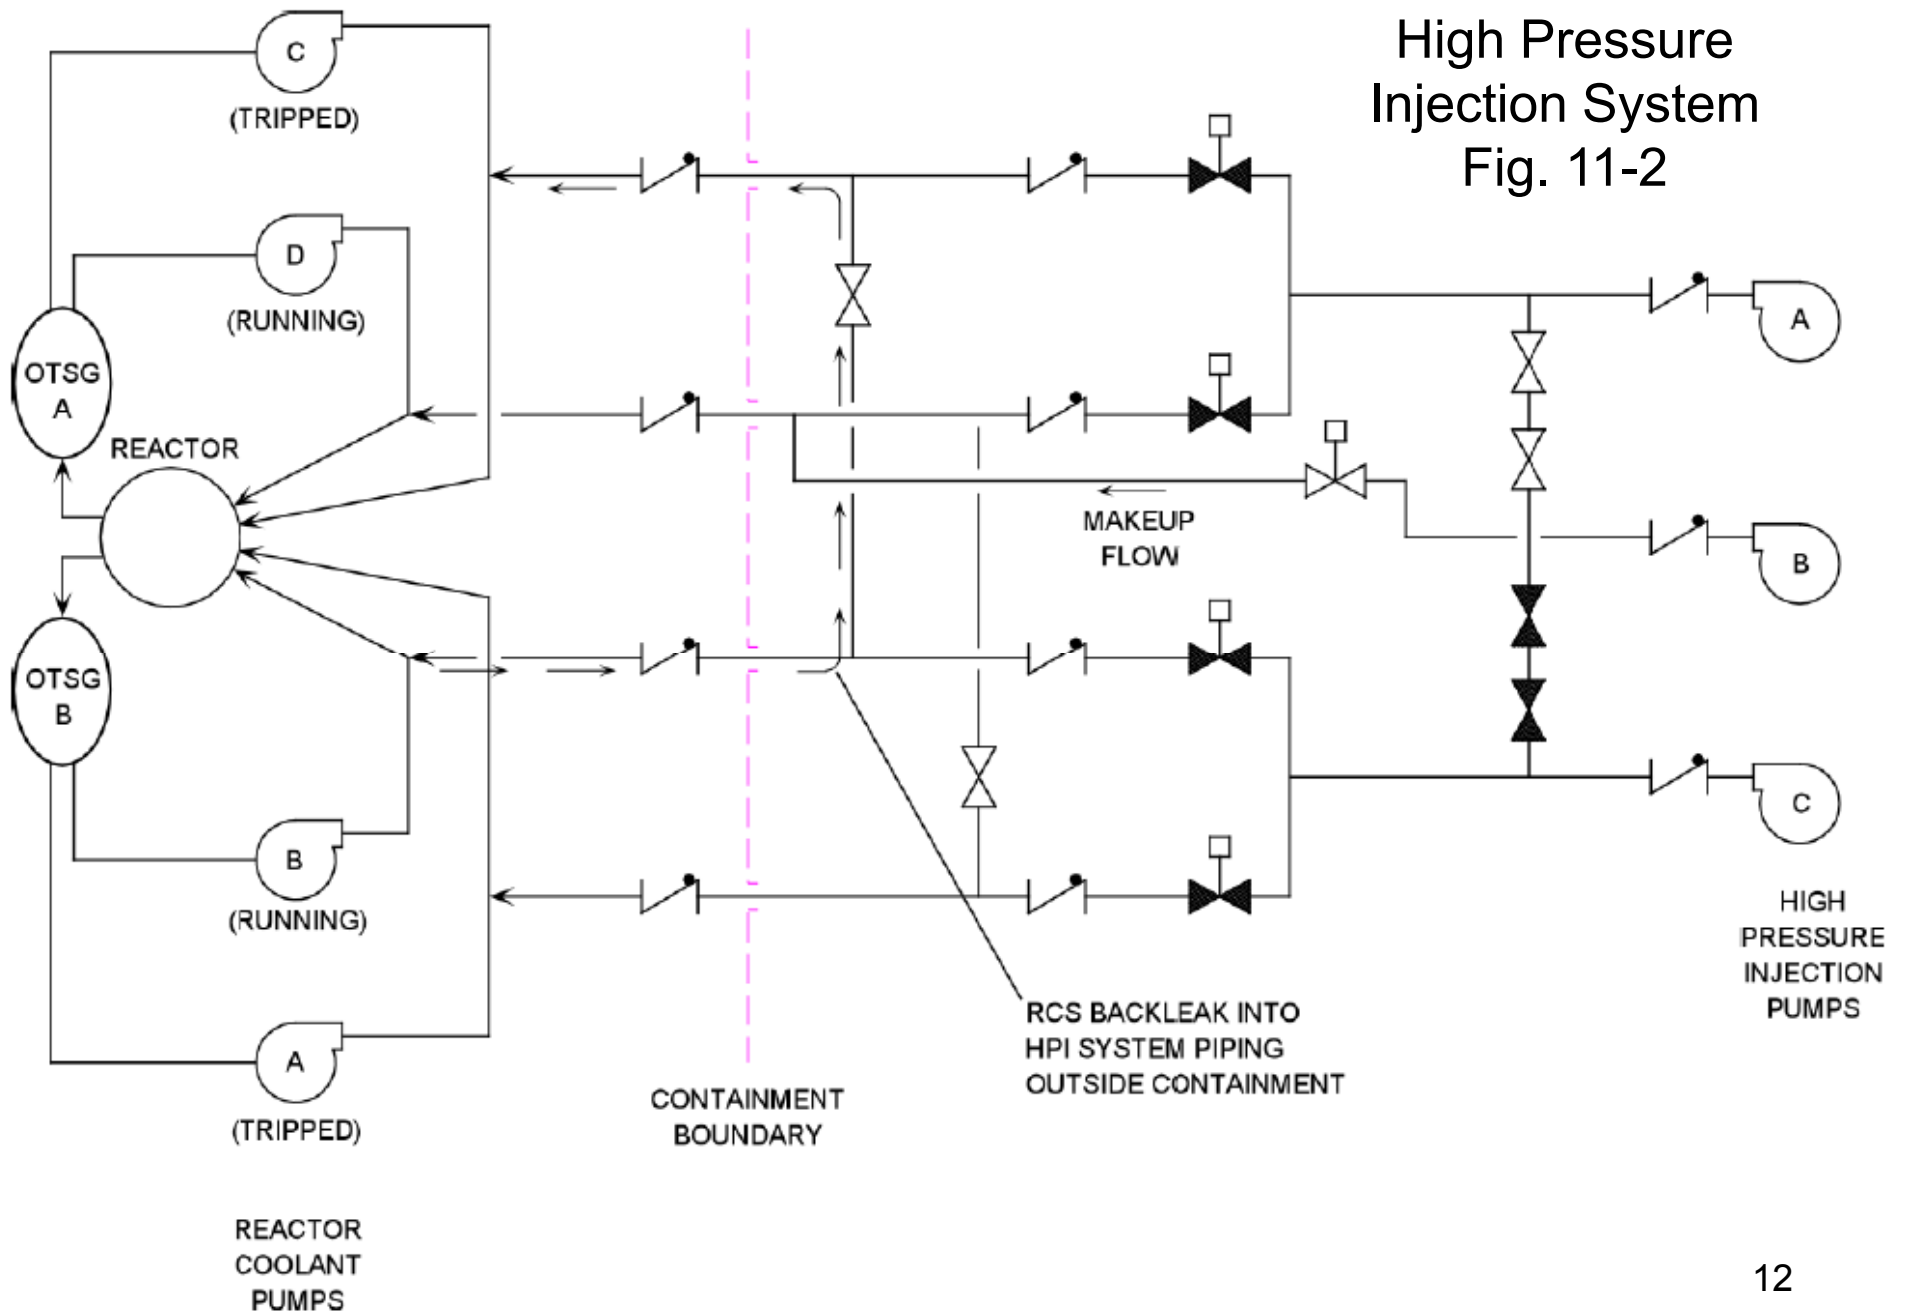
High Pressure Injection System
Fig. 11-2

(Exact time unknown) The operator dispatched to the UNPPR reports back to the control room by telephone that the temperature of the “B” and “C” HPI system injection lines, and the crossover line that connects them, is excessively high (more indicative of RCS temperature than the expected temperature of the borated water used for HPI). The smoke detector is believed to have been actuated when tape attached to the HPI piping began to melt and smolder/smoke. It was noted that this event could have gone undetected. The plant operators suspected that the high temperature in the HPI piping was caused by failure of Check Valve MU-34B to reseal after HPI Pump P36A was secured at 22:01:33. Check Valve MU-34B is located inside the reactor containment building. The leakage flow path was in the reverse direction through Check Valve MU-34B and outside the reactor containment building via the “B” HPI injection line, then through the crossover line to the “C” HPI injection line, and back inside the reactor containment building to the RCS. The upstream check valves (MU-1214 and MU-1215 in the “B” and “C” HPI injection lines respectively) performed as designed to prevent further backflow of reactor coolant into the HPI system piping.

Reactor Coolant Pumps “A” and “C” are restarted. It appears that restarting the pumps causes Check Valve MU-34B to reseal and/or removed the differential pressure which was driving the backflow, stopping the RCS back leakage into the HPI system piping. The waste control operator confirms that the piping was cooling off at this time.
