Pressurized Water Reactor
B&W Technology
Crosstraining Course Manual

Chapter 15.0

Rancho Seco Loss of ICS Power

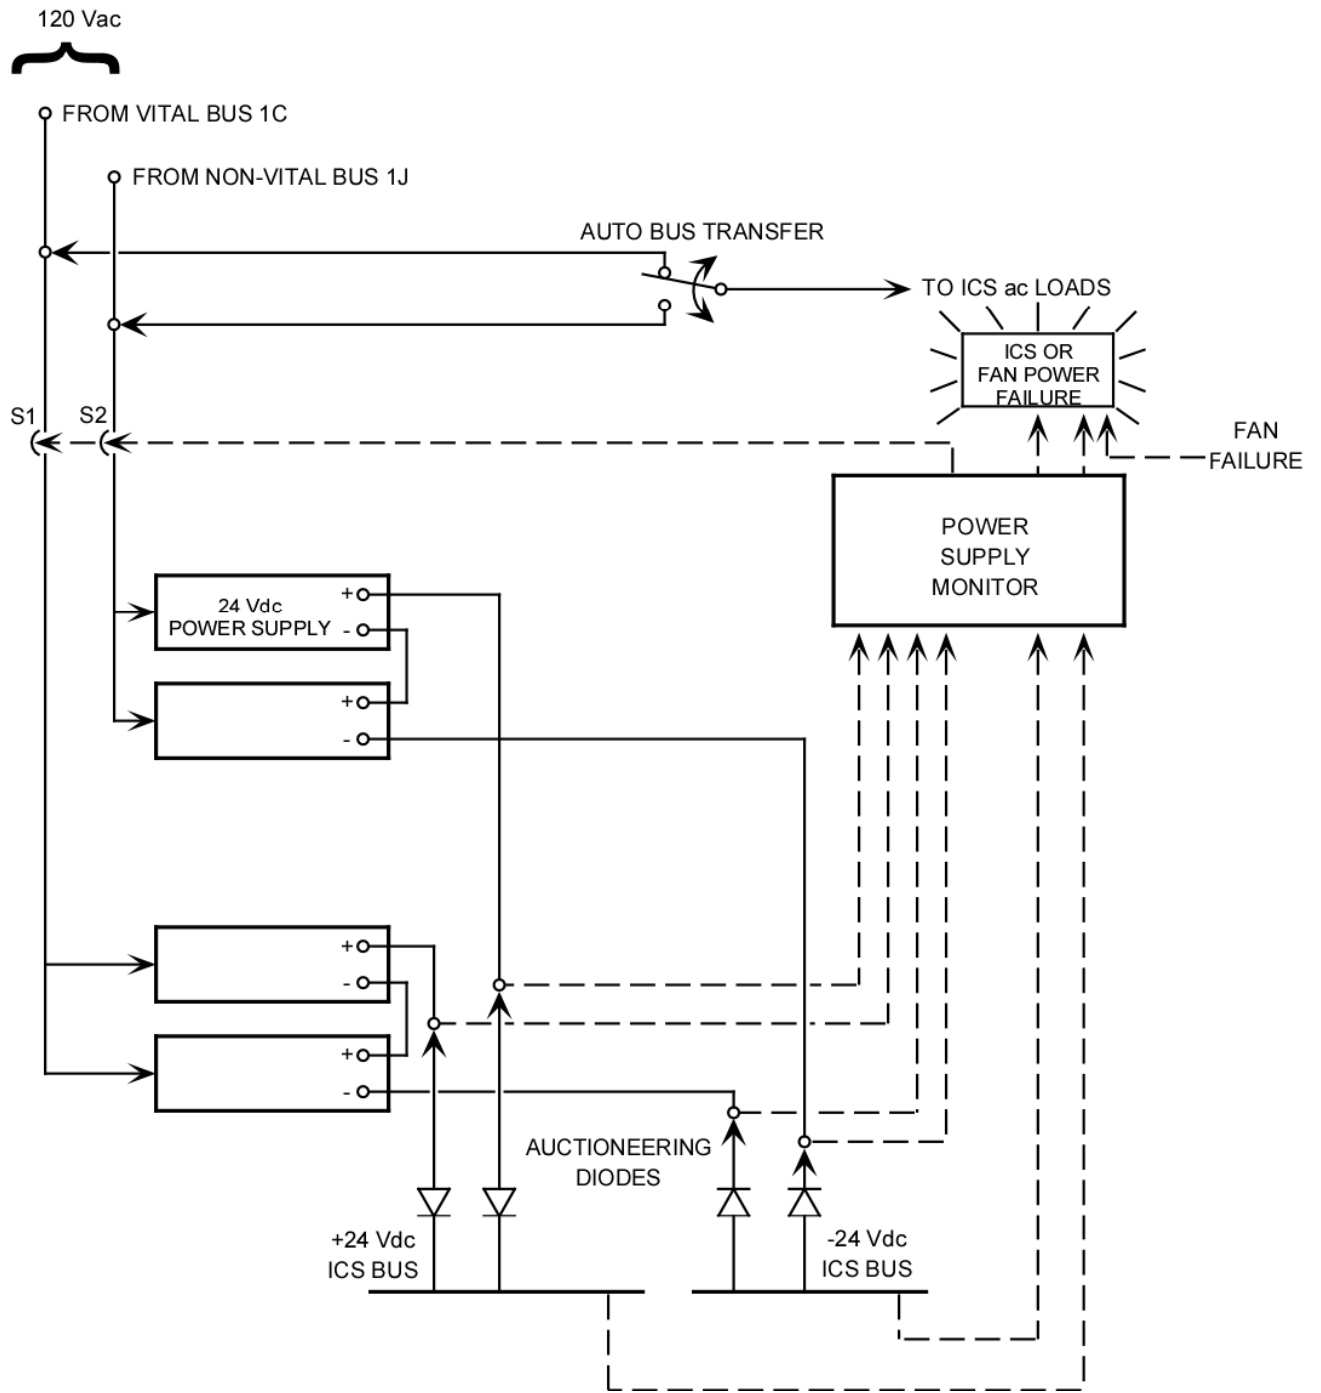
Figure 15-1 ICS Power Supplies

The loss of ICS dc power was caused by a failure of the power supply monitor which opened switches S1 and S2 (Figure 15-1). The loss of input power resulted in a zero voltage on the +/- 24-vdc busses in the ICS. At zero volts, the main feedwater regulating valves and the startup regulating valves assumed a 50% open position. Since voltage was lost, the main feedwater pumps dropped to minimum speed. With the reactor at 76% power and almost no feedwater flow to the once-through steam generators for RCS heat removal, an overheating event started even though the turbine bypass and atmospheric dump valves were 50% open due to the loss of ICS power. With reduced heat removal, the reactor's energy causes an increase in RCS temperatures. The increase in temperatures results in an increase in pressurizer pressure and pressure level. The pressurizer spray valve was manually opened in an effort to lower RCS pressure.

Early findings determined that the PSM trip setpoint was drifting. Significant to the event was the finding that small amounts of resistance, as little as one ohm, in series with the “sensed” voltage to the PSM could cause tripping of the PSM. During the troubleshooting process it was found that the time delay drop of switches S1 and S2 was much shorter than the manufacturer's tolerance.

During inspections of the physical wiring in the ICS cabinets, and in an attempt to identify the source of a possible increased input resistance, the technicians found that the input lead wire to the ± 24 Vdc monitor had an improperly crimped connection at the +24 volt bus bar in cabinet one. In fact, the lug fell free from the wire when it was disconnected from the bus. This wire is an internal cabinet wire installed by the vendor prior to delivery of the cabinets.

Following the discovery of the improperly crimped connection, the Quality Control group inspected the remainder of the factory and field wire terminations in ICS and NNI cabinets, and found numerous deficiencies in the quality of the wire terminations in these cabinets. The root cause for the loss of the ICS power was identified as the loose connection. The factory bus wiring has been replaced with current standard wiring.

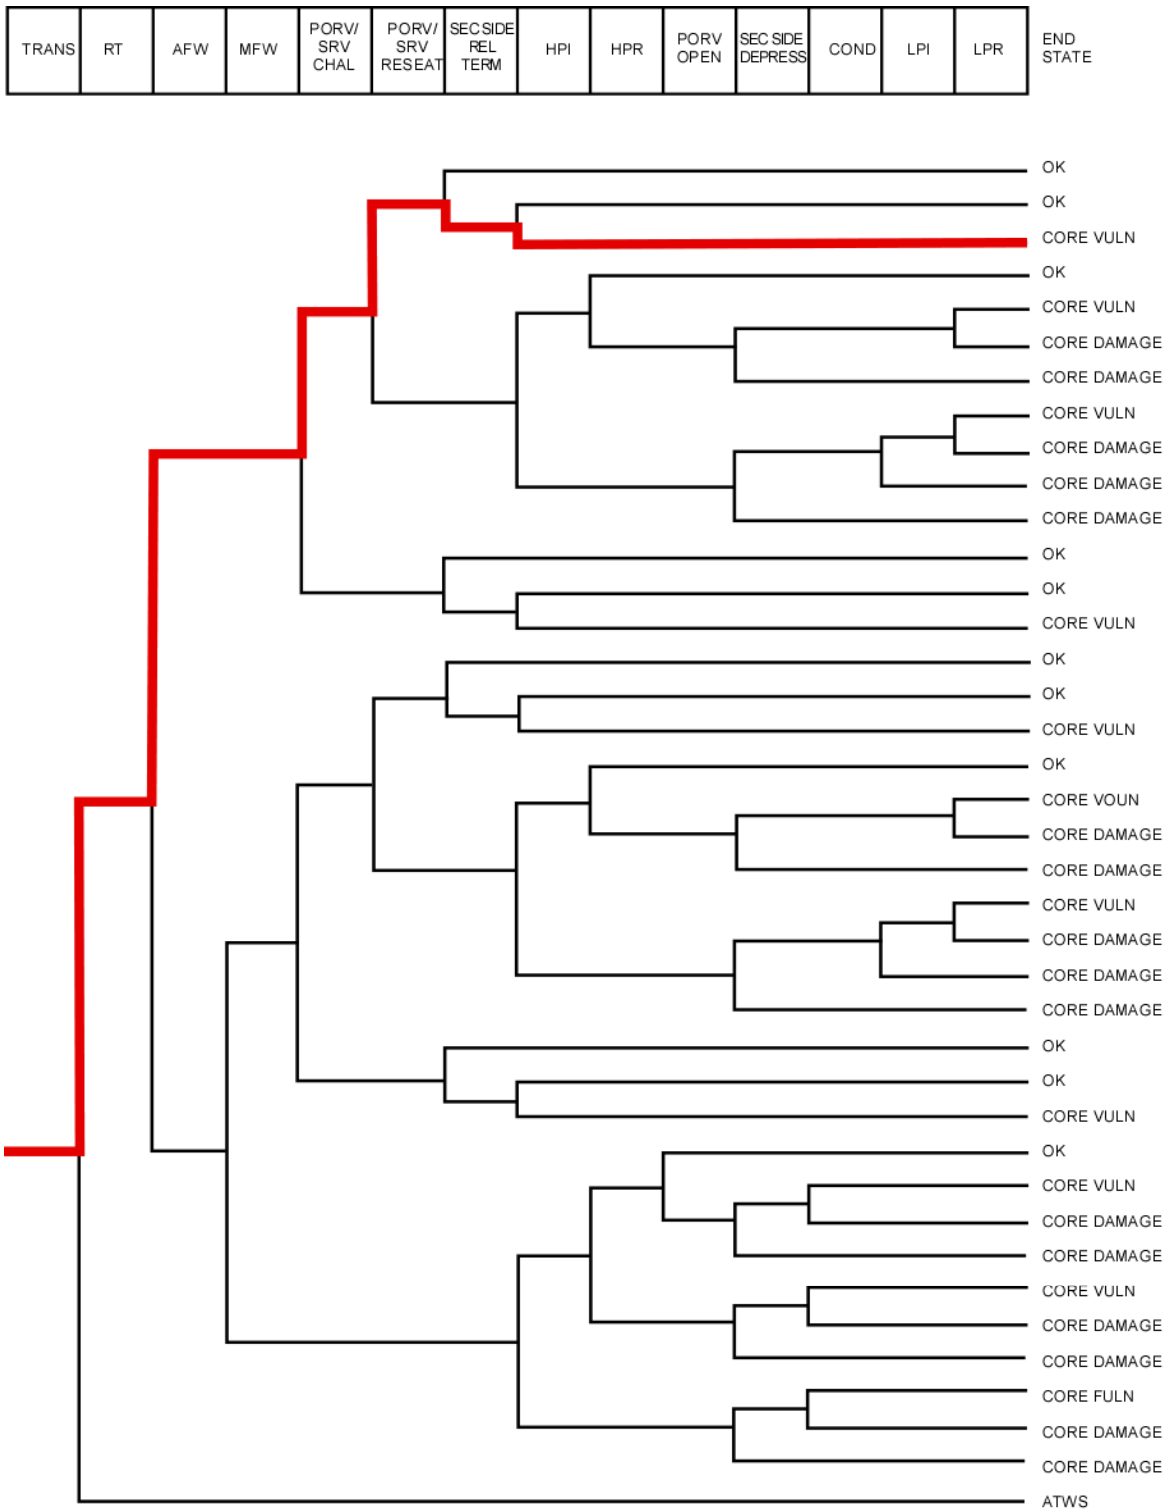
Figure 15-6 Dominant Core Vulnerability Sequence Event Tree

The major core vulnerable sequence is shown in Figure 15-6. The sequence involves a transient (initiated by the loss of ICS power), a reactor trip, success of AFW, success of Main Feedwater, a challenge to the PORV (the valve was opened to control RCS pressure), success of the reseating of the PORV, and failure of the HPI system (one pump was rendered inoperable by the incorrect suction lineup). The conditional probability for this sequence is 1.766E-4.

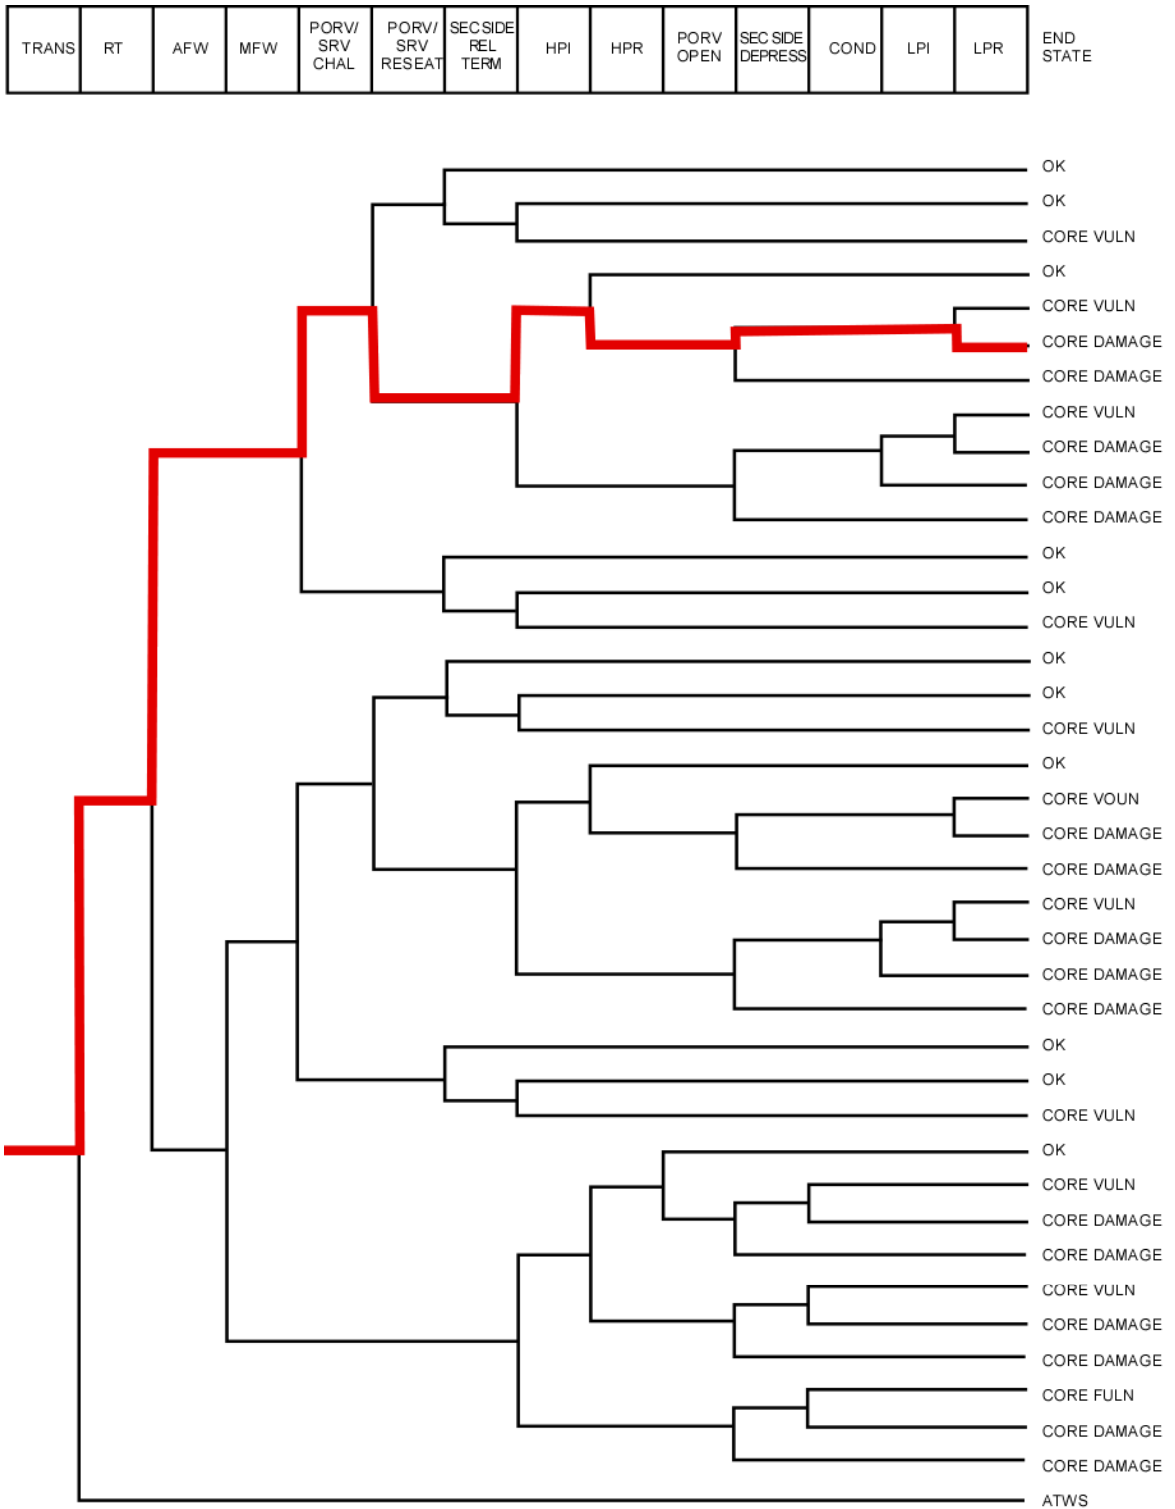
Figure 15-7 Dominant core Damage Sequence Event Tree

The major core damage sequence is shown in Figure 15-7. The sequence involves a transient initiator, successes of AFW and MFW, failure of the PORV to reseat, and HPI. The conditional probability of this sequence is 3.0E-5/Rx-yr.
