Pressurized Water Reactor
B&W Technology
Crosstraining Course Manual

Chapter 15.0

Rancho Seco Loss of ICS Power

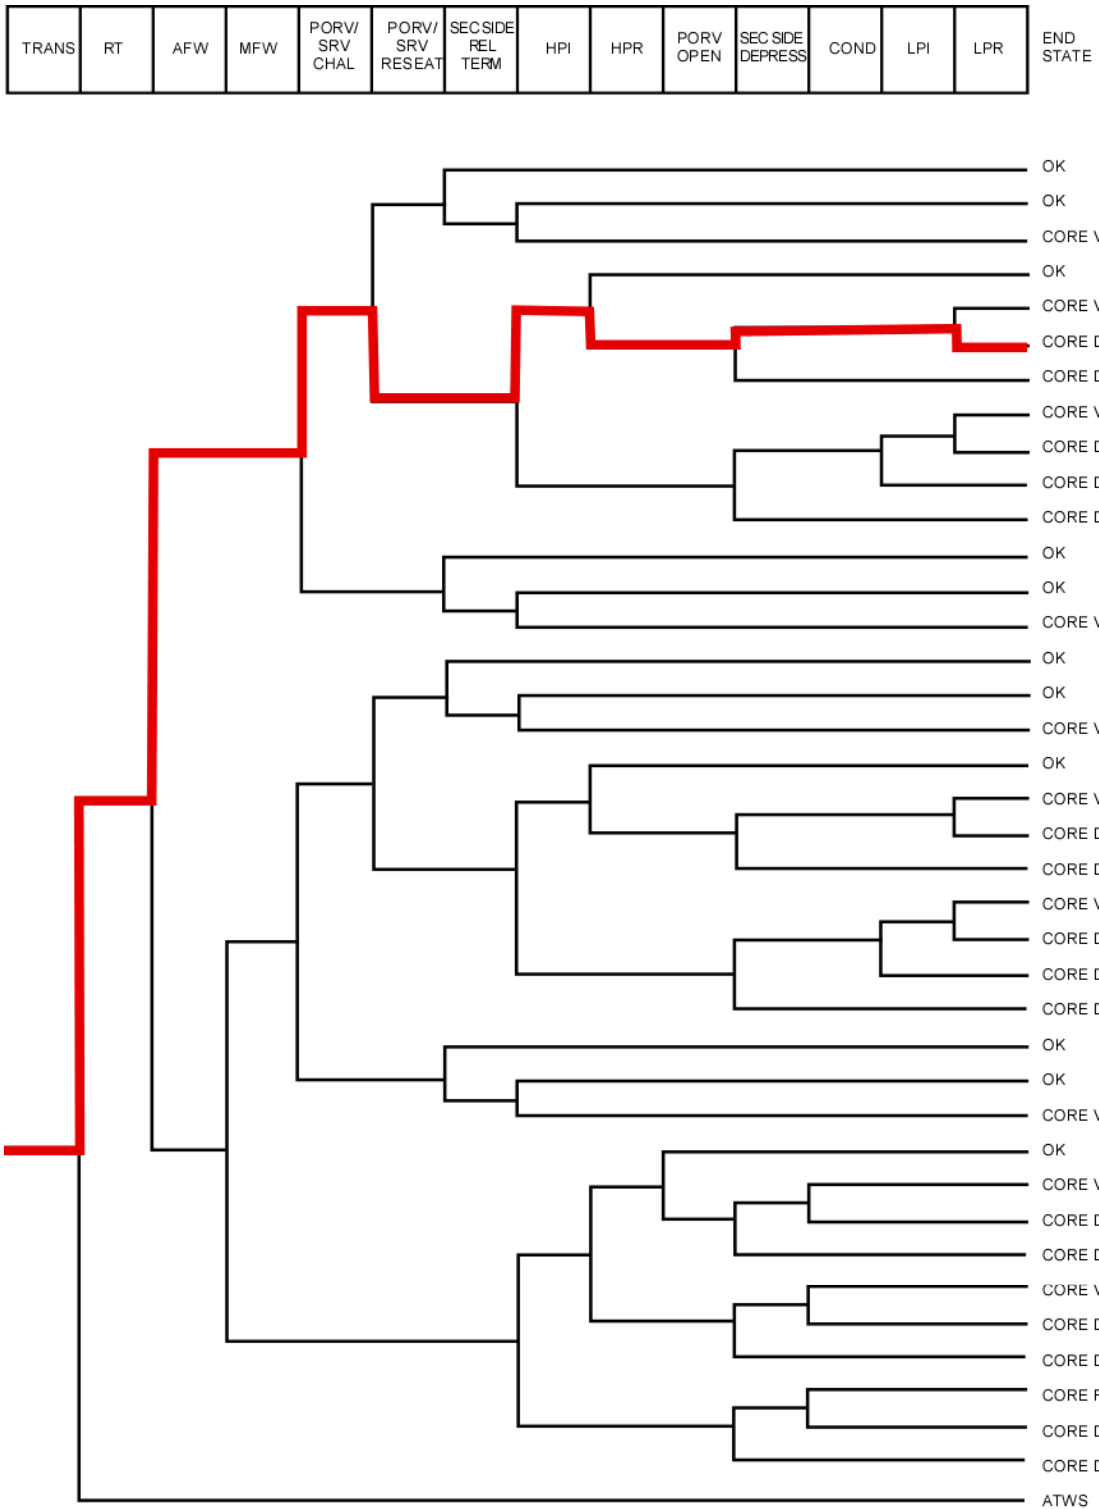
Figure 15-7 Dominant core Damage Sequence Event Tree

The major core damage sequence is shown in Figure 15-7. The sequence involves a transient initiator, successes of AFW and MFW, failure of the PORV to reseat, and HPI. The conditional probability of this sequence is $3.0E-5/Rx-yr$.
