FORWARDING REPT ENTITLED: "DUANE ARNOLD ENERGY CENTER RECIRCULATION INLET
SAFE-END REPAIR PROGRAM", AND ADVISING INITIAL CUT ON THE N2A SAFE-END IS
PRESENTLY EXPECTED TO OCCUR APPROX 08/08/78.

IOWA ELECTRIC LIGHT AND POWER COMPANY

Duane Arnold Energy Center
Recirculation Inlet Safe-End
Repair Program

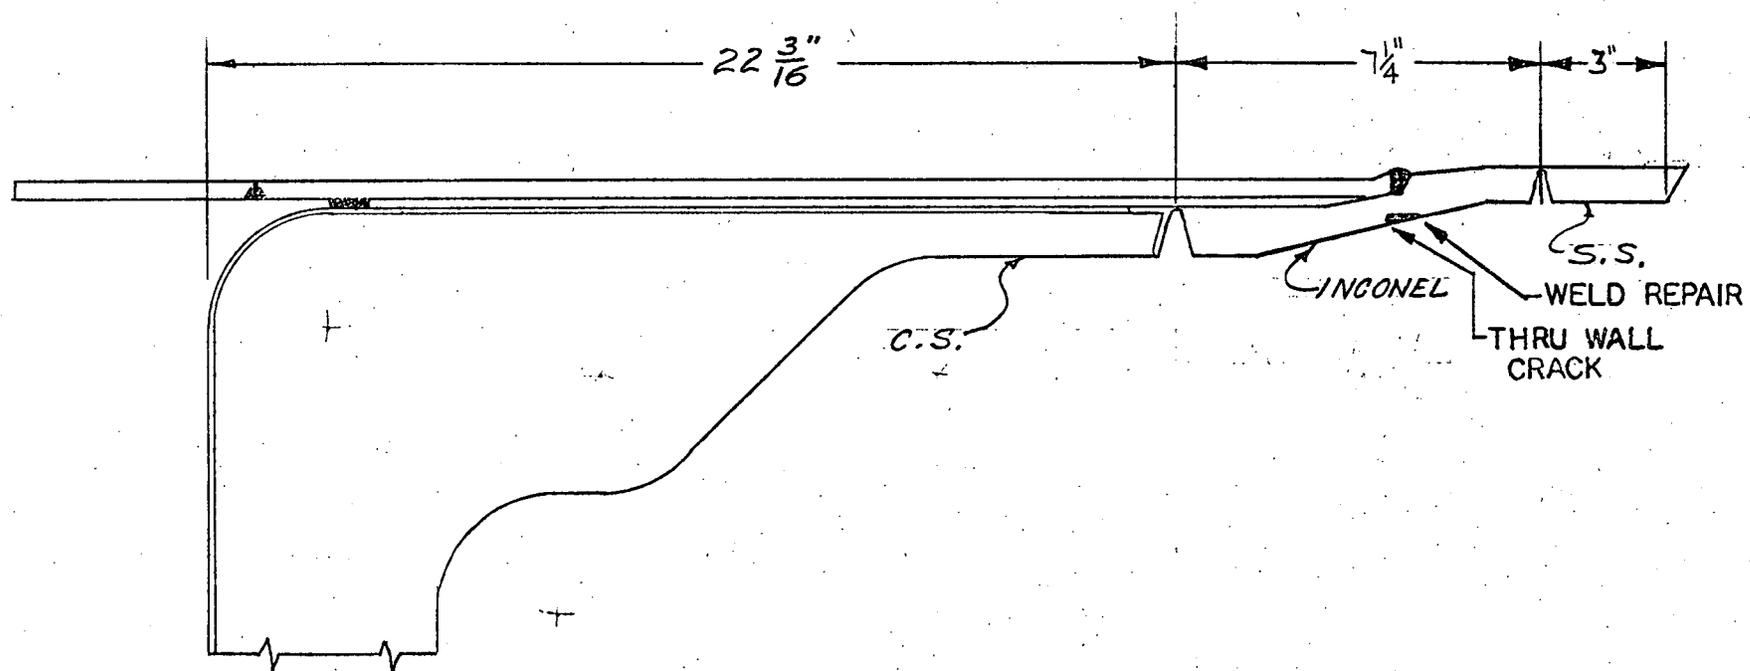
Figure 1

Ultrasonic testing and radiographic examinations were performed to determine the full extent of the cracking in the N2A safe-end and to check for similar problems in the other 7 safe-ends. The visible portion of the through wall crack in the N2A safe-end appears to be located along the fusion line of the weld repair of a fabrication machining error as shown in Figure 1. The geometry of the crack through the safe-end wall could not be determined exactly; however, it is possible that the crack initiated in the crevice at the mating surface of the thermal sleeve on the inside of the safe-end. The examinations revealed linear indications in 4 other safe-ends, none of which were through wall cracks. Another safe-end showed some non-linear indications, but meets the NDE acceptance requirements. The remaining 2 nozzle safe-ends had no indications. Representatives of the NRC Region III Office of Inspection and Enforcement have reviewed these preliminary NDE results. A summary of these preliminary findings were presented to the NRC at a meeting in Bethesda on June 27. Further details and preliminary plans for the replacement program were presented to the NRC at another meeting on July 7.

N 2 - SAFE END.

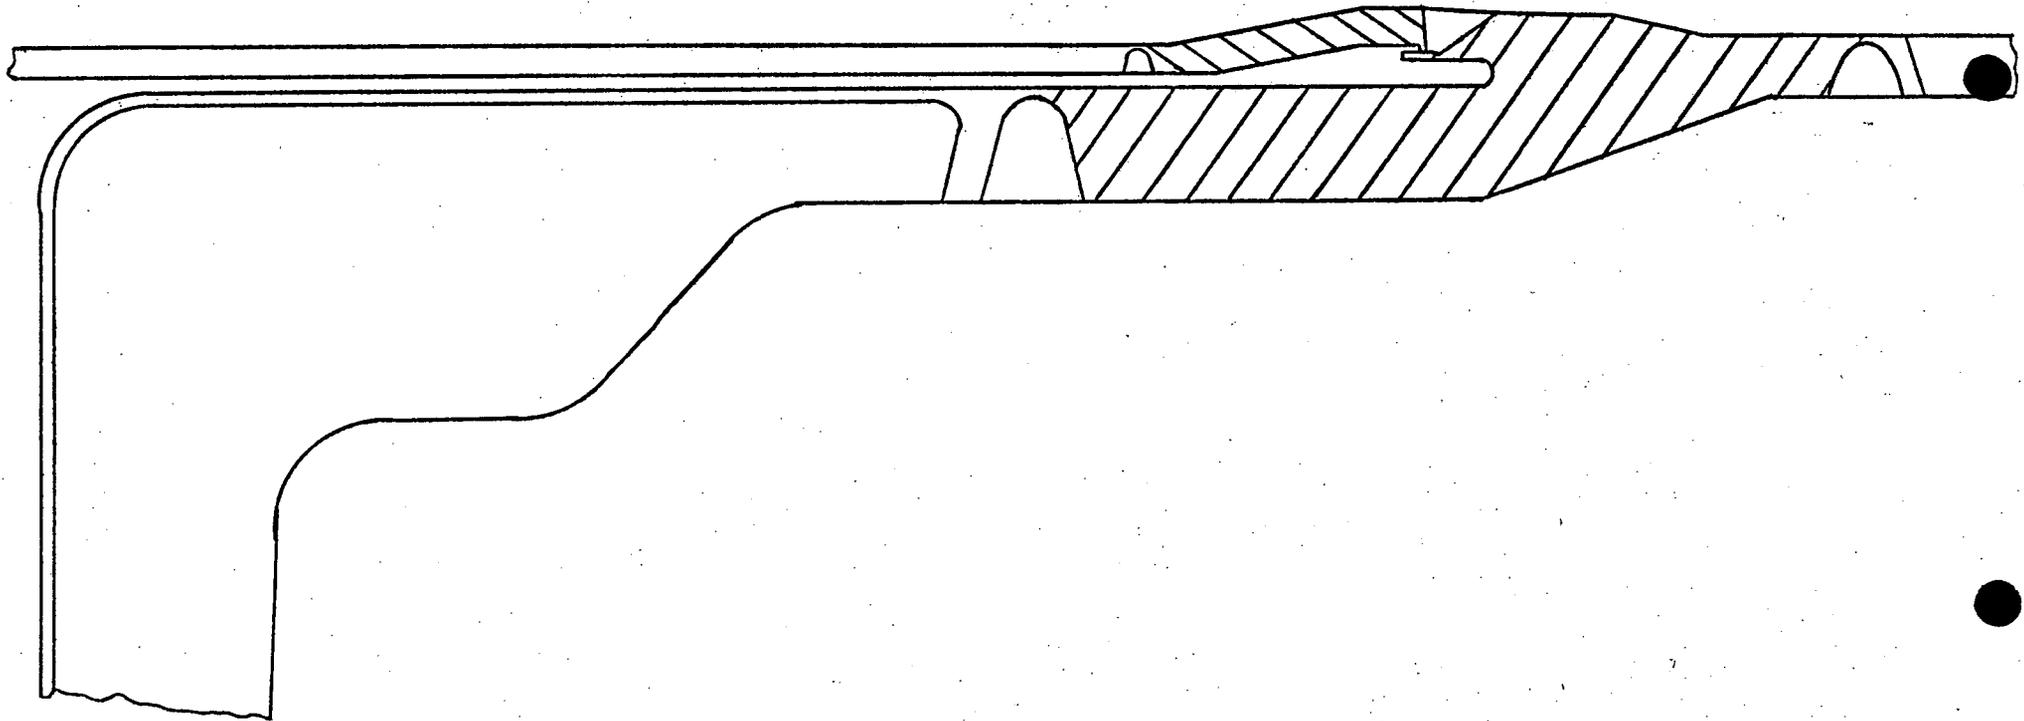
Figure 2

REPLACEMENT SAFE-END ASSEMBLY

end which will reduce the susceptibility of the safe-end to cracking. Iowa Electric has employed NUTECH corporation to perform a second party verification of these modifications. As shown in Figure 2, the replacement safe-end incorporates a tuning fork configuration to eliminate the contact crevice and has an increased cross-section thickness. These modifications also reduce stress concentrations and allow access for liquid penetrant, radiographic and ultrasonic examinations. A portion of the existing thermal sleeve will also be replaced with an adaptor compatible with the new safe-end. The replacement safe-end will be analyzed in accordance with the original stress report requirements under ASME Section III, 1965 Edition Summer 1967 Addenda. An amendment to the original stress report will be prepared for the replacement safe-end.

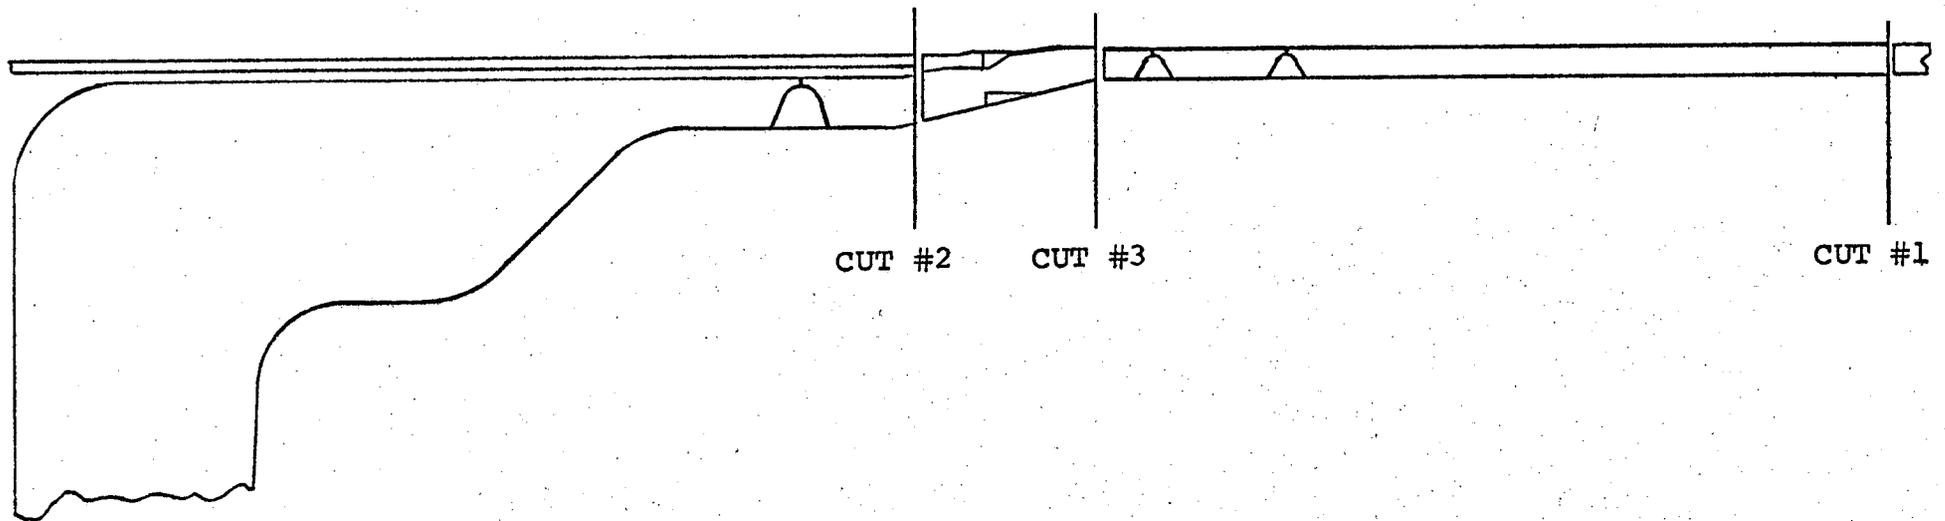
CUT SEQUENCE FOR SAFE END REMOVAL

As shown in Figure 3 the cracked safe-end will be removed by cutting the safe-end and thermal sleeve at a point approximately 2 inches inboard of the crack. A second cut will be made near the elbow in the recirculation line allowing the safe-end with its attached stainless steel transition piece and attached section of recirculation line to be removed as a unit. This will provide access for the repairs and minimizes the number of cutting operations required to be performed in the radiation area. The transition piece and section of recirculation line will be cut from the cracked safe-end (approximately 2 inches from the crack) to be reinstalled later along with the replacement safe-end. This also avoids the need for any bimetallic welds during the repair process. The cutting sequence has been reviewed by Region III I&E personnel. Iowa Electric will notify the Region III office at least 2 days prior to commencement of cutting operations.

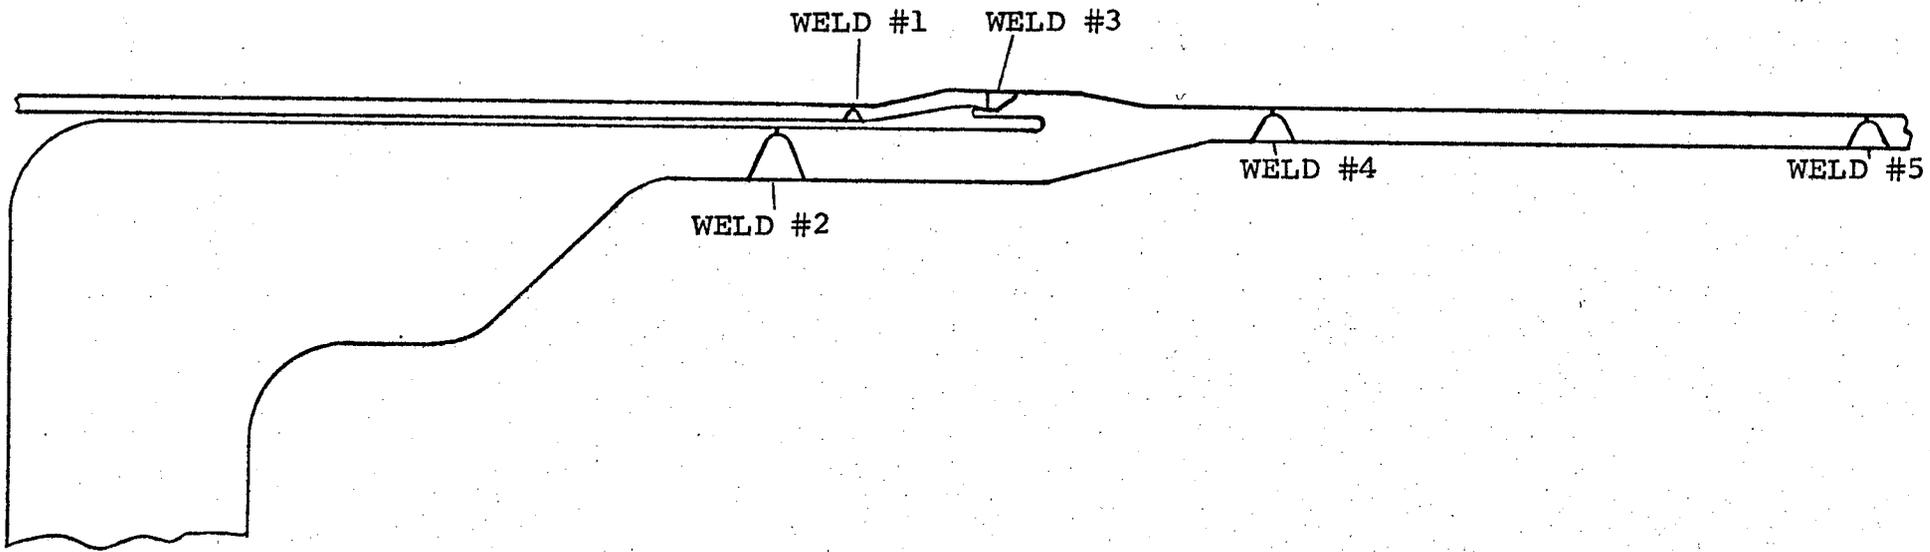
Figure 4

WELD SEQUENCE FOR REPLACEMENT SAFE END ASSEMBLY

The welding sequence for installing the replacement safe-end assembly is shown in Figure 4. The replacement safe-end will be installed using welding materials meeting the requirements of ASME Section III, 1974 Edition, Summer 1975 Addenda, NB-2400, or a later edition of the Code, depending on material availability. All welds will be examined by radiography and liquid penetrant within the limits afforded by the access and structure. These non-destructive examinations will be in accordance with ASME Section III, 1974 Edition, Summer 1975 Addenda, NB-5000. An ultrasonic inservice "baseline" examination will be performed on all new butt welds in accordance with ASME Section XI, 1974 Edition, Summer 1975 Addenda, in accordance with the present DAEC inservice inspection program. A hydrostatic test of the primary system including all welds made during this repair will be performed in accordance with ASME Section XI, 1974 Edition, Summer 1975 Addenda, Section IWB-5222.
