SUBJECT: Submits info re mod to load sequencing of ECCS equipment
 result of 850822 loss of transformer concurrence w/LOCA that
 could have defeated load sequencing logic of diesel update.

Subject: Duane Arnold Energy Center
Docket No: 50-331
Op. License No: DPR-49
Load Sequencing of ECCS Equipment
Reference: LER 85-36
File: A-118b

TITLE (4) **Emergency Diesel Generators Sequencing Design Anomaly**

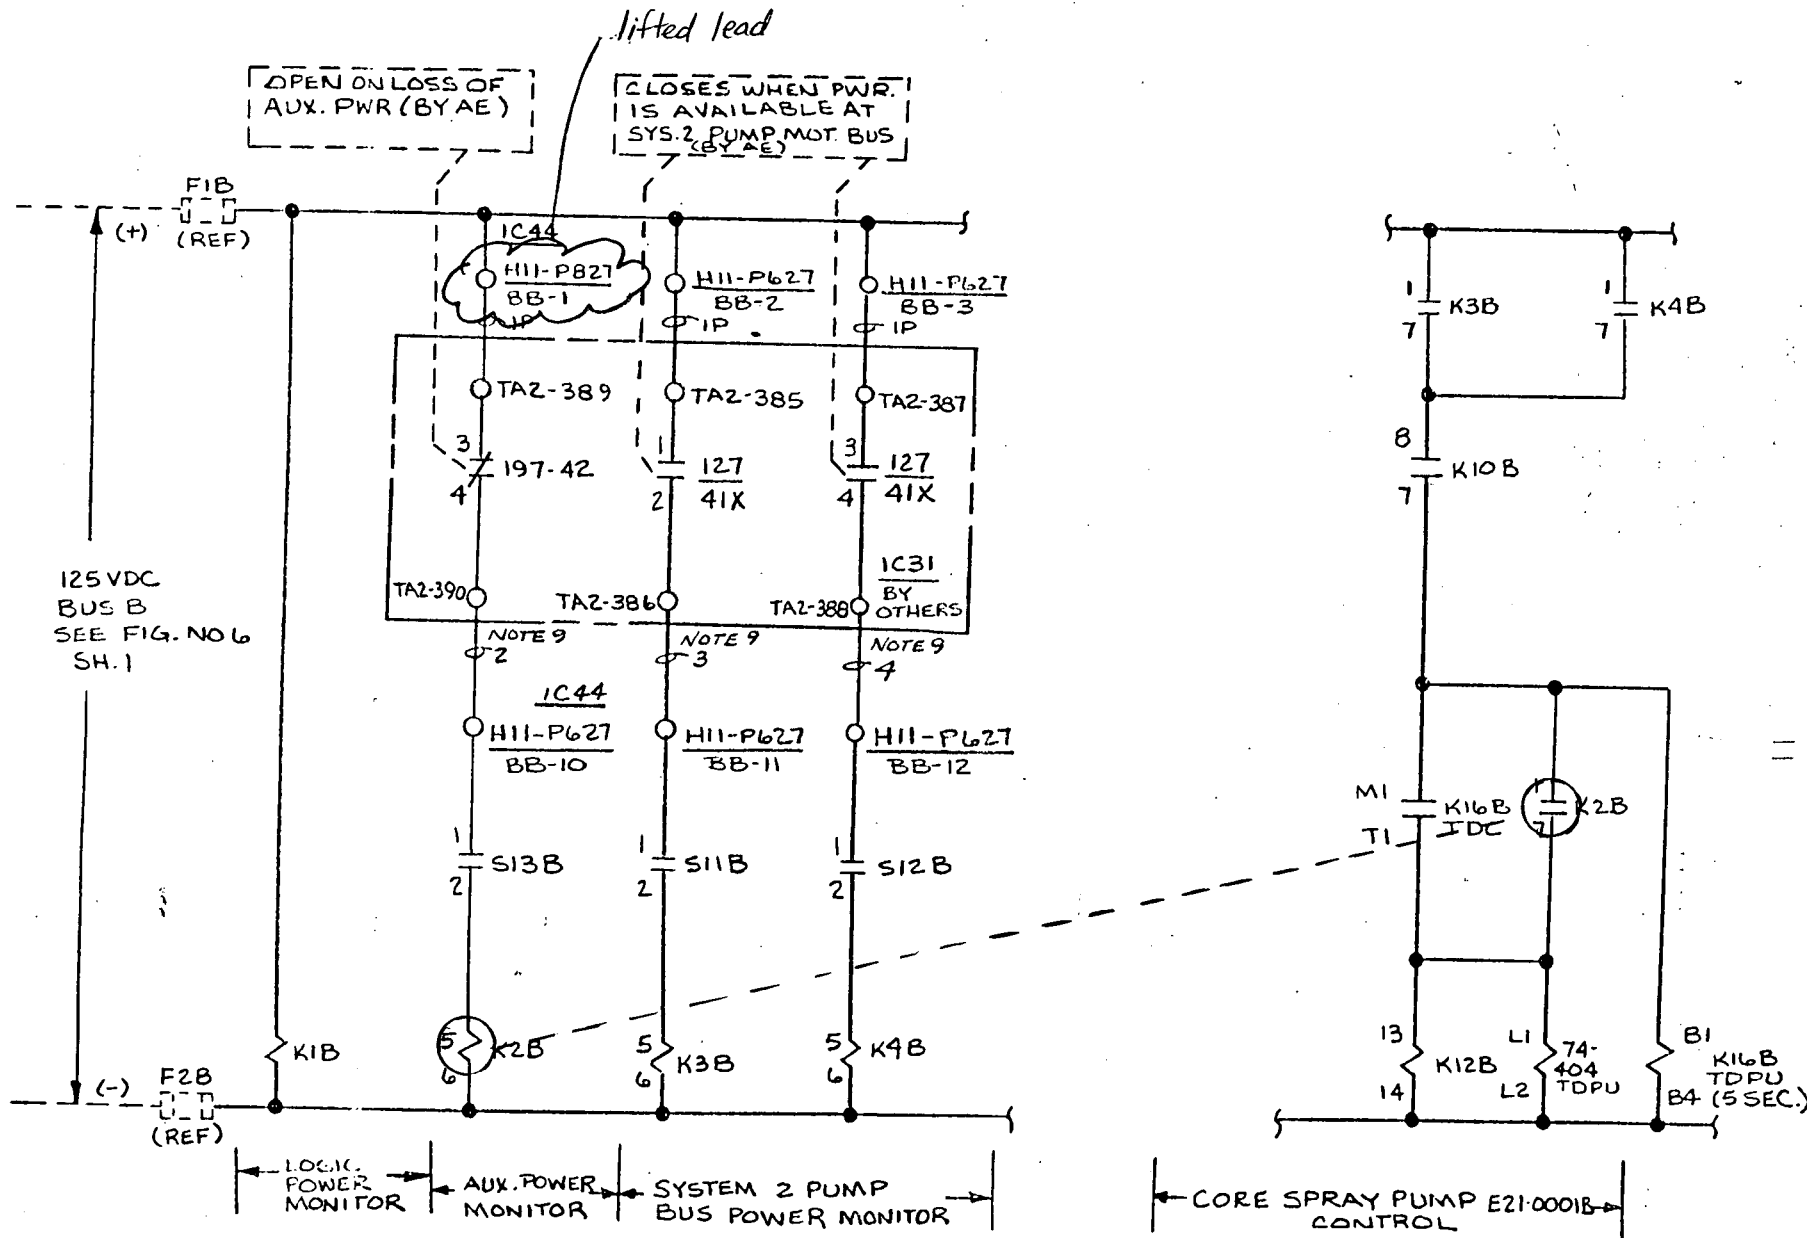
SCHEME 2R201

degraded bus voltage condition occurs. Therefore, if the essential loads were powered by the standby transformer and a LOCA occurred at the same time as the standby transformer failed, the output voltage of the startup transformer would have prevented the LOOP detection logic from sending a LOOP signal to the pump start circuitry. This would have caused all CS and RHR pumps to load to their respective diesel generators simultaneously.

A design change was made to correct the problem described above permanently. The automatic CS and RHR pump start circuitry was modified so that the pumps sequence on at all times following a LOCA signal regardless of the status of offsite power. The design change disconnected one wire leading to each K-2A (Division I) and K-2B (Division II) relay coil, thereby preventing actuation of the K-2A and K-2B relays under any condition (see Attachment 1, left side). Disconnecting these relays bypasses the automatic instantaneous start feature (K-2A/B relay contacts remain open) on the pumps and directs the LOCA pump start signal to the appropriate time delay pickup (TDPU) relay (Attachment 1, right side). As a result, the pumps will sequence onto their respective buses.

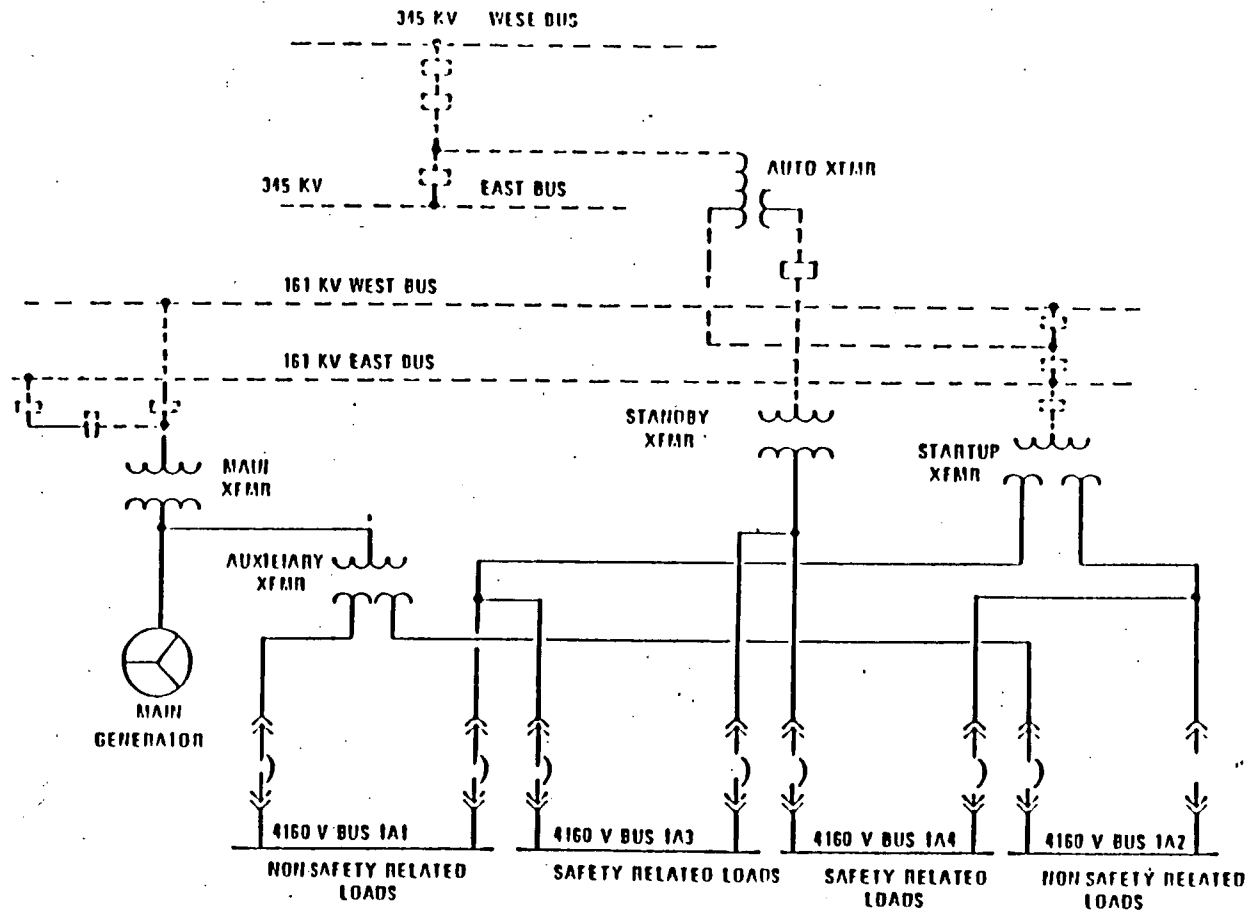
DAEC Electrical System
Figure 8.2-6

The Duane Arnold Energy Center has four 4160 V buses, two vital and two non-vital. (See attached drawing identified as Figure 8.2-6.) The normal plant lineup when in power operation has the two vital buses powered off the Startup Transformer (which is connected to offsite power) and the two non-vital buses powered from the Auxiliary Transformer (which is fed from the plant's main generator). A third transformer, the Standby, which can only supply the two vital buses remains idle. Should the Startup Transformer fail, the vital buses are automatically transferred to the Standby Transformer and the EDGs start. Should the Standby Transformer also fail to provide power to the vital buses, the EDGs will load.

In a LOCA condition (without loss of offsite power), the vital buses provide offsite power for the instantaneous startup of the Core Spray and RHR pumps. In a LOCA event with a concurrent Loss of Offsite Power (LOOP-LOCA), the Core Spray and RHR pump logics will sequentially load these pumps onto the vital buses now powered by the EDGs if their respective logics sense either: a) loss of power at both the Startup and Standby Transformers or b) a degraded bus voltage.

On November 4, 1984, the Auxiliary Transformer failed. (See LER 84-40.) This necessitated placing the plant in an alternate electrical lineup with the non-vital buses on the Startup Transformer. (Since the auxiliary transformer receives power from the generator this is a normal lineup for unit startups and hot standby.) With both the vital and non-vital buses on the Startup Transformer, the transformer voltage was reduced. To avoid causing the vital buses to shed (92.5% degraded voltage), and resultant scram from minor grid fluctuations, the vital buses were transferred to the Standby Transformer. In this alternate lineup (vital buses on the Standby Transformer) if the Standby Transformer fails, the vital buses are not (by design) automatically transferred to the Startup Transformer, but would instead be powered by the EDGs. Under this lineup, if a LOCA signal occurs and only the Standby Transformer fails, but there is no full loss of offsite power, the Core Spray and RHR pump logics would sense power at the Startup Transformer, and thus would not load-sequence when starting. The simultaneous start of all essential loads could then result in the EDGs tripping. However, in this partial LOOP, non-vital power would still be available (motor-driven feed pumps, etc).

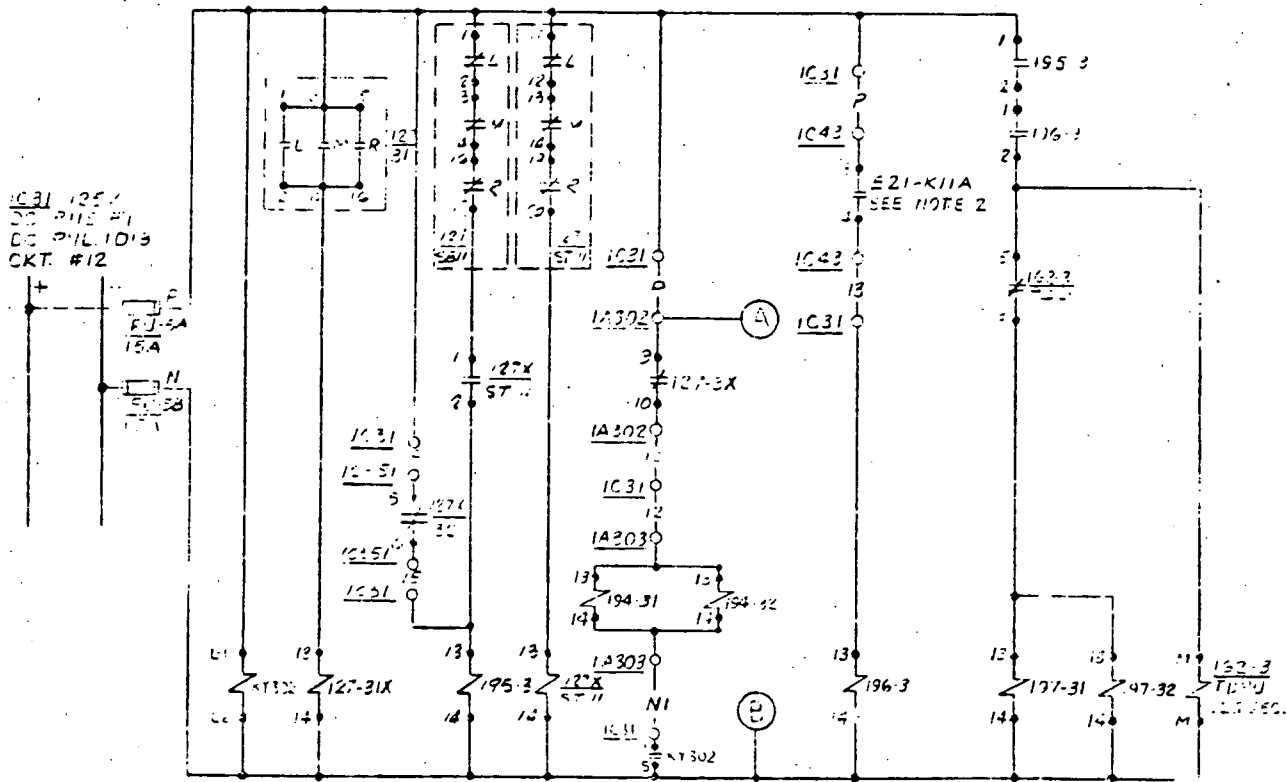
ESSENTIAL BUS IAB3 LOAD SHEDDING CIRC
 SCHEME 1M30

The specifics of the logic are as follows: (see attached partial schematics). On APED drawings (GE) the core spray and RHR pumps receive autostart signals through two parallel paths, K2A contacts or K70A TDC (time delay contacts - Note relay numbers differ for core spray and the other RHR pumps). The K2A relay coil is in series with relay 195-3 contacts and is energized (195-3 contacts closed, 195-3 deenergized) by 125 V DC unless both the Startup and Standby Transformers are less than 65% voltage on their secondaries. A degraded voltage relay (vital bus voltage, 92.5%) can also deenergize relay K2A (by energizing 195-3) when the logic is satisfied (8.5 seconds below 92.5% and either transformer output breaker are closed onto the vital bus). Were the vital buses on the Standby Transformer and were only this transformer to fail, the following sequence would occur. Since the Startup Transformer still would have normal output voltage on its secondaries, the series logic would not energize relay 195-3. Similarly, 195-3 would not energize on degraded voltage (92.5% with 8.5 second delay) since the vital bus breakers would be open. Therefore, K2A contacts would remain closed and the pumps would be immediately loaded onto the diesel when it achieved nominal output.

The resolution of this problem was to place two keylock test switches (per electrical division) in the RHR and Core Spray pump start logics in the test position. This always load sequences the pumps onto the vital buses in the event of a LOCA, with or without a concurrent loss of the Startup or Standby Transformers. The DAEC LOCA analysis considers, as a design basis event, a complete loss of offsite power with a concurrent LOCA, and therefore takes into account the time delays associated with the sequencing of these pumps. At 2240 - hours on August 22, 1985, the test switches were placed in the test position, rendering both EDGs operable and cancelling the twenty-four hour Limiting Condition for Operation.
