SUBJECT: Provides results of control room panels emergency illumination test. Results confirm 850405 info re util estimate of overall lighting levels assuming loss of one div of control room lighting. Test configuration encl.

Subject: Duane Arnold Energy Center
Docket No: 50-331
Op. License No: DPR-49
Control Room Emergency Lighting
Illumination Levels
Reference: Letter, R. McGaughy (Iowa Electric) to
H. Denton (NRC) dated April 5, 1985
(NG-85-1338)
File: P-72a

EMERGENCY LIGHTING TEST CONFIGURATION

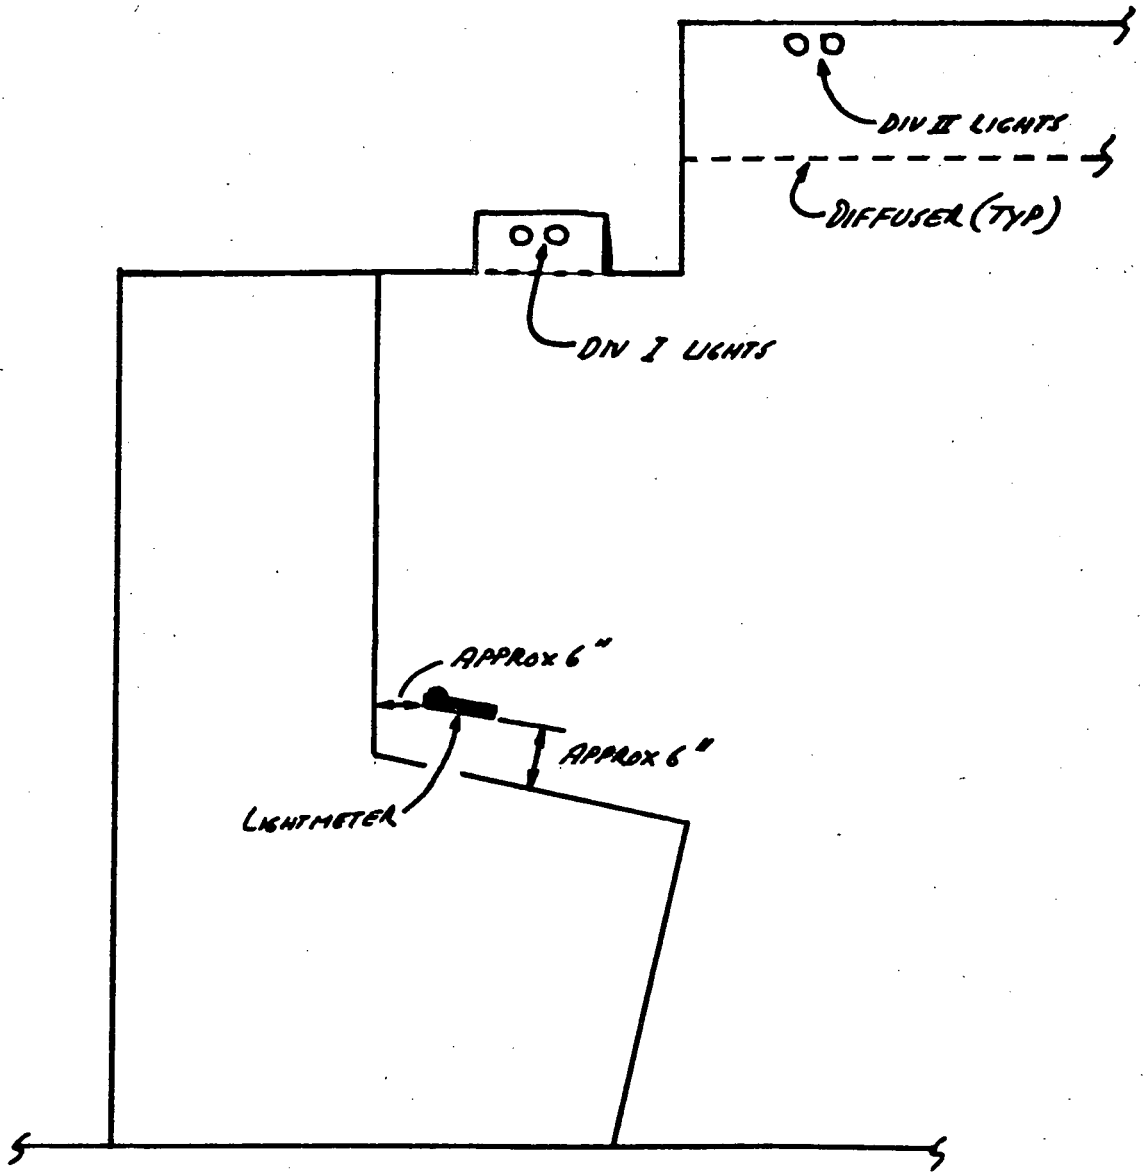
CROSS SECTION OF CONTROL ROOM BENCHBOARD SHOWING
LOCATION OF LIGHTMETER & LIGHT FIXTURES
(NTS)

The purpose of this letter is to provide the results of our control room panels illumination test. The purpose of the test was to confirm the information provided to the NRC in the referenced letter regarding our estimate of the overall lighting levels in the Control Room assuming the loss of one division of Control Room lighting. In the DAEC control room, half of the lights (alternating rows of fluorescent lights) are powered by Division I emergency power (backed up by one emergency diesel generator) with the other half powered by Division II emergency power (backed up by the other emergency diesel generator). In the referenced letter we stated that we expected the lighting levels following the loss of either division of Control Room lighting power to be approximately 20 to 30 footcandles throughout the Control Room. However, due to the physical location of the lighting soffit immediately above the control panel benchboards, we found that the lighting levels were less than the 20 to 30 footcandles stated under worst case conditions. This is due to the fact that the soffit blocks direct illumination from the operating Division II lights onto the upper portion of the benchboards (see Attachment 1).

The illumination test was conducted in the most conservative test configuration possible, i.e., with the Division II lights on and Division I lights off. To achieve this most conservative lighting condition requires the occurrence of a highly unlikely event, the postulated loss of offsite power in conjunction with the loss of the Division I diesel generator or the loss of offsite power in conjunction with the loss of the Division I essential bus or associated cabling. The test configuration (see Attachment 1) precluded direct illumination onto the benchboard due to

light blockage by the overhead soffit. In addition, no contribution to illumination levels was provided by the existing 90-minute battery-backed emergency lights. The test results (see Attachment 2) indicate that under the above worst case test configurations and assumptions, the illumination levels were only slightly less than the guidance of NUREG-0700, "Guidelines for Control Room Design Reviews." Section 6.1.5.4 of NUREG-0700 states, "the control room emergency illumination system should be designed to provide a minimum illumination level of 10 foot-candles at all work stations in the primary operating area."

Based upon the fact that the test configuration assumed the occurrence of a highly unlikely event scenario, no credit was taken for use of the 90-minute battery-backed emergency lights, and the lighting levels were only slightly less than the guidance of NUREG 0700, we believe the emergency lighting levels on the control room benchboard to be adequate. However, we are continuing to investigate possible options for improving the lighting levels under this scenario.

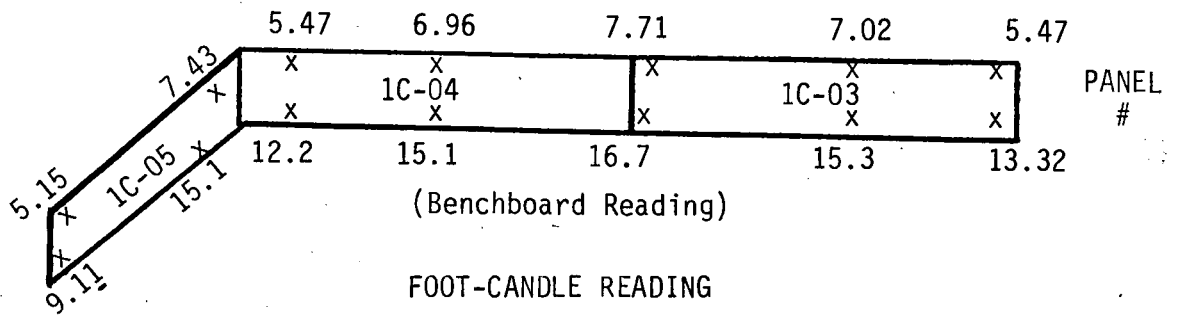
DIVISION II CONTROL ROOM ILLUMINATION TEST RESULTS

(DIVISION II LIGHTS ON, DIVISION I LIGHTS OFF)

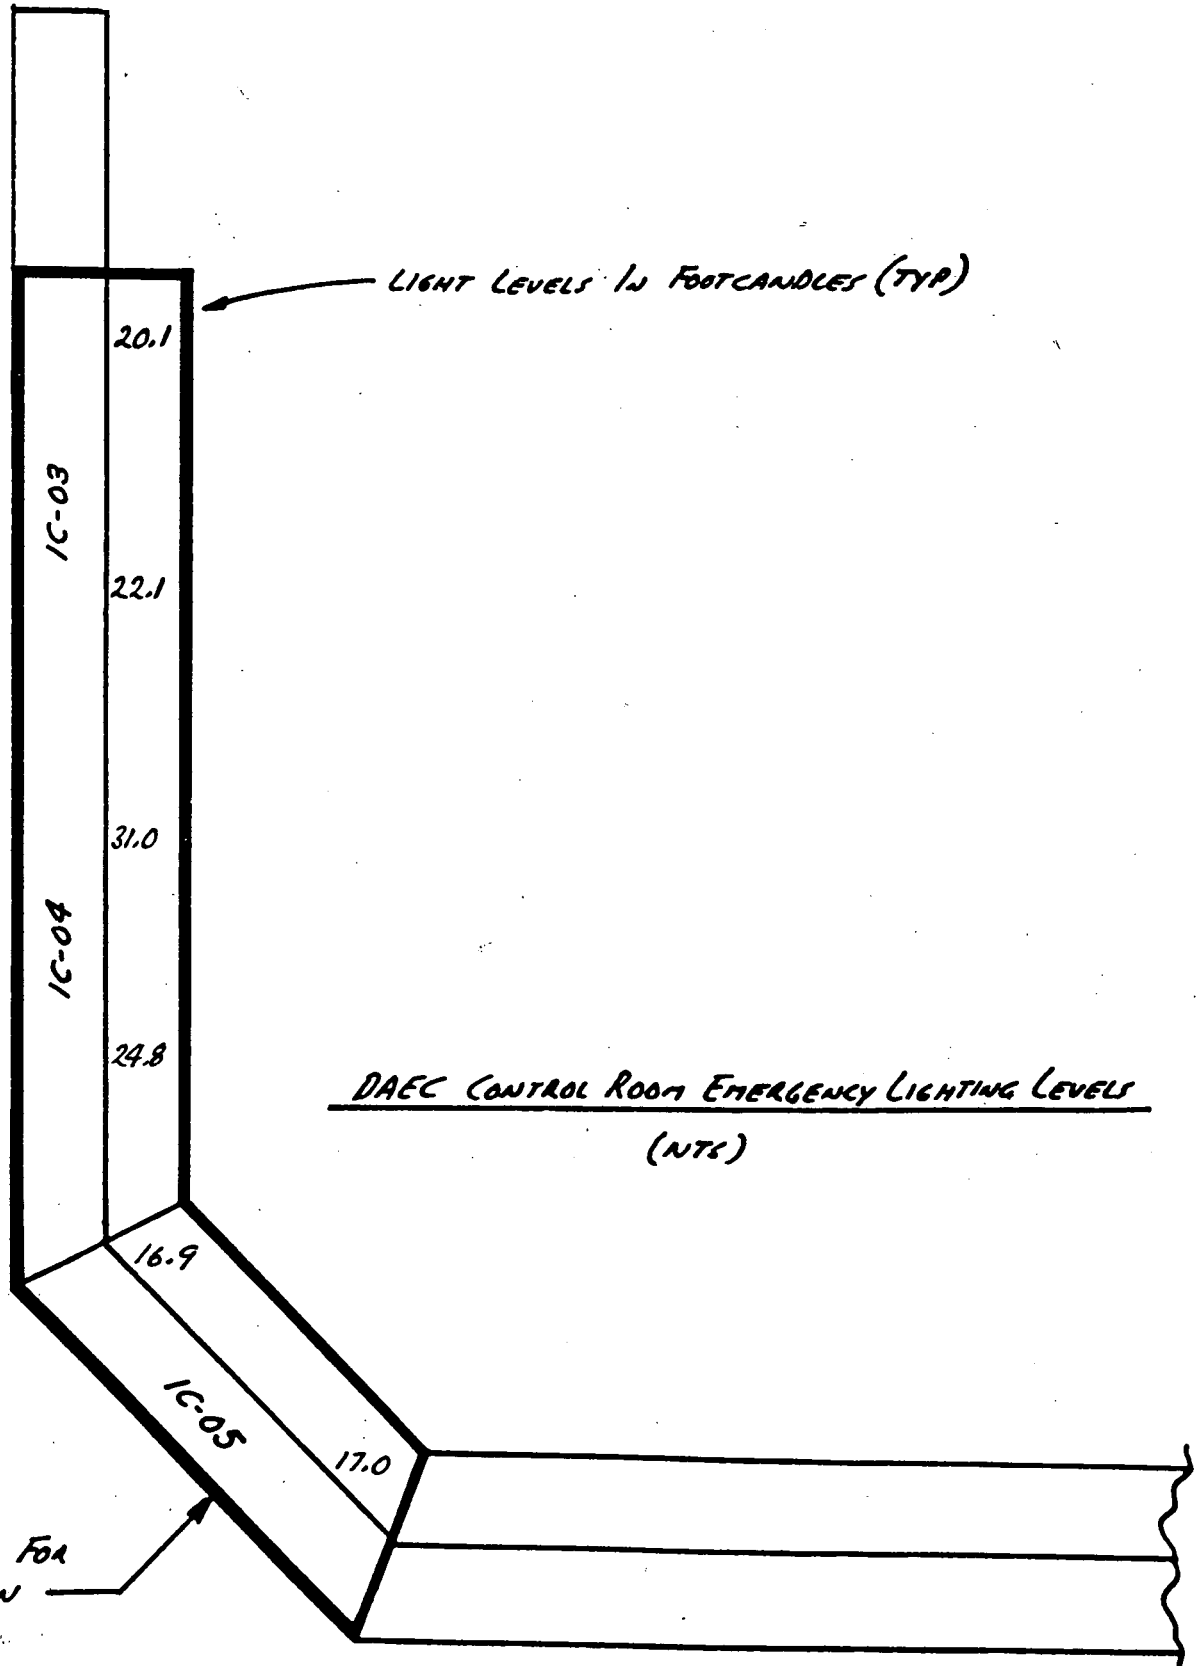
DIVISION I CONTROL ROOM ILLUMINATION TEST RESULTS

For the purpose of comparison, a similar test conducted in June, 1985, with the Division I lights on and Division II lights off revealed illumination levels greater than 10 foot-candles (see Attachment 3).

DIV I CONTROL ROOM LIGHTS ON

DIV II CONTROL ROOM LIGHTS OFF
