Subject: 10CFR21 Reporting of Defects and Non-Compliance -  
Engine Systems, Inc. Report No. 10CFR21-0102, Rev. 0

Air Start Motors with Friction-Clutch Inertia Drives

**Report No. 10CFR21-0102**

**10CFR21 REPORTING OF DEFECTS  
AND NON-COMPLIANCE**

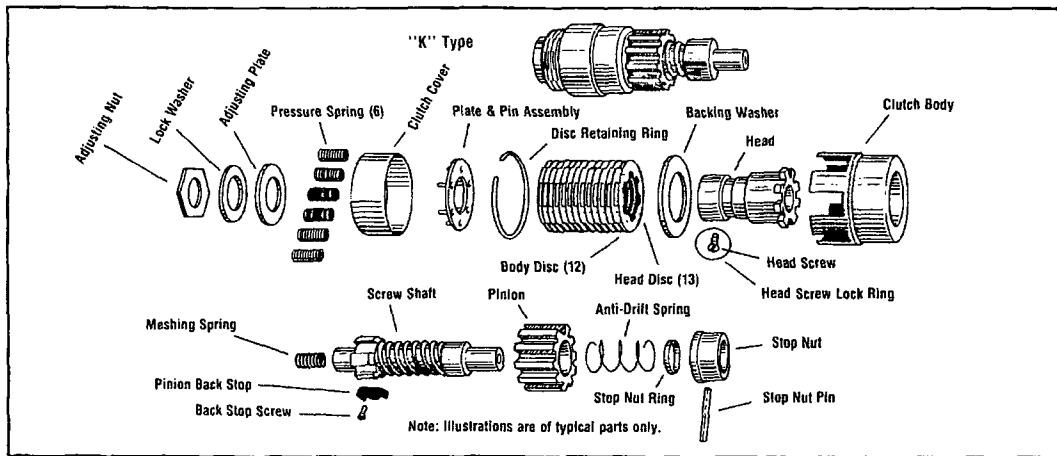
**EXPLODED VIEW OF FRICTION-CLUTCH INERTIA DRIVE**

The evaluation was concluded on 08/01/11 and determined the air motor failure to be a reportable defect as defined by 10CFR21. The starter drive failure was attributed to excessive torque adjustment of the clutch assembly. This overstressed the clutch disc plates which lead to eventual failure of the friction-clutch inertia drive assembly. Failure of the clutch drive renders the air start motor inoperative. Depending upon the configuration of the engine’s starting system, an inoperative air start motor could cause excessive starting times or a start failure. Either scenario has the potential to prevent the emergency diesel generator from performing its safety related function.

The friction-clutch inertia drive is utilized on air starting motors that do not incorporate the pre-engagement feature. In this case, air motor rotation begins before the drive pinion gear meshes with the engine ring gear. The clutch is designed to slip at a prescribed torque setting to absorb the initial torque inrush experienced by the air motor as the pinion and ring gears mesh. This drive assembly was originally manufactured by Facet and was their “K” Type friction clutch. Facet P/N A-3111 was used on clockwise rotation (RH) air starters and P/N A-3236 was used on counterclockwise rotation (LH) air starters. Facet has not supplied starter drives since 2003 and the clutch drives are now supplied by two (2) other manufacturers, ASC (Air Starter Components) and Sun Autoelektrik.

Users should return any of the suspect air start motors in their inventory to ESI for verification of the inertia drive clutch torque setting. These starters can then be used to replace currently installed starters once the torque setting is verified.

At the next available maintenance interval, users should return any installed starters to ESI for verification of the inertia drive clutch torque setting.

ESI will include clutch torque setting verification in the dedication process for all future shipments of air start motors with friction-clutch inertia drives.
