SUBJECT: LER 88-008-01: on 880724, vibration transmitter failure
 resulted in turbine trip & reactor scram.

FACILITY NAME (1) Duane Arnold Energy Center (DAEC)										DOCKET NUMBER (2) 0 5 0 0 0 3 3 1										PAGE (3) 1 OF 05	
--	--	--	--	--	--	--	--	--	--	--------------------------------------	--	--	--	--	--	--	--	--	--	---------------------	--

Vibration Transmitter Failure Results in Turbine Trip and Reactor Scram

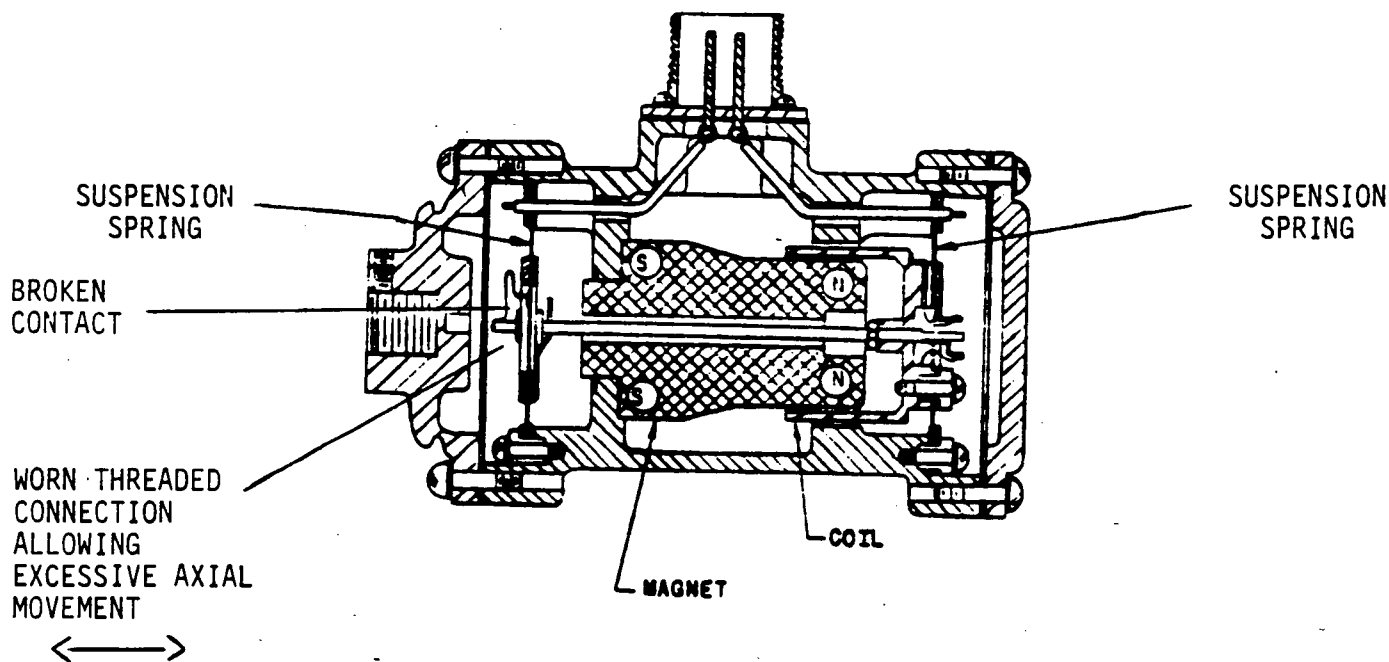
ATTACHMENT 1

The cause of the event was a failure of the vibration transmitter for the number ten journal bearing resulting in a false high vibration indication. The vibration signal increased from its normal range to fifteen mils over a period of thirty seconds during which the turbine trip setpoint (10 mils) was exceeded. The high vibration indication continued for five minutes during turbine coastdown, returning then to normal and eventually to zero.

Inspection of the transmitter noted that minor tapping on the side of the transducer unit yielded a sporadic open coil condition (minimum output). Initial inspection of the internals of the transducer found no obvious indication of degradation. After discussion with vendor representatives, a further examination of the transmitter was performed by Licensee personnel. Two discrepancies were noted which affect the transducer output signal (see attachment 1). A broken contact was found on the wire connecting the center post to the suspension spring. The wire was normally in contact creating electrical continuity, however, an intermittent open condition could be created which is indicated by loss of output signal. The second discrepancy was a worn threaded fitting by which the center post is attached to a seismic suspension spring. This fitting was sufficiently worn that additional axial movement was possible which would allow greater voltage to be generated for a given

vibratory motion. The voltage increase is electronically sensed as an increase in the magnitude of vibration. It had been noted that during recent operation, a higher than normal vibration had been experienced (between 4 and 7 mils).

The vibration transmitter probe tip normally rides on the surface of the rotating main shaft and communicates radial motion to the transducer. The transducer converts the motion to an electrical signal proportional to the magnitude of the motion. A probe tip modification was suggested by the vendor to ensure that a thick film of oil was not building up under the probe tip as the oiled shaft rotates. The vendor has indicated that the buildup of this oil layer could cause excessive service to the vibration monitor and erroneous vibration readings.

Cross-sectional view of vibration detector

The entire vibration monitoring unit was replaced on July 25, 1988. The probe tip on the replacement monitoring unit was modified in accordance with the vendor recommendation. Vibration indications were closely monitored during turbine startup on July 27, 1988, with no unusual vibration readings detected during startup or subsequent power operations. Calibration of all turbine vibration monitor electronic circuits and vibration detectors is scheduled during the Fall 1988 refuel outage.
