SUBJECT: LER 88-013-00: on 881026, inadequate sealing of level switch
 electrical housing results in core spray & EDG actuations.
 W/8 ltr.

LICENSEE EVENT REPORT (LER)

FACILITY NAME (1) Duane Arnold Energy Center (DAEC)										DOCKET NUMBER (2) 0 5 0 0 0 3 3 1 1 OF 1 0										PAGE (3) 1 OF 1 0																													
TITLE (4) Inadequate Sealing of Level Switch Electrical Housing Combined with Cognitive Personnel Error results in Core Spray and Emergency Diesel Generator Actuations																																																	
EVENT DATE (5) MONTH DAY YEAR 1 0 2 6 8 8										LER NUMBER (6) YEAR SEQUENTIAL NUMBER REVISION NUMBER 8 8 - 0 1 3 - 0 0										REPORT DATE (7) MONTH DAY YEAR 1 1 2 5 8 8										OTHER FACILITIES INVOLVED (8) FACILITY NAMES None																			
OPERATING MODE (9) N										THIS REPORT IS SUBMITTED PURSUANT TO THE REQUIREMENTS OF 10 CFR § (Check one or more of the following) (11)																																							
POWER LEVEL (10) 0 0 0										20.402(b)										20.405(c)										X 50.73(a)(2)(iv)										73.71(b)

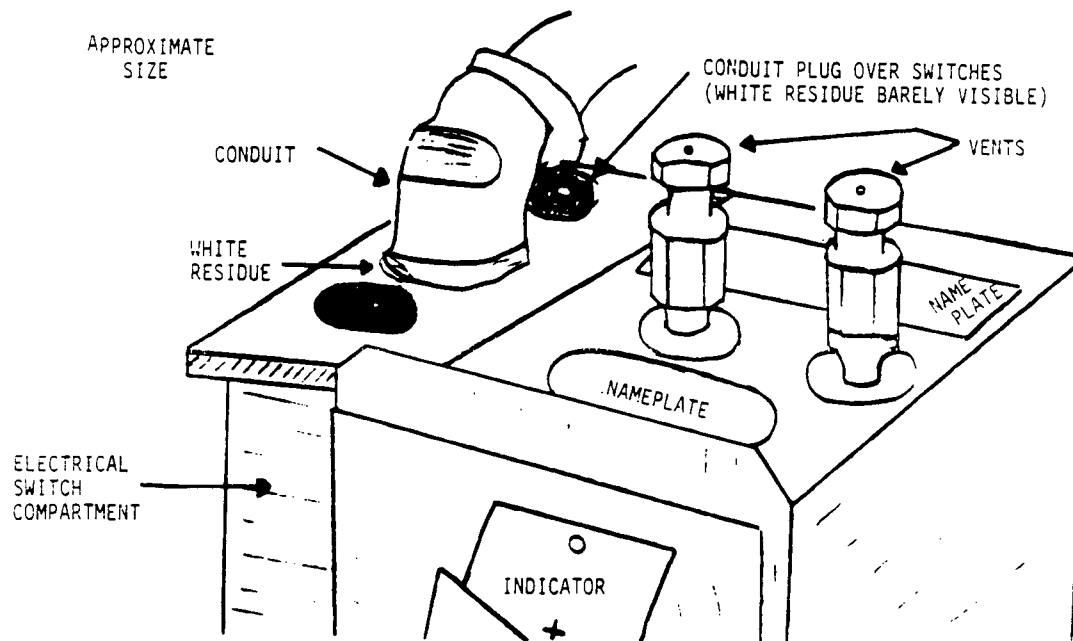
FIGURE 1: TOP OF LIS 4531 (YARWAY 4418C)

(Refer to Figures One, Two and Three for the following). LIS4531 has four microswitches arranged in two rows, with the small microswitch contact arms hanging downward. On the top of the electrical switch housing above the microswitches is a conduit penetration to provide a pathway for field wiring to the overhead junction box, and two unused penetrations currently plugged by plastic stoppers. One of the plastic stoppers is about six inches directly overhead of the microswitches within the switch housing.

Instrument line water leaves a white residue upon evaporation. Upon inspection, a small amount of similar residue was identified on the microswitch no. 1 contacts and contact arms. This residue is also apparent on the outside of the LIS4531 electrical switch housing, around the conduit plugs, and on the inside cover of the housing. An examination of the surroundings overhead revealed some evidence of water in the past dripping onto a junction box directly over the switch housing, but no source for such water was apparent. There was no evidence of leakage from the mechanical housing of LIS4531, which contains the switch's water-filled sensing unit, into the electrical switch housing.

The most likely source of water was from LIS4531 itself, via instrument vents on top of the mechanical housing, which is side by side with the electrical switch housing. LIS4531 is vented at the end of each surveillance test to insure no air is trapped within the switch's water-filled sensing unit. The two small vents on top of the mechanical housing are wrapped with cloth to catch the small overflow of water, but at some time during a recent calibration or instrument check, some water may have migrated to the top of the switch housing, and subsequently down through the edges of the conduit plugs or conduit. Water clinging to the underside of the switch housing could then have been disturbed by the work being performed on the instrument, and subsequently dripped onto the microswitch. The switch had been vented a week prior to October 26, 1988. It was also vented at the end of the October 26 calibration, and although excessive water discharge during venting was not noted, the water intrusion into the electrical switch housing could have occurred at that time. The root cause of the moisture intrusion therefore was inadequate sealing of conduit and conduit plugs on the top of the LIS4531 electrical switch housing.

As a corrective action to prevent moisture intrusion into Yarway electrical switch housings, all plant Yarway level switches of similar design will have sealant applied to the tops of the switch housing around the conduit and conduit plugs. This action shall be completed by December 31, 1988.

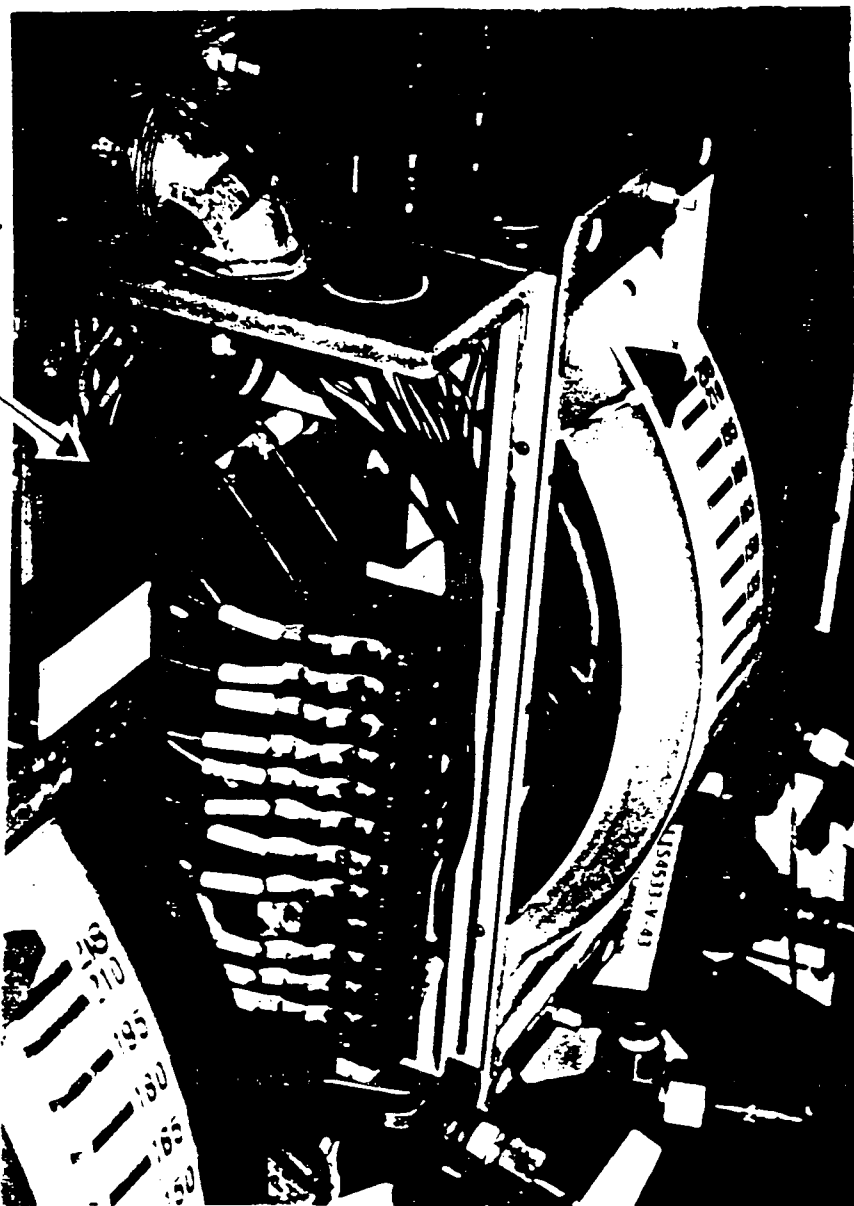
FIGURE 2:
LIS 4531 FROM
ELECTRICAL SWITCH
COMPARTMENT SIDE

CONDUIT PLUG
DIRECTLY
OVER SWITCHES

SWITCH LOCATION
(HIDDEN FROM VIEW)
