SUBJECT: LER 88-007-00: on 880706, Barton switch non-repeatability due to misassembly.

FACILITY NAME (1)	DOCKET NUMBER (2)	LER NUMBER (6)			PAGE (3)		
		YEAR	SEQUENTIAL NUMBER	REVISION NUMBER			
Duane Arnold Energy Center (DAEC)	0 5 0 0 0 3 3 1	8 8	— 0 0 7	— 0 0	0 2	OF	0 7

I. DESCRIPTION OF EVENT:

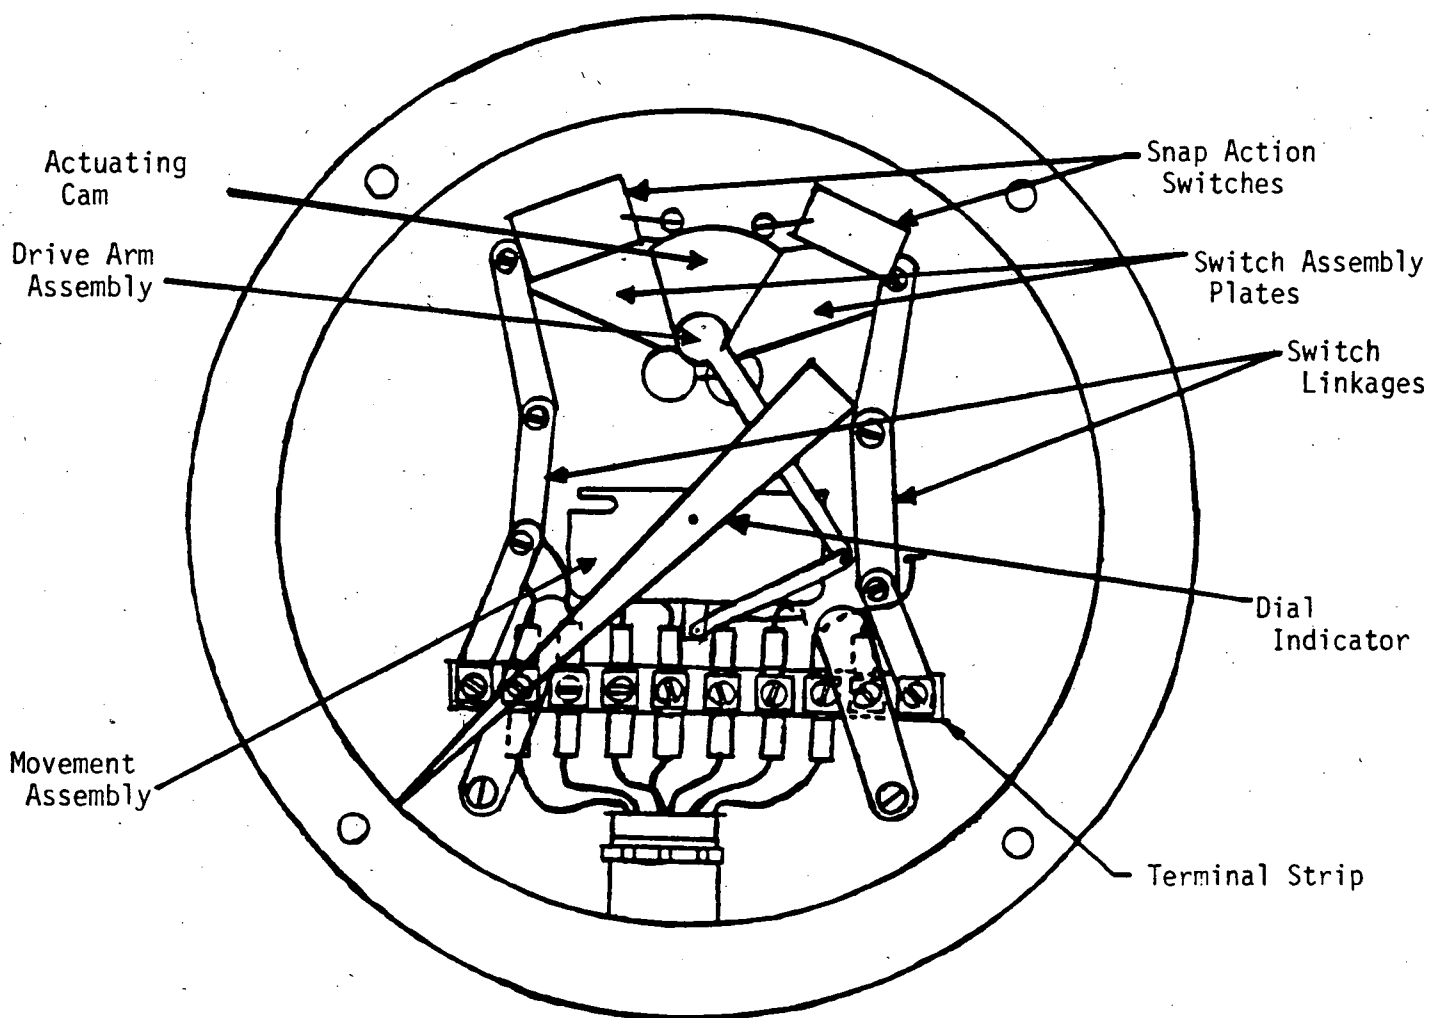
FIGURE 1. General Representation of Barton 280A Switch

Investigation into the inability to calibrate LIS3210 to the new setpoint revealed a problem associated with the instrument's internal assembly. Two ITT Barton Model 288A Differential Pressure Indicating Switches are utilized in the level control instrumentation as LIS's. Each LIS monitors the level of fuel oil in its respective Day Tank to control the operation of the Diesel Fuel Oil Transfer Pumps which provide make-up fuel oil to either Day Tank. Each Day Tank holds 1000 gallons (60") of fuel oil to provide a sufficient inventory for approximately four hours of diesel operation. Each LIS has two individual switches: the Low Switch starts the respective make-up pump to add fuel oil; the High Switch stops the make-up pump when the Day Tank approaches full. LIS3210 monitors fuel oil level in the SBDG 'B' Diesel Fuel Oil Day Tank. When fuel level falls to approximately 8" of fuel oil, equivalent to 128 gallons, the LIS3210 Low Switch trips, provides an alarm to indicate the low level condition, and starts the respective make-up pump to transfer fuel oil from the Diesel Fuel Oil Storage Tanks to the SBDG 'B' Day Tank. When fuel level has risen to approximately 55" of fuel oil, equivalent to 882 gallons, the LIS3210 High Switch trips and secures the make-up pump to stop the make-up of fuel oil.

transfers the signal to the instrument's Drive Arm Assembly. The Drive Arm Assembly provides the mechanical linkage to the Movement Assembly (to provide rotational output to the Dial Indicator) and to the Actuating Cam (to apply the sensed change in parameter to the High and Low Switch Assemblies). If the sensed change exceeds either the Low or High Switch setpoint, the respective Switch trips to either start or stop the make-up of fuel oil to the Day Tank. Referring to Figure 2, the High and Low Switch Assemblies are configured such that the Low Switch Assembly is mounted behind or in back of the High Switch Assembly. The instrument technicians identified they were assembled just the opposite, with the High Switch Assembly mounted behind (or in back of) the Low Switch Assembly. This improper assembly caused misalignment and binding of the Switch Linkages which resulted in unreliable operation of the instrument High and Low Switches. Subsequent investigation and extensive research of the maintenance history associated with this instrument revealed that the misassembly occurred prior to installation of the instrument. No maintenance had been performed to the degree required where disassembly of the High and Low Switch Assemblies could have occurred.

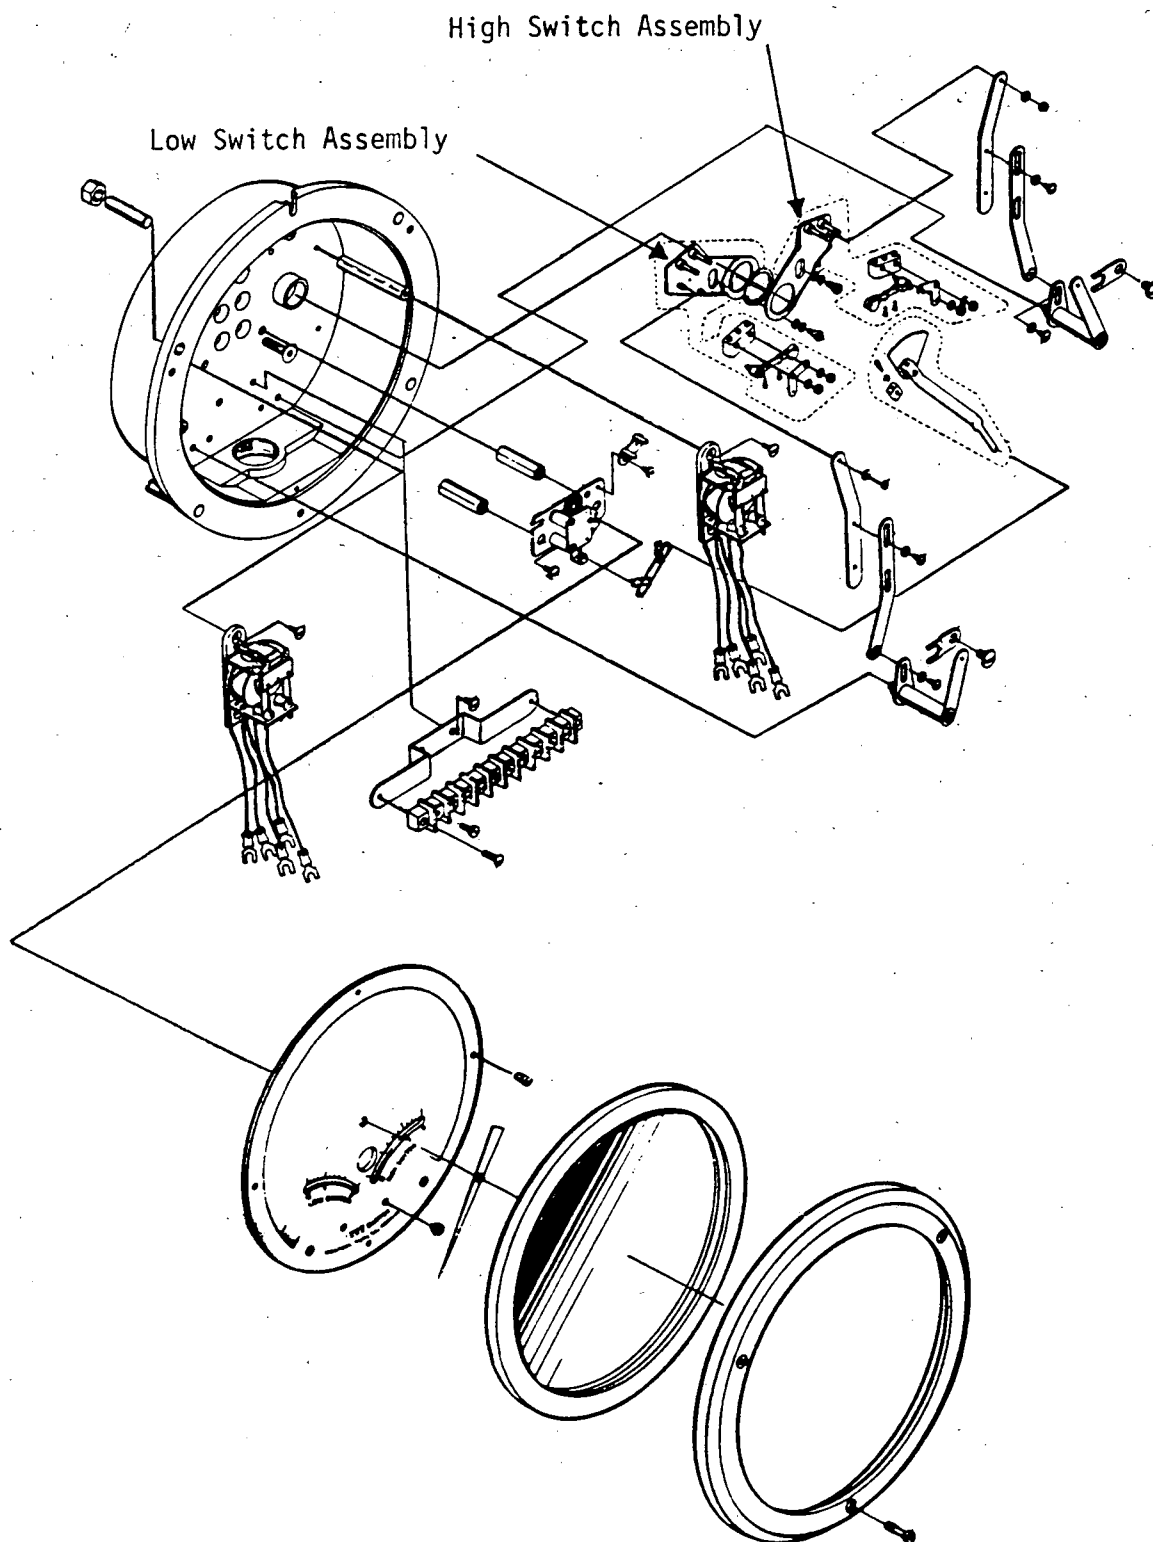
FIGURE 2. Barton 288A Indicating Switch - Exploded View

Once the internal assembly problem was identified, the instrument technicians referenced the manufacturer's literature for the ITT Barton Model 288A Differential Pressure Indicating Switch. Utilizing this information, they were able to identify that the High Switch Assembly and Low Switch Assembly had been improperly assembled into the instrument in reverse order. Referring to Figure 1, the two Snap Action switches and their associated Switch Assembly Plates are mounted behind the Switch Linkages, the instrument face plate (not shown in Figure 1), and the Dial Indicator. The differential pressure unit senses the changes in the monitored parameter (in this case Day Tank level) and

Immediate corrective action upon the discovery of LIS3210 being misassembled was revision of the maintenance instructions to allow repair of the instrument. LIS3210 was disassembled, reassembled per the manufacturer's literature, bench calibrated, reinstalled, the calibration verified, then returned to service at 2300 hours on June 24.
