SUBJECT: LER 89-006-00: on 890224, isolation of RCIC & HPCI due to broken thermocouple lead & poor performance of test switch.

FACILITY NAME (1) **Duane Arnold Energy Center (DAEC)** DOCKET NUMBER (2) **0500031311** PAGE (3) **1 OF 10**

TITLE (4) **Isolation of RCIC and HPCI Due to a Broken Thermocouple Lead and Poor Performance of Test Switches in Steam Leak Detection System Logic**

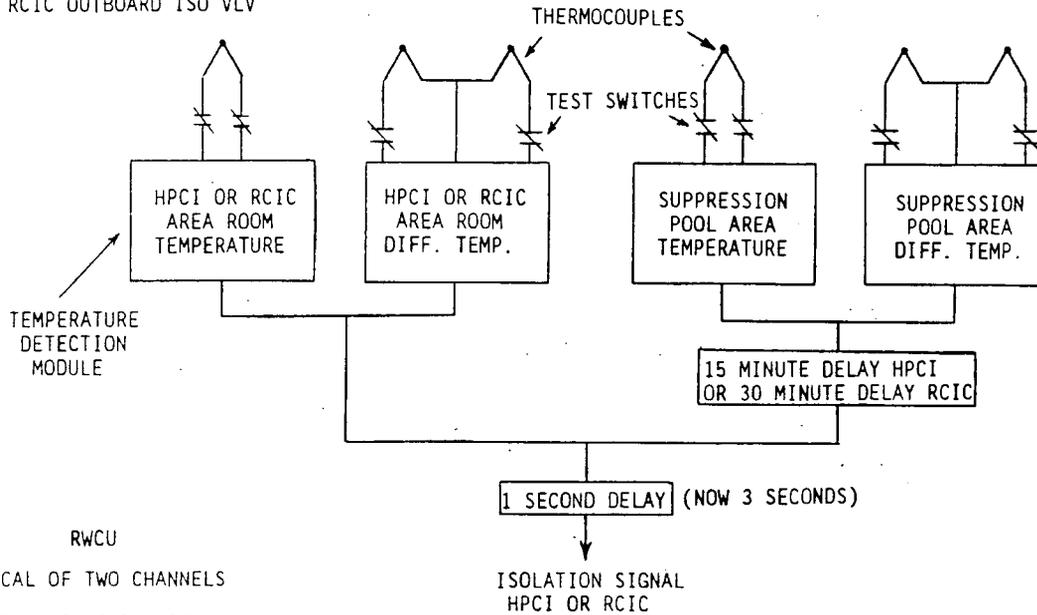
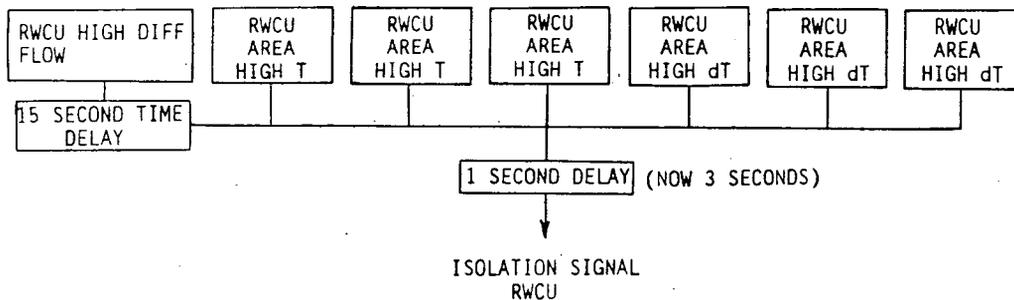
FIGURE I

As detailed in Figure I, there are four discrete signals which can result in a HPCI or RCIC isolation: HPCI or RCIC room high ambient

temperature, HPCI or RCIC room high differential temperature, suppression pool area high ambient temperature, and suppression pool area high differential temperature. All four signals are subject to a one second time delay. This time delay was installed in 1986 to aid in prevention of spurious isolations in the one-out-of-one isolation signal logic. The suppression pool signals must also remain in for fifteen minutes (HPCI) or thirty minutes (RCIC) prior to an isolation signal occurring. (See LERs 84-28 Revision 1, and 86-007 for details). RWCU will also isolate on high area room temperatures and differential temperatures, and has had a one second time delay installed since 1985. (See LER 85-023).

The SLDS temperature detection modules are Amtek (formerly Riley) Pan Alarm model 288's. The modules currently in place are upgraded models purchased and installed the latter half of 1988. This was done as a corrective action in response to problems with the SLDS temperature instrumentation, with the goal of making the system more reliable. The upgraded models were received with a "burnout protection" option which was not contained within most of the previous modules in use. This feature will result in the module signaling for an isolation ("tripping") if it senses an open thermocouple lead. The SLDS temperature detection modules for RCIC, HPCI and RWCU are mounted within one panel on the Control Room.
