SUBJECT: LER 89-006-01: on 890224, isolation of RCIC & HPCI due to broken thermocouple lead & poor perf of test switches.

Subject: Duane Arnold Energy Center
Docket No: 50-331
Op. License DPR-49
Licensee Event Report #89-006, Rev 1

| TITLE (4) Isolation of RCIC and HPCI Due to a Broken Thermocouple Lead and Poor Performance of Test Switches in Steam Leak Detection System Logic | | | | | | | | | | | | | | | | | | | | | | |

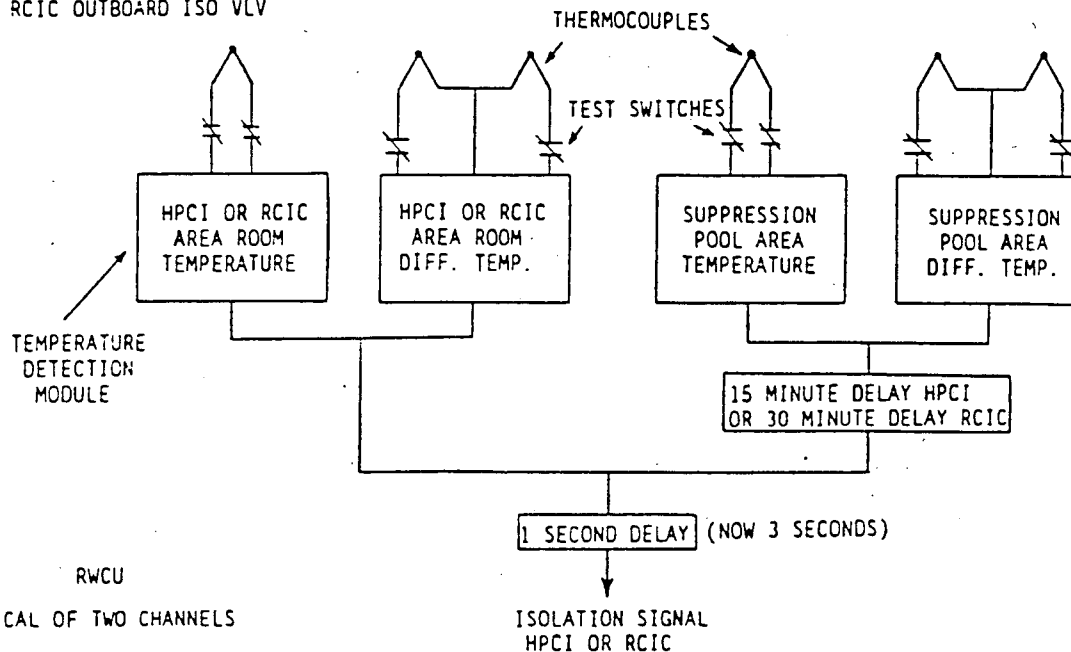
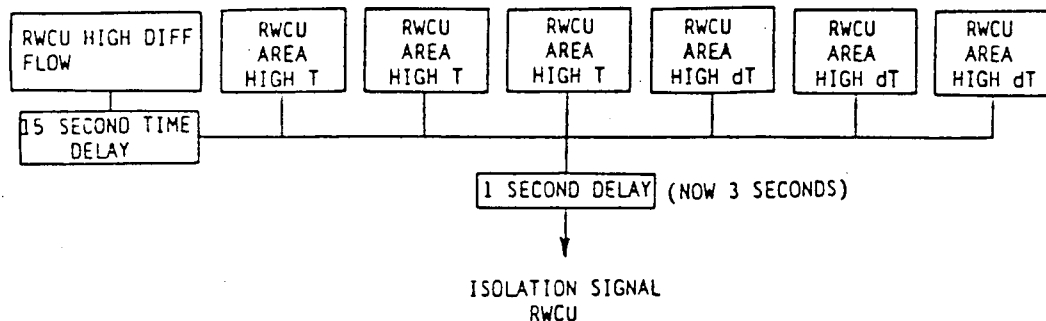
FIGURE I

As detailed in Figure I, there are four discrete signals which can result in a HPCI or RCIC isolation: HPCI or RCIC room high ambient temperature, HPCI or RCIC room high differential temperature, suppression pool area high ambient temperature, and suppression pool area high differential temperature. All four signals are subject to a one second time delay. This time delay was installed in 1986 to aid in prevention of spurious isolations in the one-out-of-one isolation signal logic. The suppression pool signals must also remain in for fifteen minutes (HPCI) or thirty minutes (RCIC) prior to an isolation signal occurring. (See LERs 84-28 Revision 1, and 86-007 for details). RWCU will also isolate on high area room temperatures and differential temperatures, and has had a one second time delay installed since 1985. (See LER 85-023).
