SUBJECT: LER 90-010-00:on 900519,CRD insert/withdraw line leakage & indications at one bundle due to high cycle fatigue.
 W/9 ltr.

Subject: Duane Arnold Energy Center
Docket No: 50-331
Op. License DPR-49
Licensee Event Report #90-010

**LICENSEE EVENT REPORT (LER)
TEXT CONTINUATION**

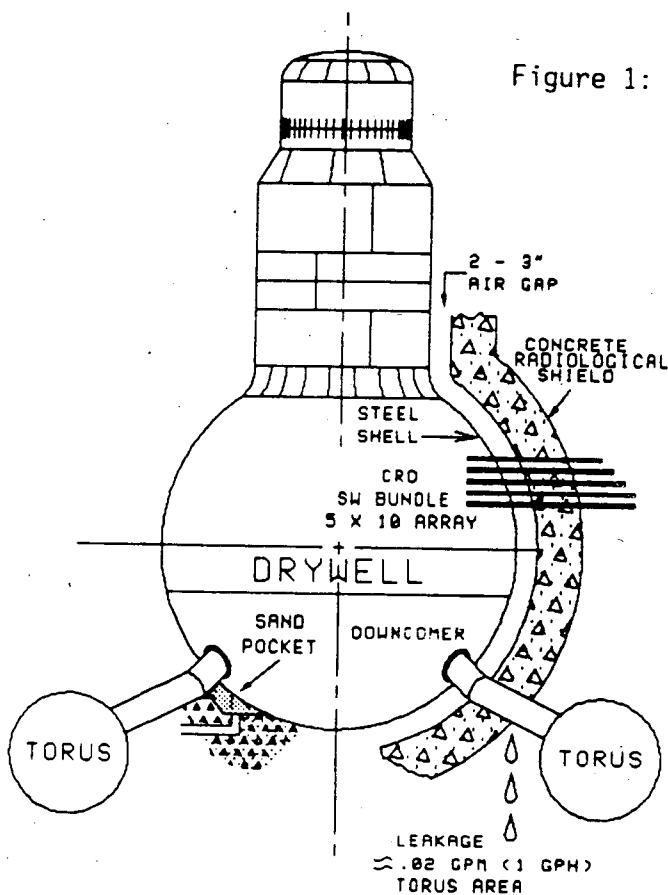
Figure 1:

During the past few years, with the reactor in various operational modes, small quantities of water have been observed dripping intermittently from a torus downcomer penetration in the southwest torus area. From the location of the downcomer, it appeared likely that the source of the water was in the air gap (annulus) region between the steel drywell shell and the outer, concrete radiological shield. (See Figure One). At one point the leakage was quantified at approximately one gallon per hour.

Drywell Shell, With Relative Location of Torus Downcomer and Southwest CRD Bundle

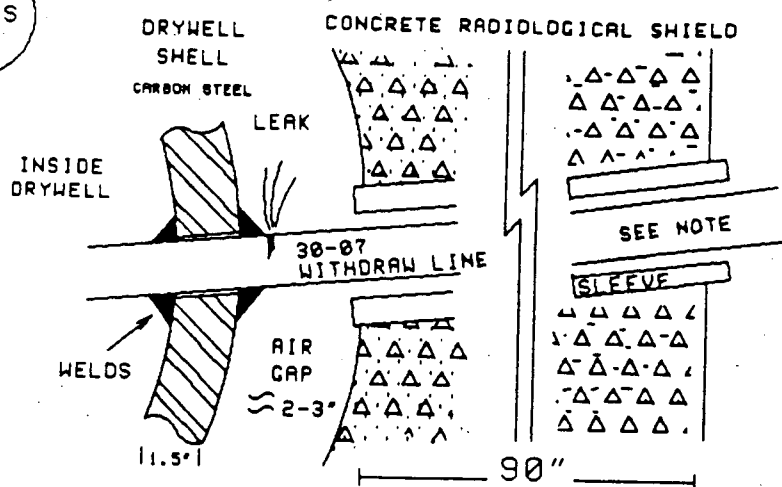
Figure 2:

On May 19, 1990, a Control Rod Drive (CRD, EIIS Code AA) withdraw line with a small (pinhole) leak was found at penetration X-37C/ X-38C. The leak in the pipe was at the toe of fillet weld between the pipe and the drywell shell. (See Figure Two). A second line at this penetration appeared to be weeping at a similar location. Penetration X-37C/X-38C is a bundle of fifty CRD insert and withdraw lines in the southwest quadrant of containment. (There are four CRD bundles in total, each located in a different quadrant). Upon inspection, roughly half of the southwest bundle lines were found to be visibly wet, and others had mineral streaks in evidence, indicating they had been wet in the past. Some corrosion and discoloration was in evidence on the pipes and drywell shell. Visual inspection within the air gap region of the other three CRD insert/withdraw line bundles saw no evidence of leakage, discoloration or notable corrosion. The dripping at the southwest torus downcomer penetration was noted at this time to be on the order of one gallon per hour.

no thru-wall cracks noted. All indications were circumferential in nature, in the pipes at the toe of the shell to pipe fillet weld, and from the outside diameter in. The indications were very fine and tight. (The withdraw line leak was not visible below 700 psig reactor pressure, and upon removal, its thru-wall crack could not be seen). A sampling of lines at the other three CRD bundle penetrations found no evidence of abnormal indications, indicating the problem was specific to the southwest CRD bundle.

To aid in determination of the root cause, examples of insert and withdraw lines from the southwest bundle with indications were sent to an off-site laboratory for metallurgical testing. The results indicated transgranular fracturing at multiple locations from the outside diameter in, with striations present consistent with high cycle fatigue and periodic crack growth. No evidence was found of stress corrosion cracking (chloride-induced or otherwise).

A subsequent review of the metallurgical analysis, CRD system history and performance, and characteristics unique to the southwest bundle has not resulted in a root cause determination. Evidence points to the existence of a high cycle forcing function, currently unknown, which periodically over time is inducing excessive fatigue in the southwest CRD bundle lines. The predisposition of these lines to high cycle fatigue due to unique, non-cyclic fabrication, construction, environmental and operational factors is also under consideration.

30-07 WITHDRAW LINE

LEAKAGE OBSERVED AT POWER

Close-up Perspective of Leaking Southwest Bundle CRD Withdraw Line

THRU-WALL INDICATION NOT VISIBLE UPON REMOVAL

As a corrective action for the extensive indications noted in the southwest CRD bundle, all lines in that bundle have been replaced at the penetration into the drywell. A sleeve has been welded to the CRD pipe, and then attached to the drywell shell plate utilizing a partial penetration groove weld with a cover fillet. This new design provides increased flexibility for thermal transients without sacrificing the carrying capacity needed for mechanical loads. Enhanced leakage monitoring is also under review.
